CROSSINGS CAMPUS

Addendum to Draft Environmental Impact Report State Clearinghouse No. 2021110079

ADDENDUM TO THE ENVIRONMENTAL IMPACT REPORT FOR THE CROSSINGS CAMPUS PROJECT

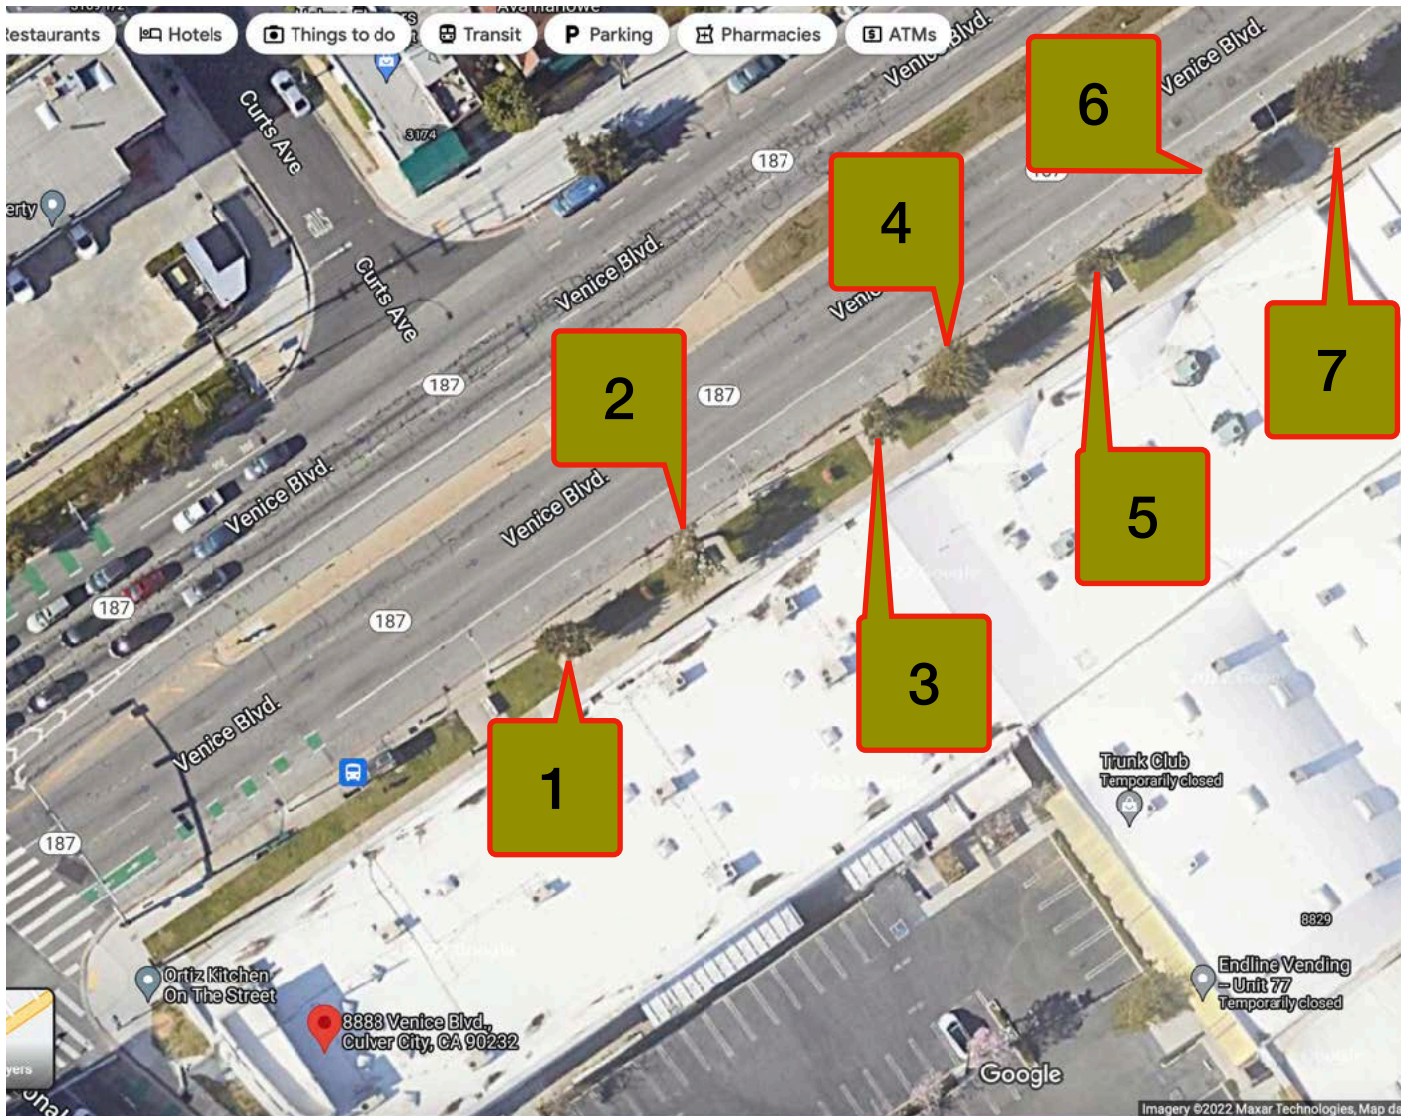
PHOTO 1 - Shows City of Los Angeles street trees #1- #7. Trees #1 - #7 are recommended for removal and replacement.

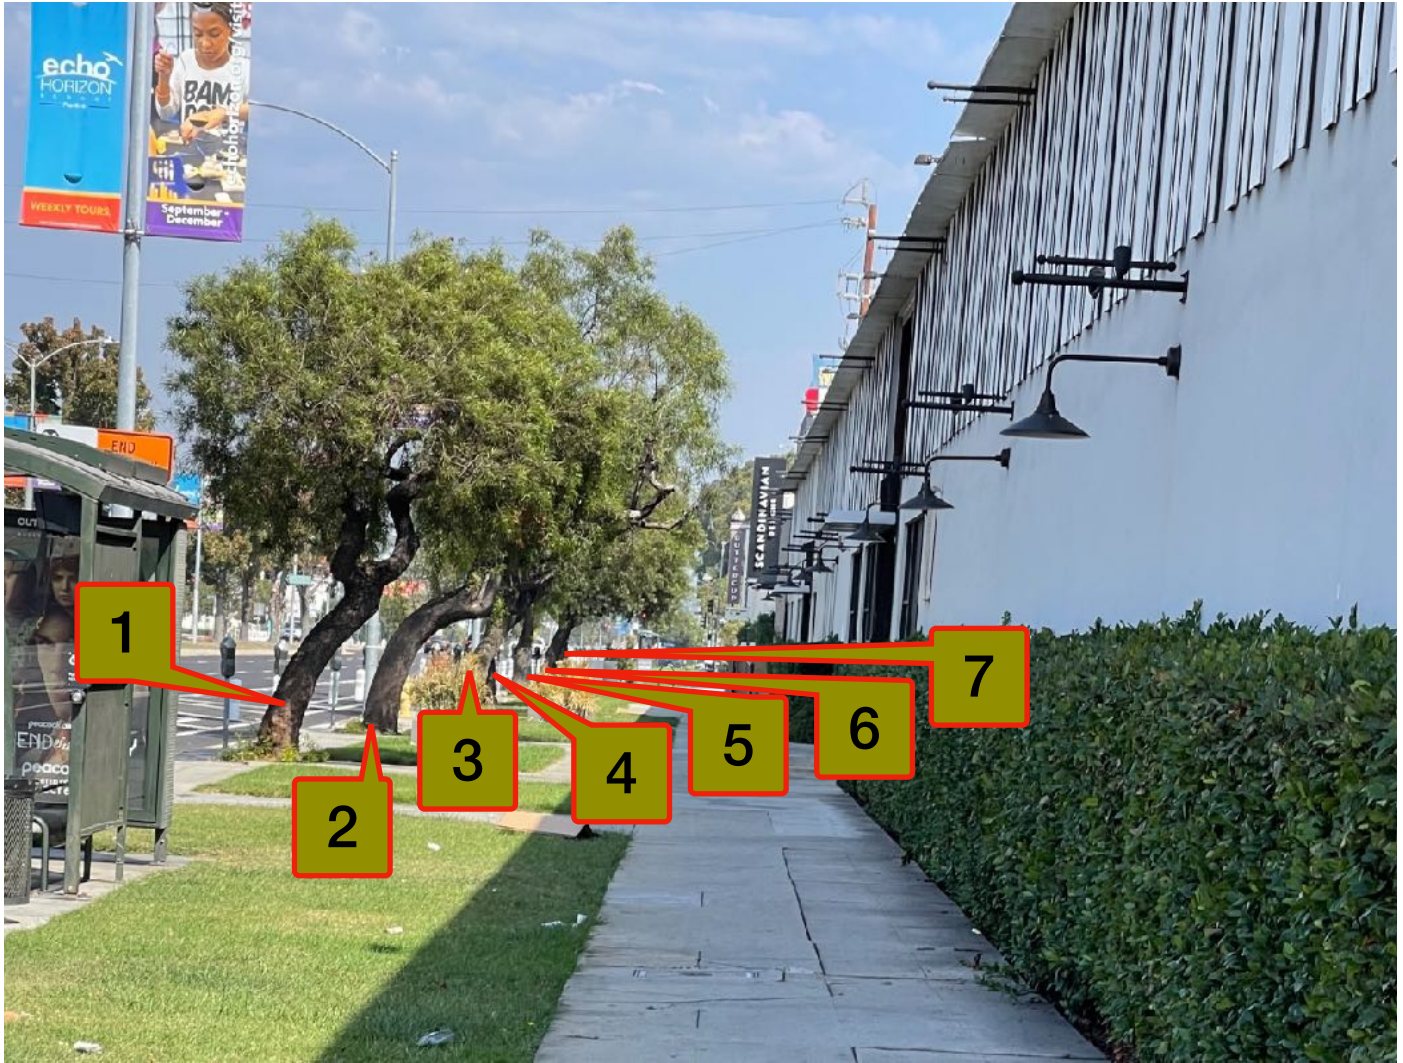
PHOTO 2 - Shows City of Los Angeles street trees #1- #7. Trees #1 - #7 are recommended for removal and replacement.

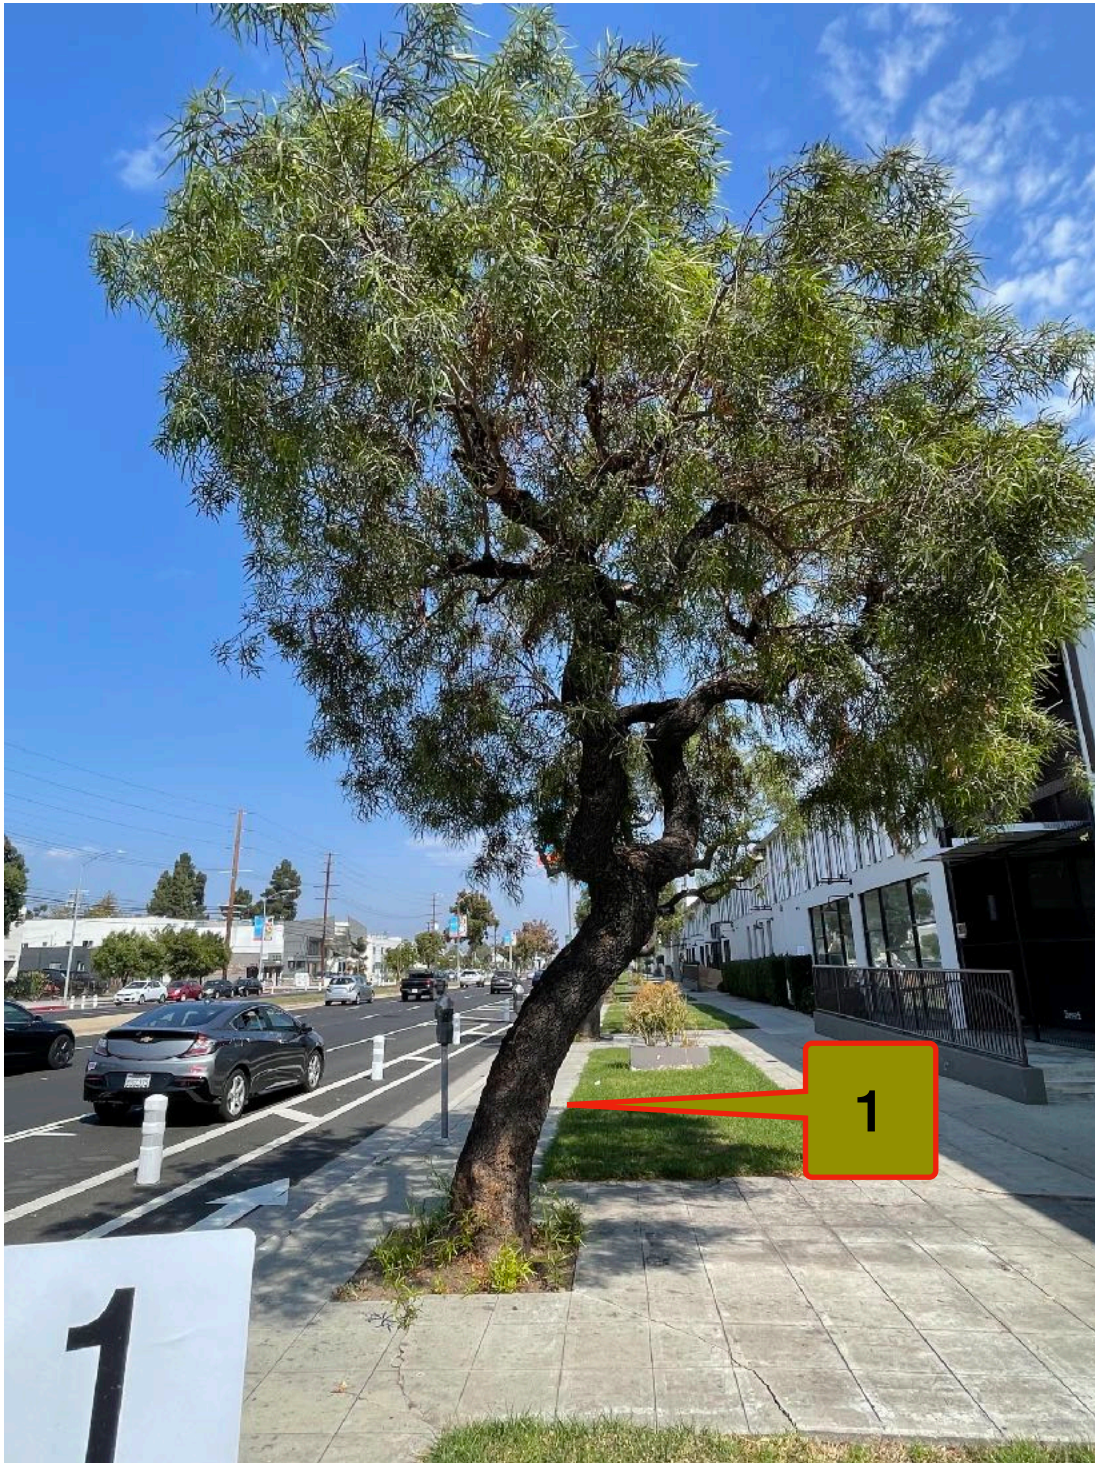
PHOTO - Shows City of Los Angeles street tree #1. Trees #1 through #7 are recommended for removal and replacement.

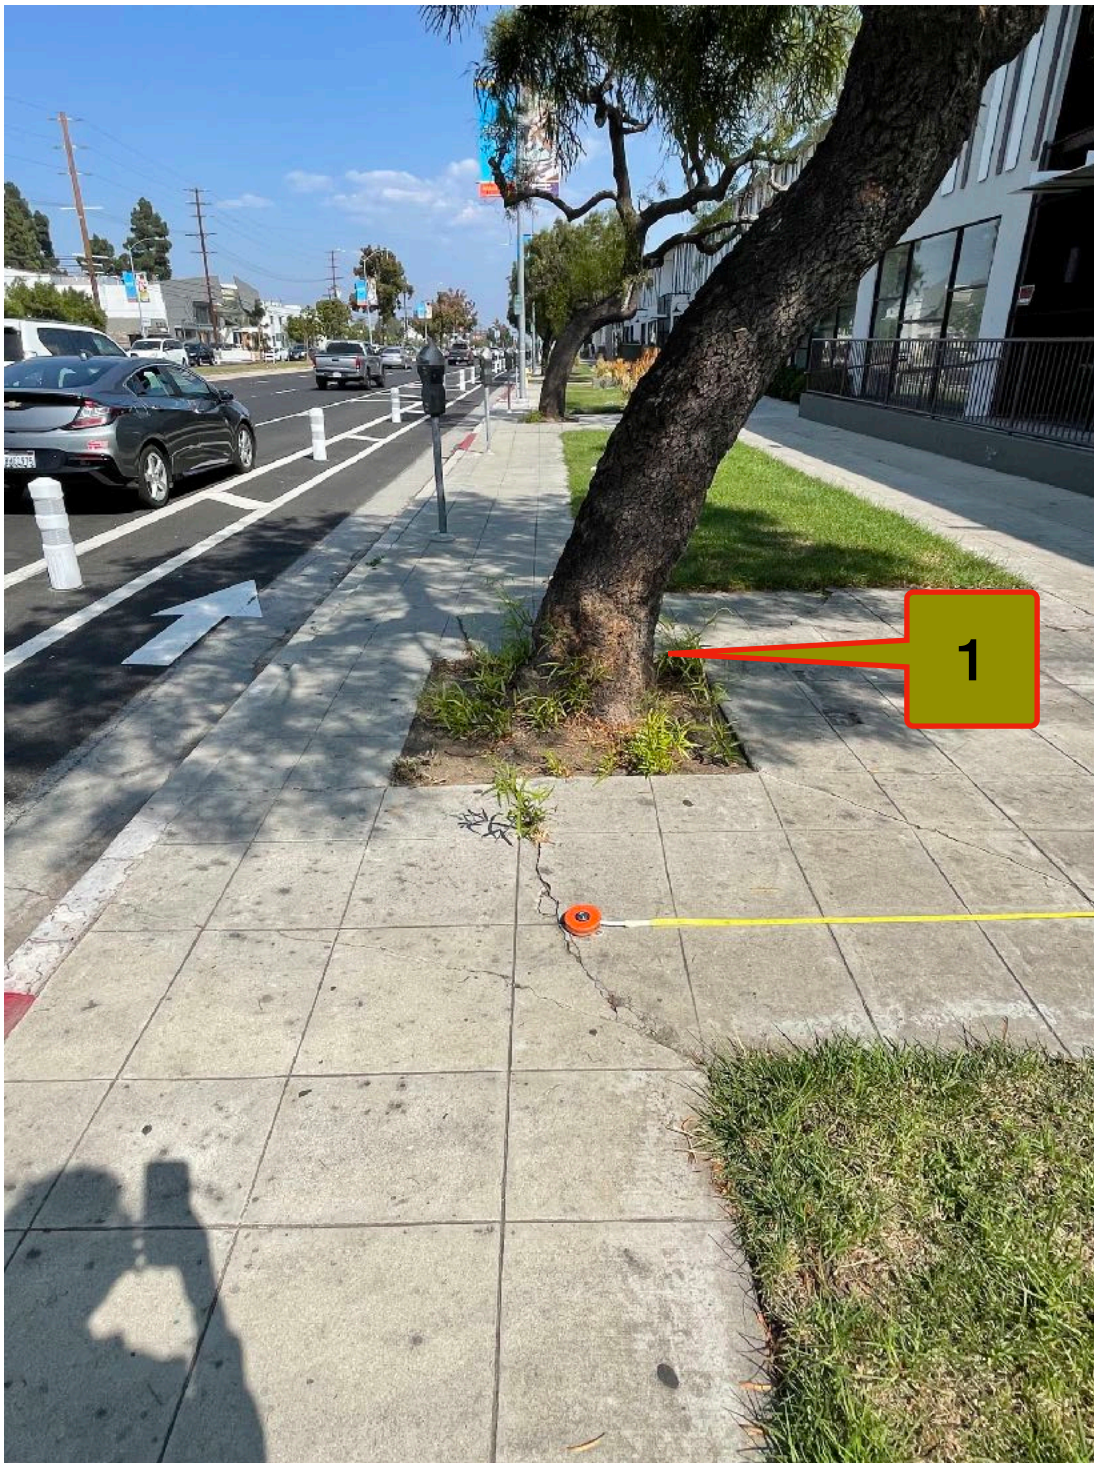
PHOTO 4 - Shows City of Los Angeles street tree #1 with prominent lean.

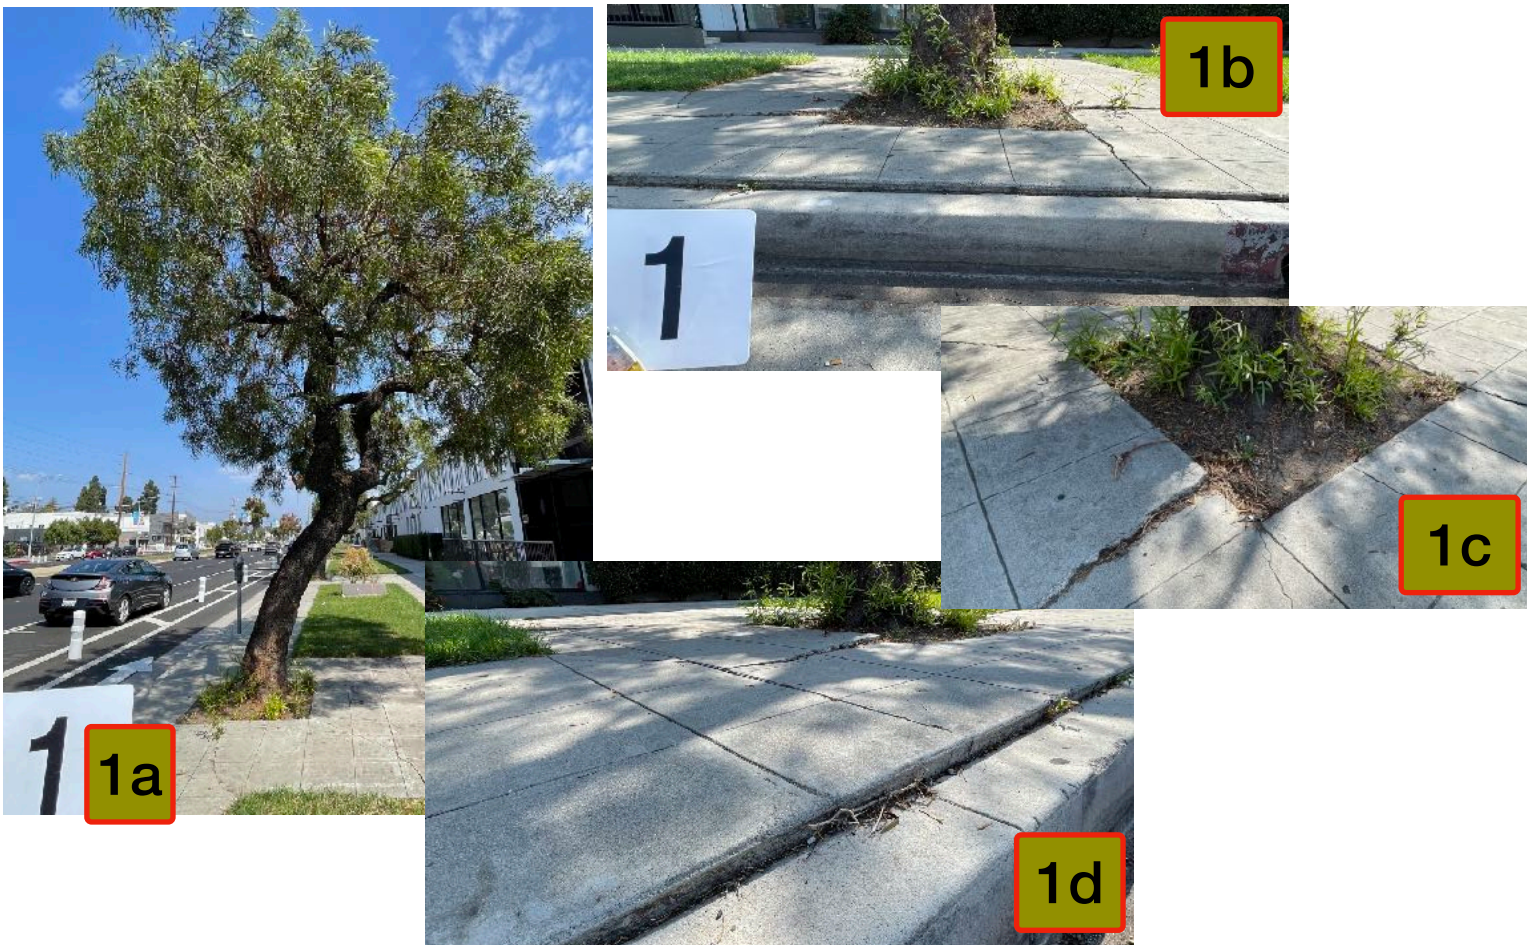
PHOTO 5 - Shows City of Los Angeles street tree #1, recommend for removal.

1a) Leaning trunk, asymmetrical canopy

1b, c, d) Cracking and lifting sidewalk

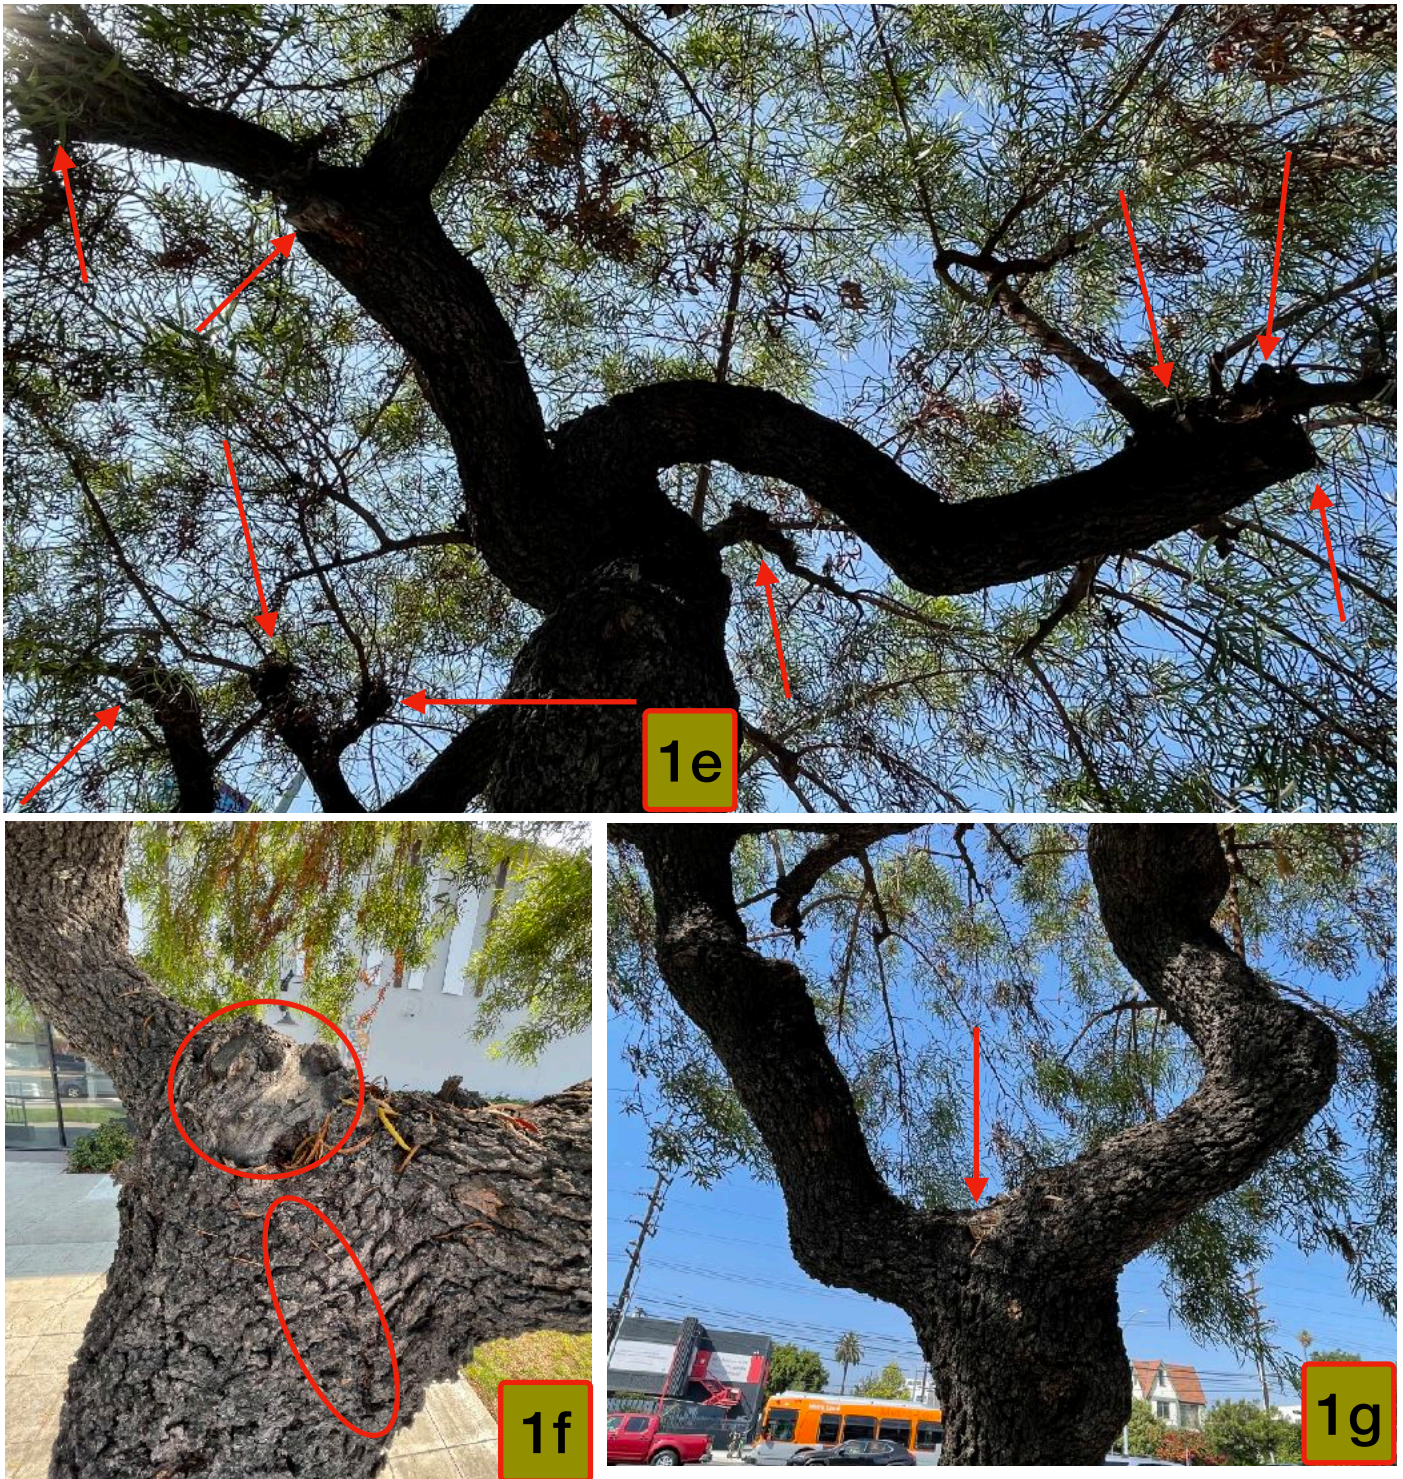
PHOTO 6 - Shows City of Los Angeles street tree #1, recommend for removal.

1e) Wound wood and regrowth from decades of topping, sparse regrowth (a tree of this species and age should have a more dense full canopy), regrowth is prone to breakage.

1f) Red circle is an old topping wound, decay column present, Red oval is a bark fissure; The red circle and oval weakened attachment at the main union between bole (main trunk) and the two primary scaffold limbs.

1g) Shows opposite side of main union as seen in 1f.

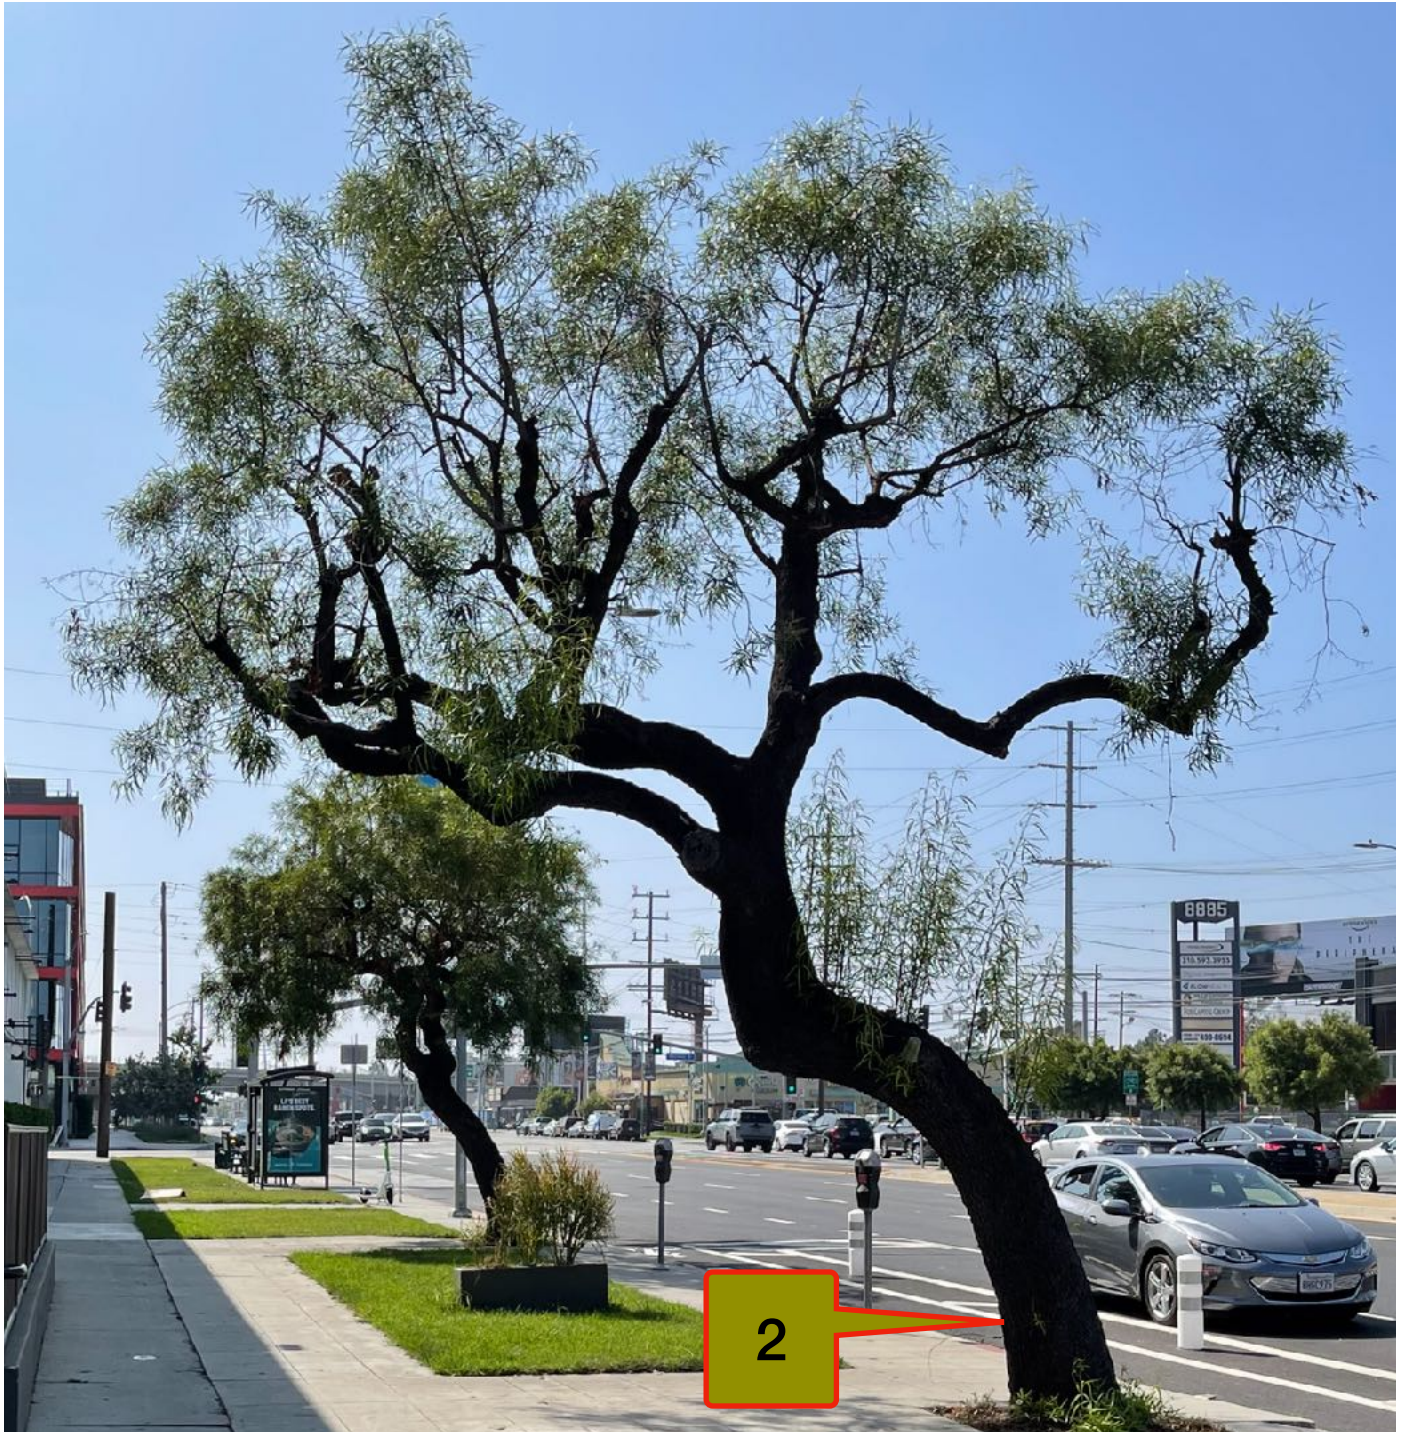
PHOTO - Shows City of Los Angeles street tree #2. This tree has a sparse canopy density and lack of leaf area to produce photosynthesis is not enough to sustain the health and vigor of a tree of this age and size. Trees #1 through #7 are recommended for removal and replacement.

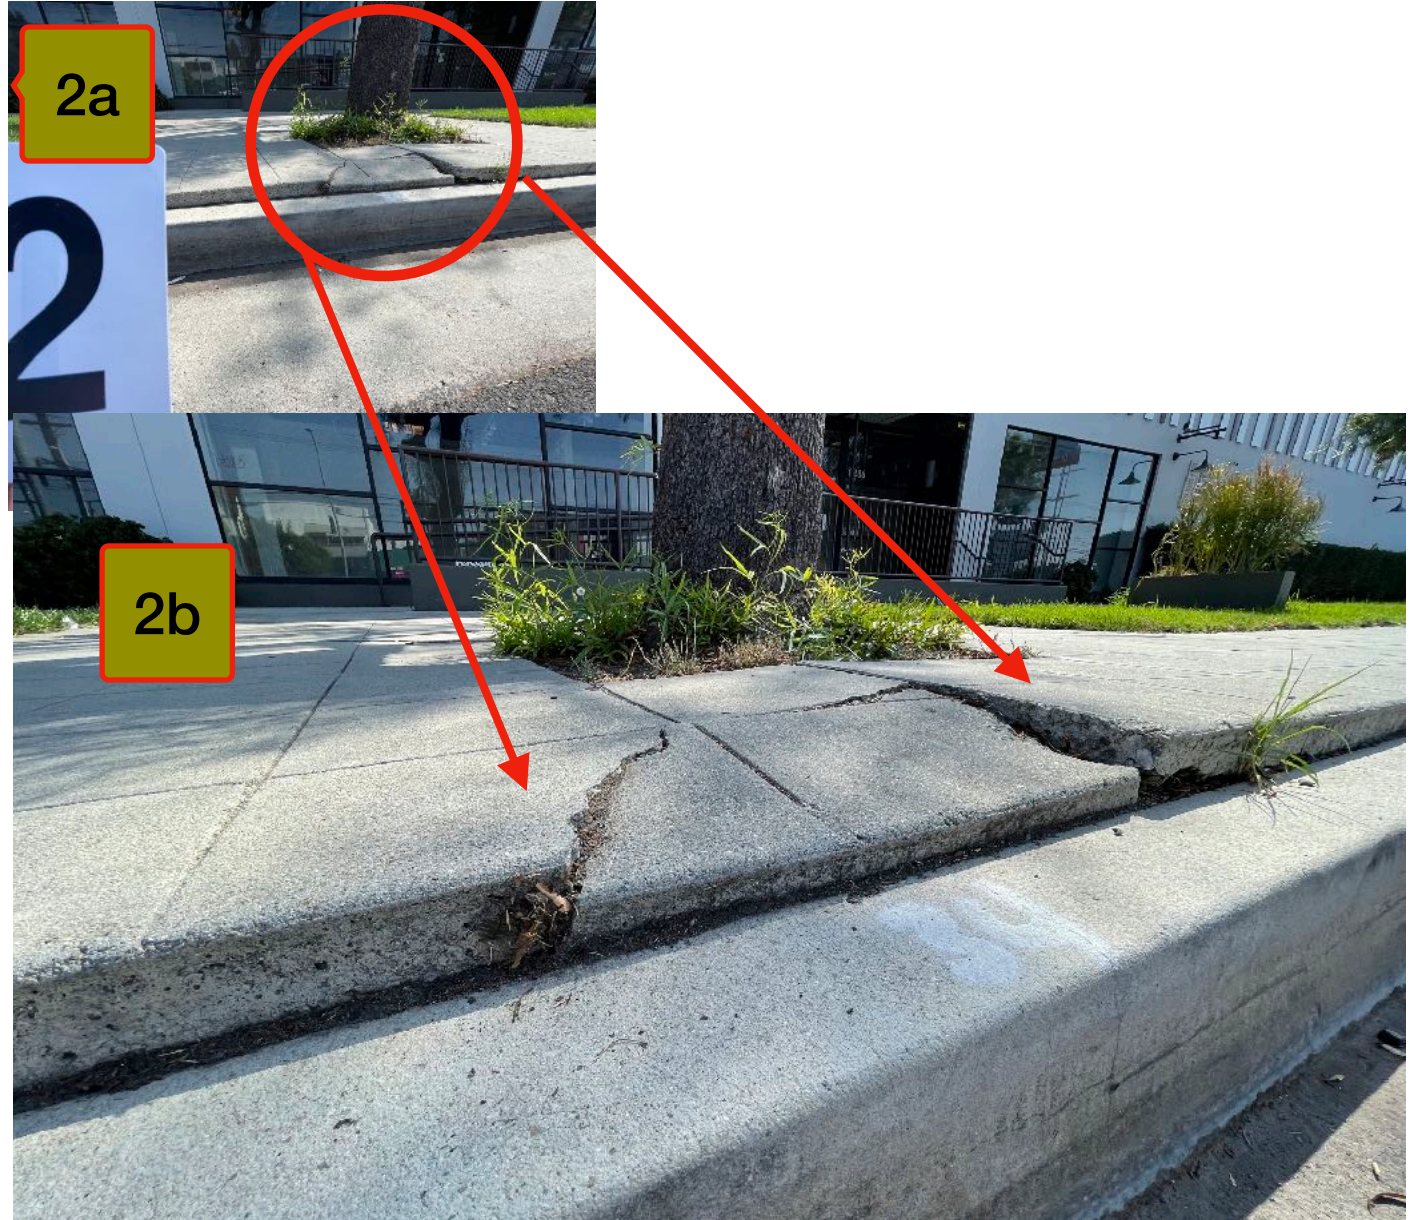
PHOTO - Shows City of Los Angeles street tree #2, recommend for removal.
2a, b) Cracking and uplifting of sidewalk in public right of way

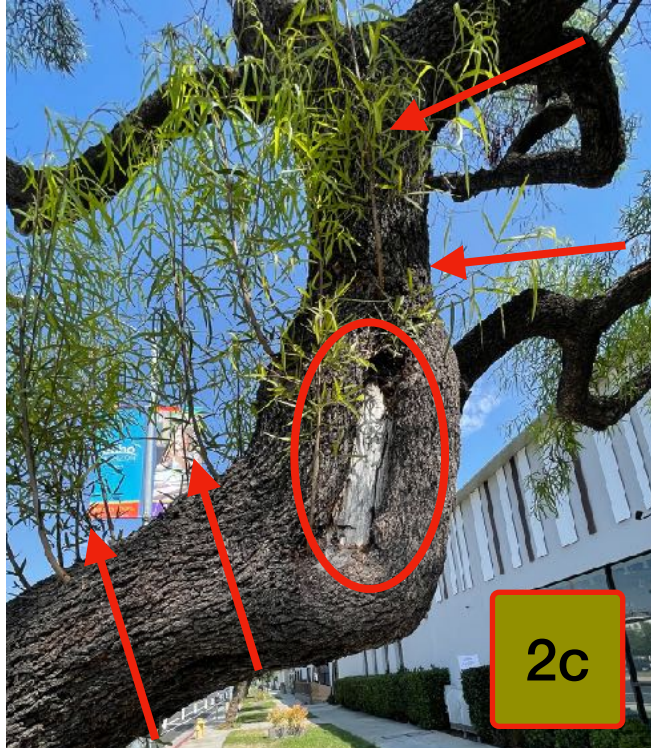
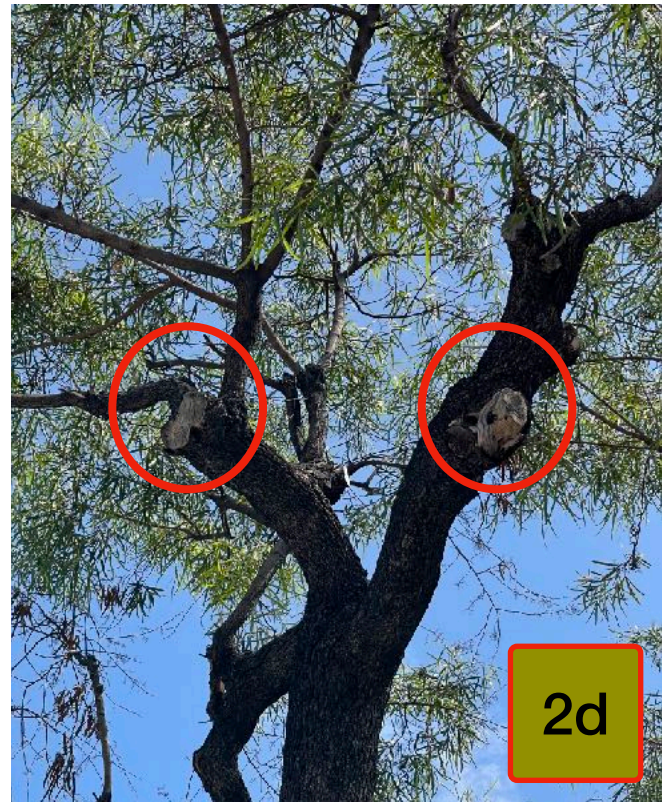
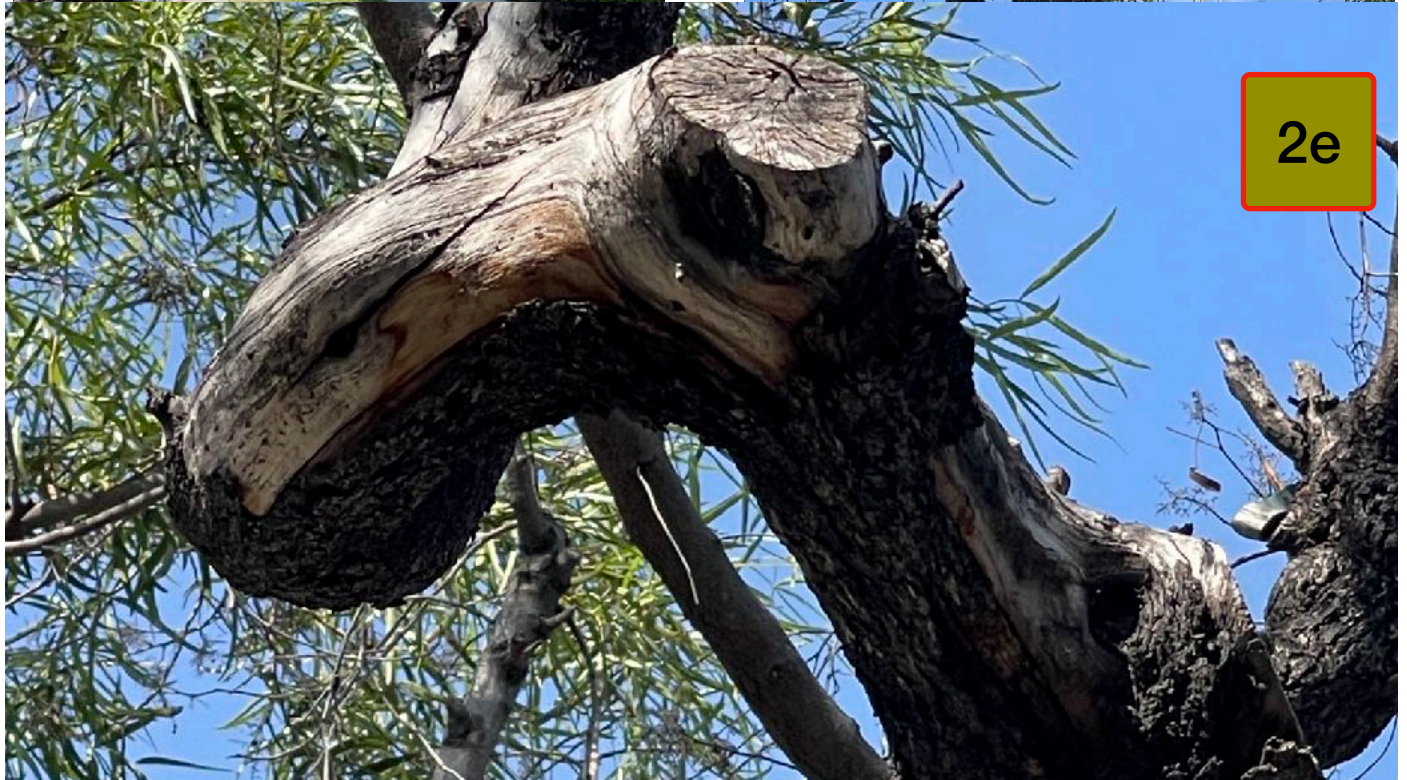
PHOTO 6 - Shows City of Los Angeles street tree #2, recommend for removal.

2c) Red oval is an old trunk segment break, decay column present, Red arrows show epicormic sprout growth in reaction to repeated topping.

2d) Red circles are old topping wounds too large for the tree to properly close off, site for breakage & decay

2e) Necrotic old topping wound stub

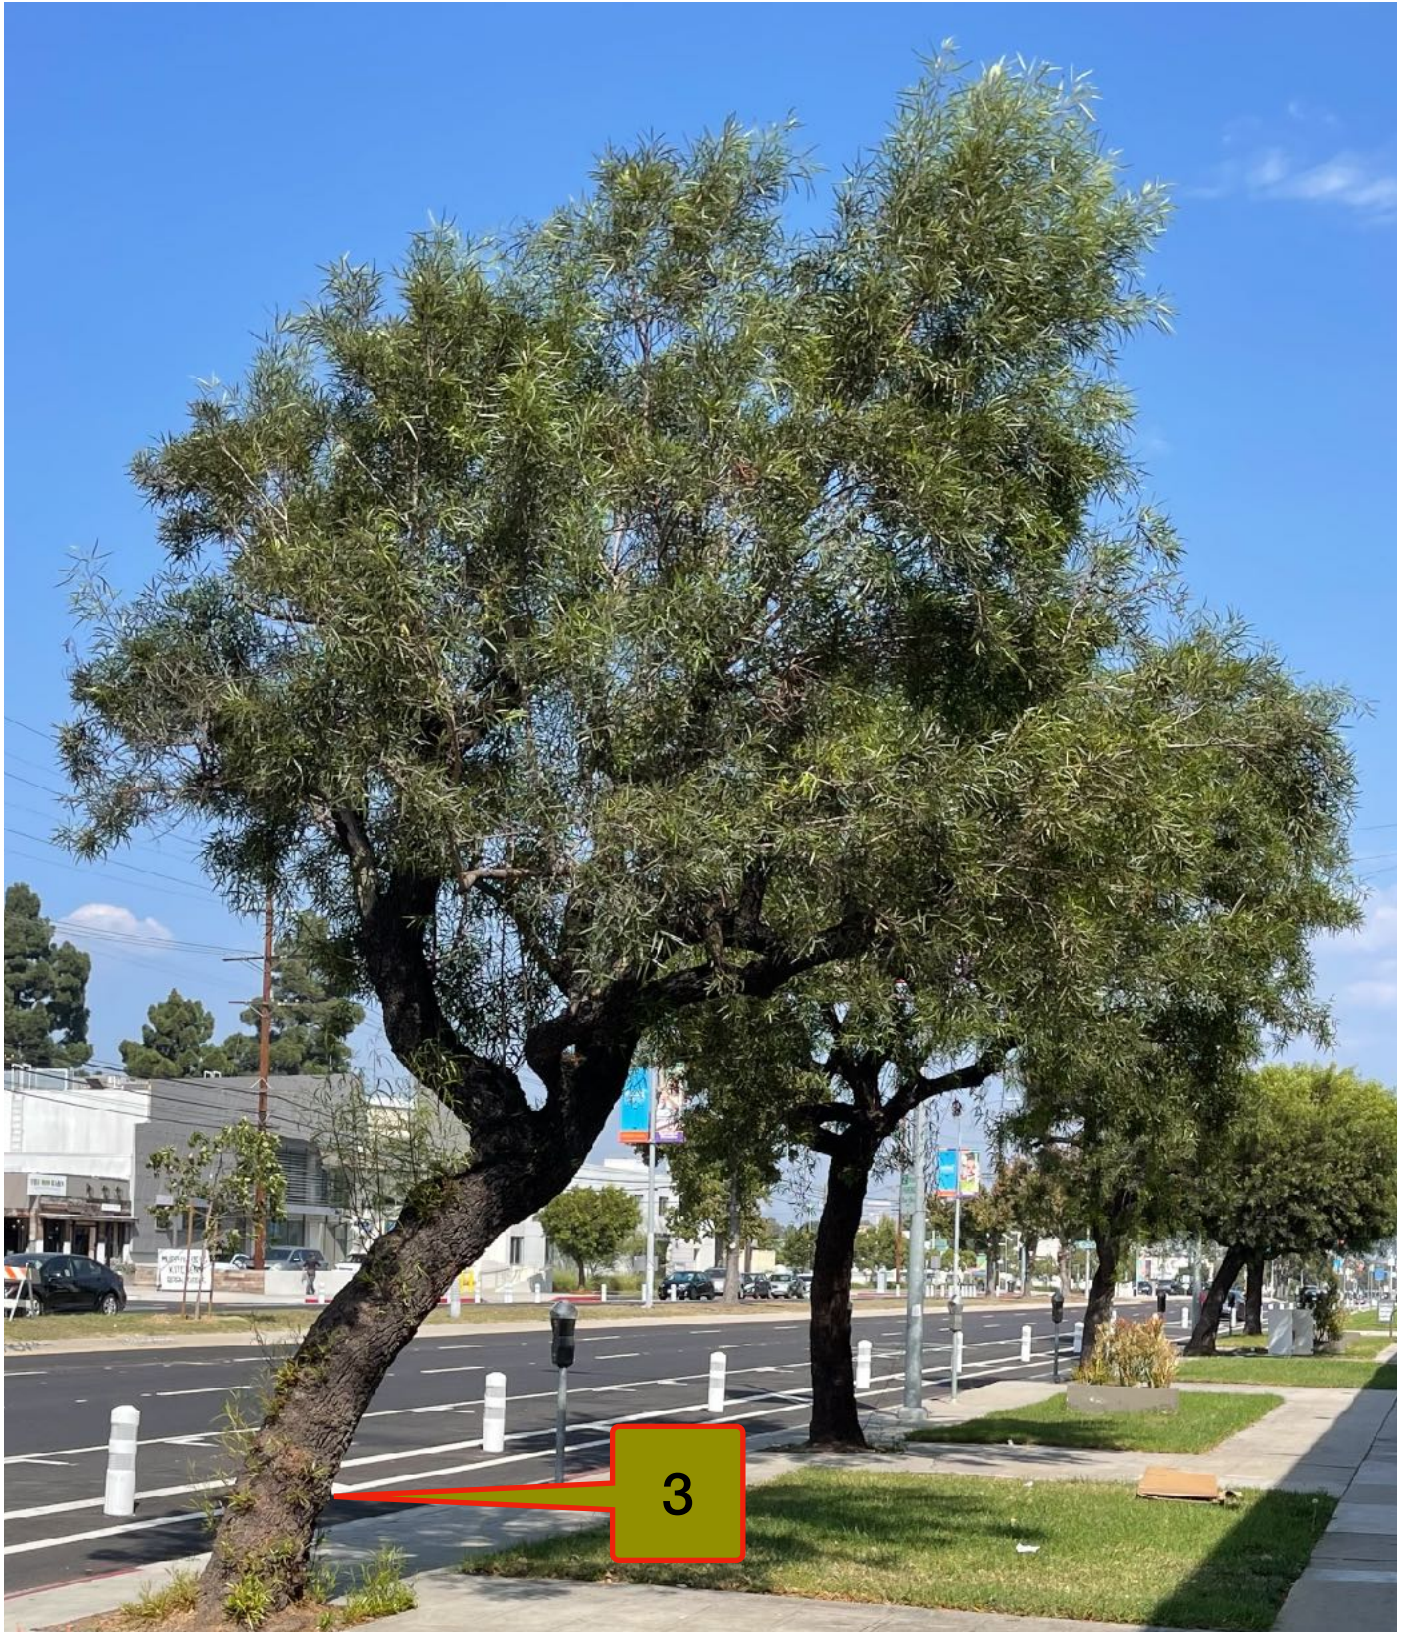
PHOTO - Shows City of Los Angeles street tree #3. Tree has a pronounced lean and an asymmetrical canopy. Trees #1 through #7 are recommended for removal and replacement.

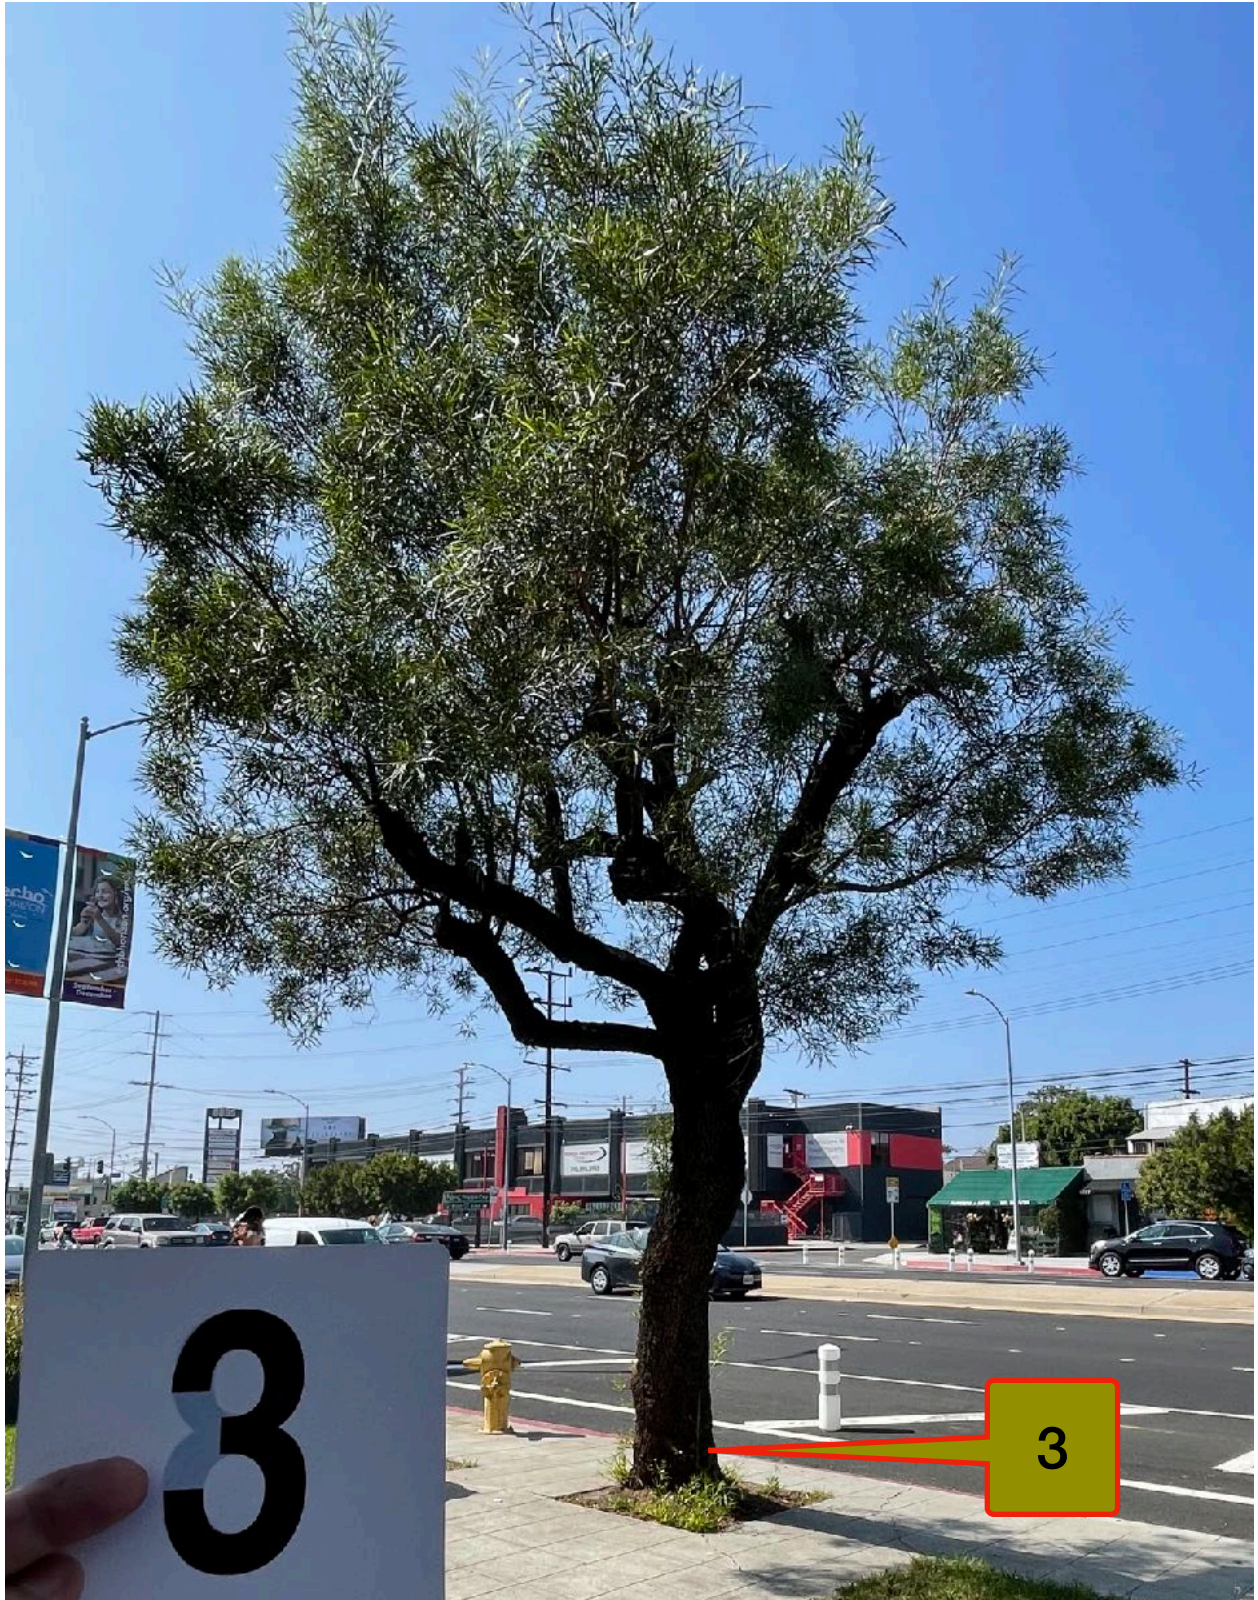
PHOTO - Shows City of Los Angeles street tree #3. Tree has an asymmetrical canopy from repeated toppings. Trees #1 through #7 are recommended for removal and replacement.

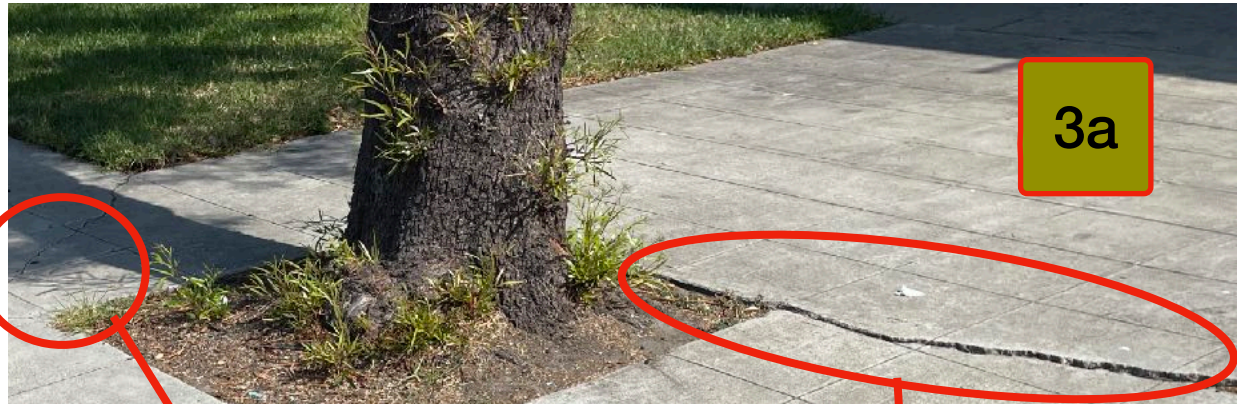
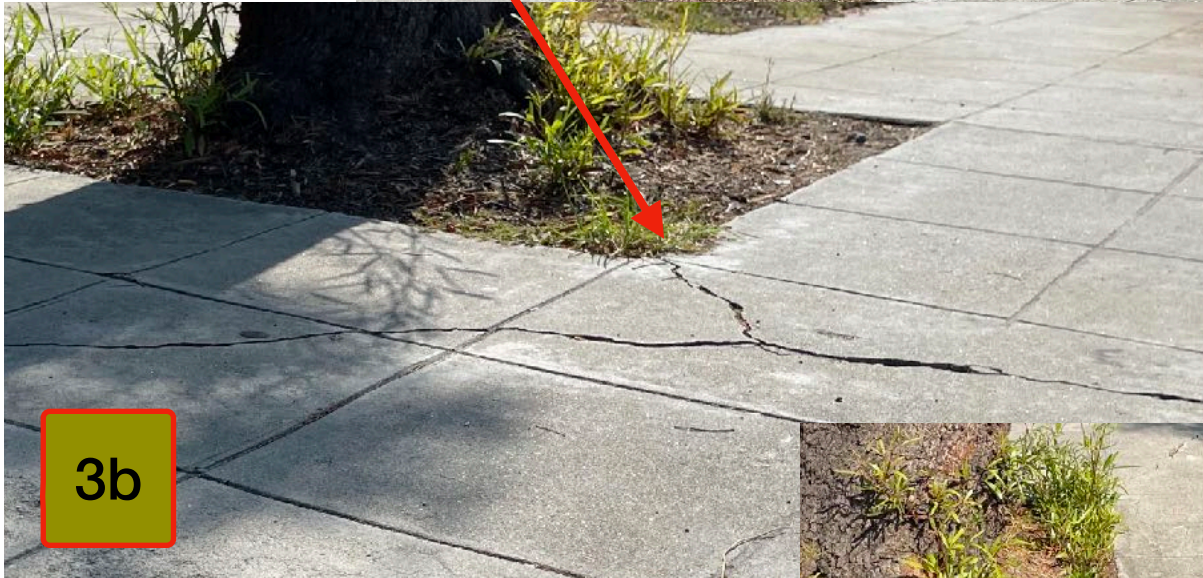
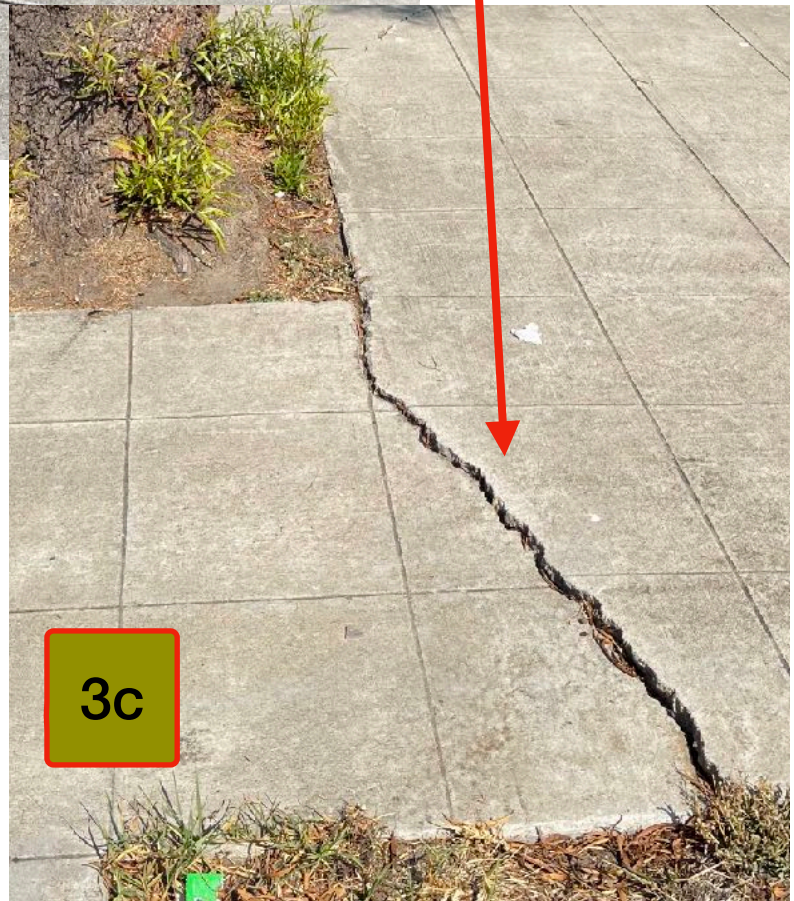
PHOTO - Shows City of Los Angeles street tree #3, recommend for removal.

3a, b, c) Cracking and uplifting of sidewalk in public right of way
