CROSSINGS CAMPUS

Addendum to Draft Environmental Impact Report State Clearinghouse No. 2021110079

ADDENDUM TO THE ENVIRONMENTAL IMPACT REPORT FOR THE CROSSINGS CAMPUS PROJECT

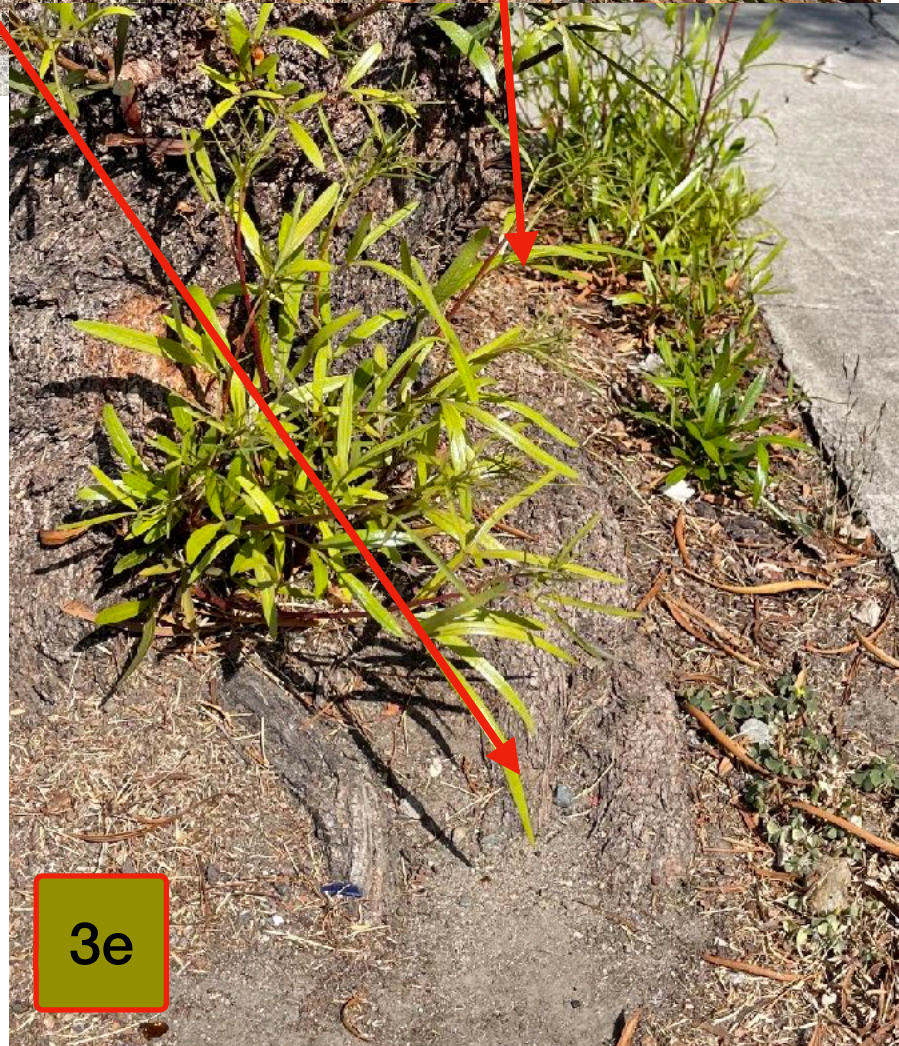
PHOTO - Shows City of Los Angeles street tree #3, recommend for removal.

3d) Yellow arrows show epicormic trunk and root sprouting, an indication the tree is stressed.

3d, e) Double red arrows show STEM GIRDLING ROOTS wrapped around trunk - from two different angles and indication how the ends correspond in each photo.

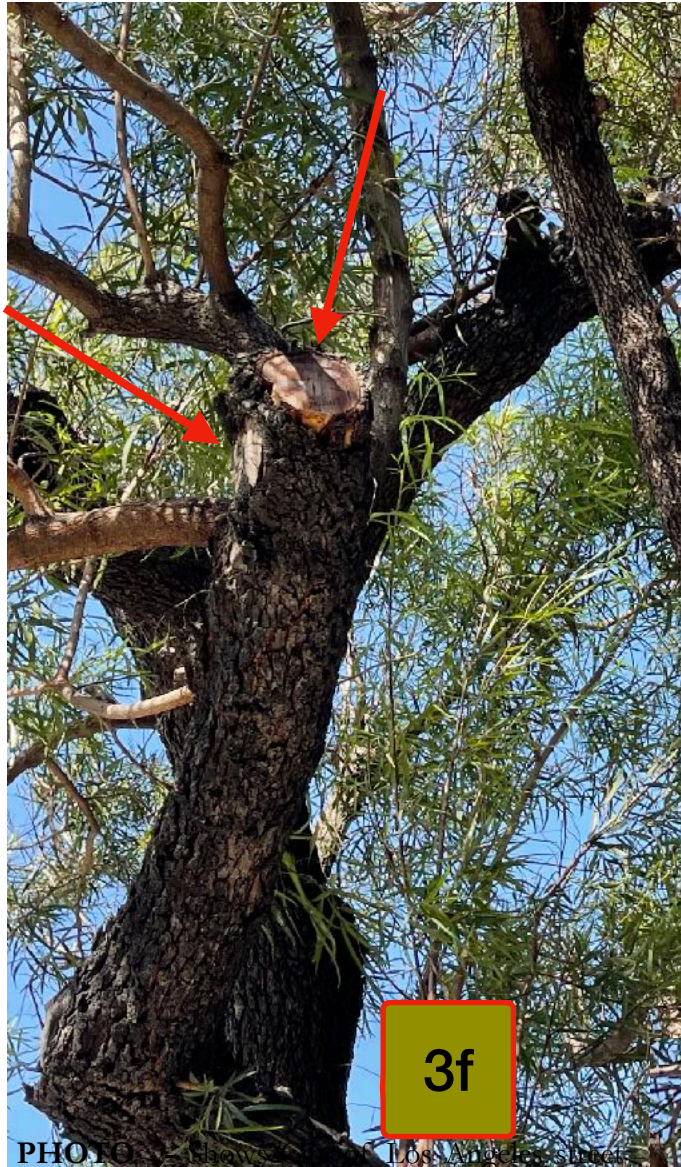
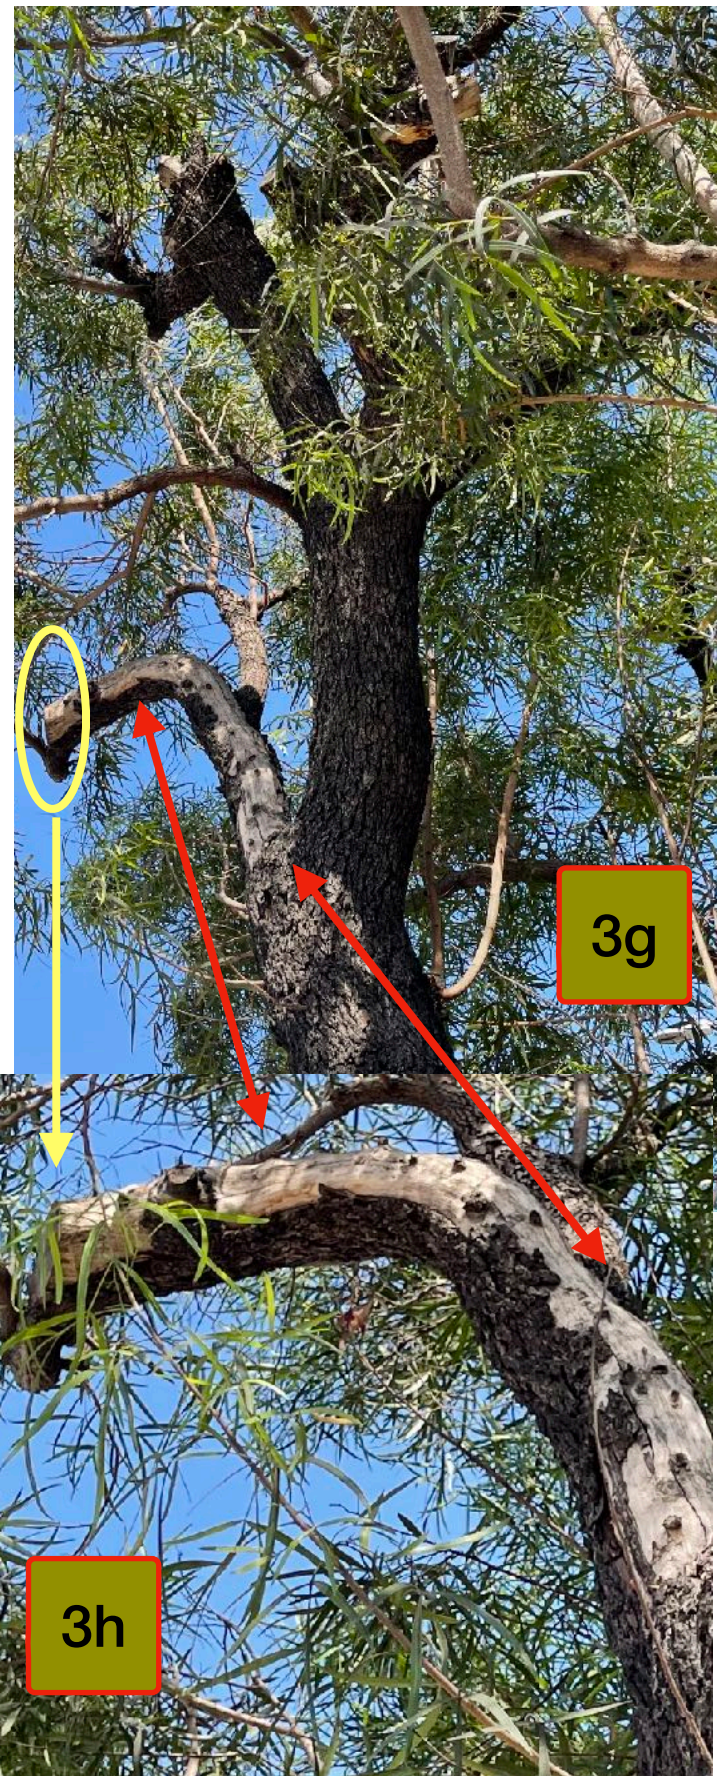
PHOTO 3f shows tree #3, recommend for removal.

3f) Old aggressive heading and topping cuts, all wood present at the time of wounding shall decay. The stems growing out of or adjacent to these topping cuts are more weakly attached to the tree and more prone to breakage.

3g, h) SUNSCALD - reduces branch strength and integrity - increases likelihood of branch failure. Topping exposes interior scaffold limbs to sun scald. Necrotic tissue on limb is a result of over exposure to direct sunlight and stub cut (yellow circle).

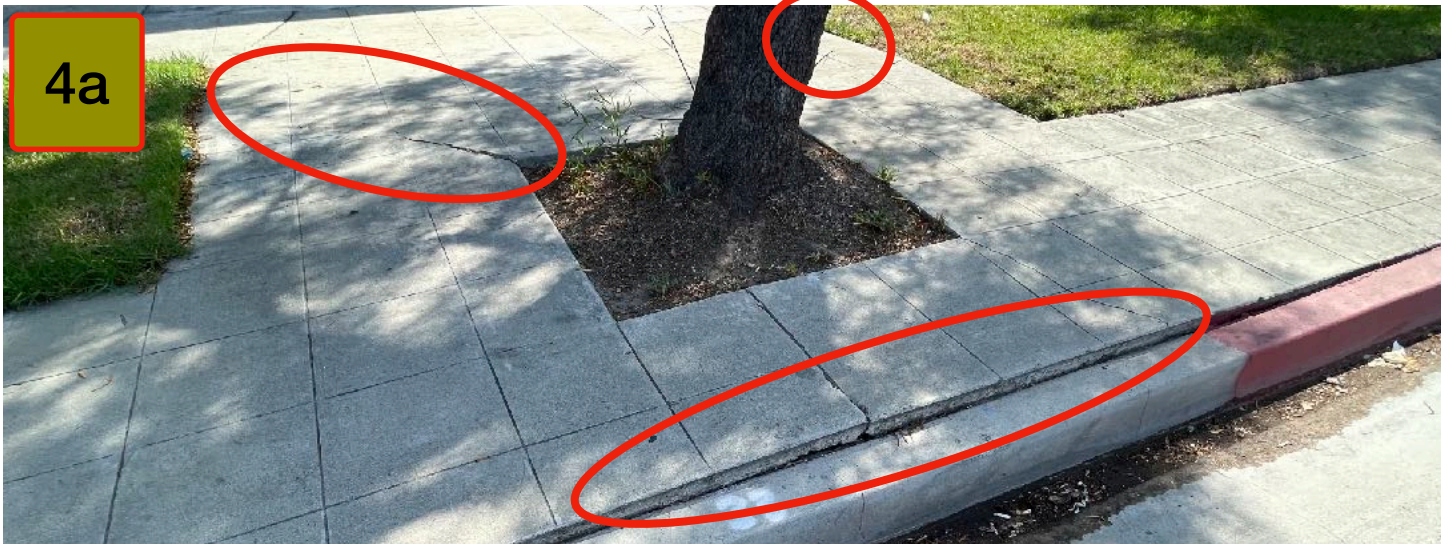
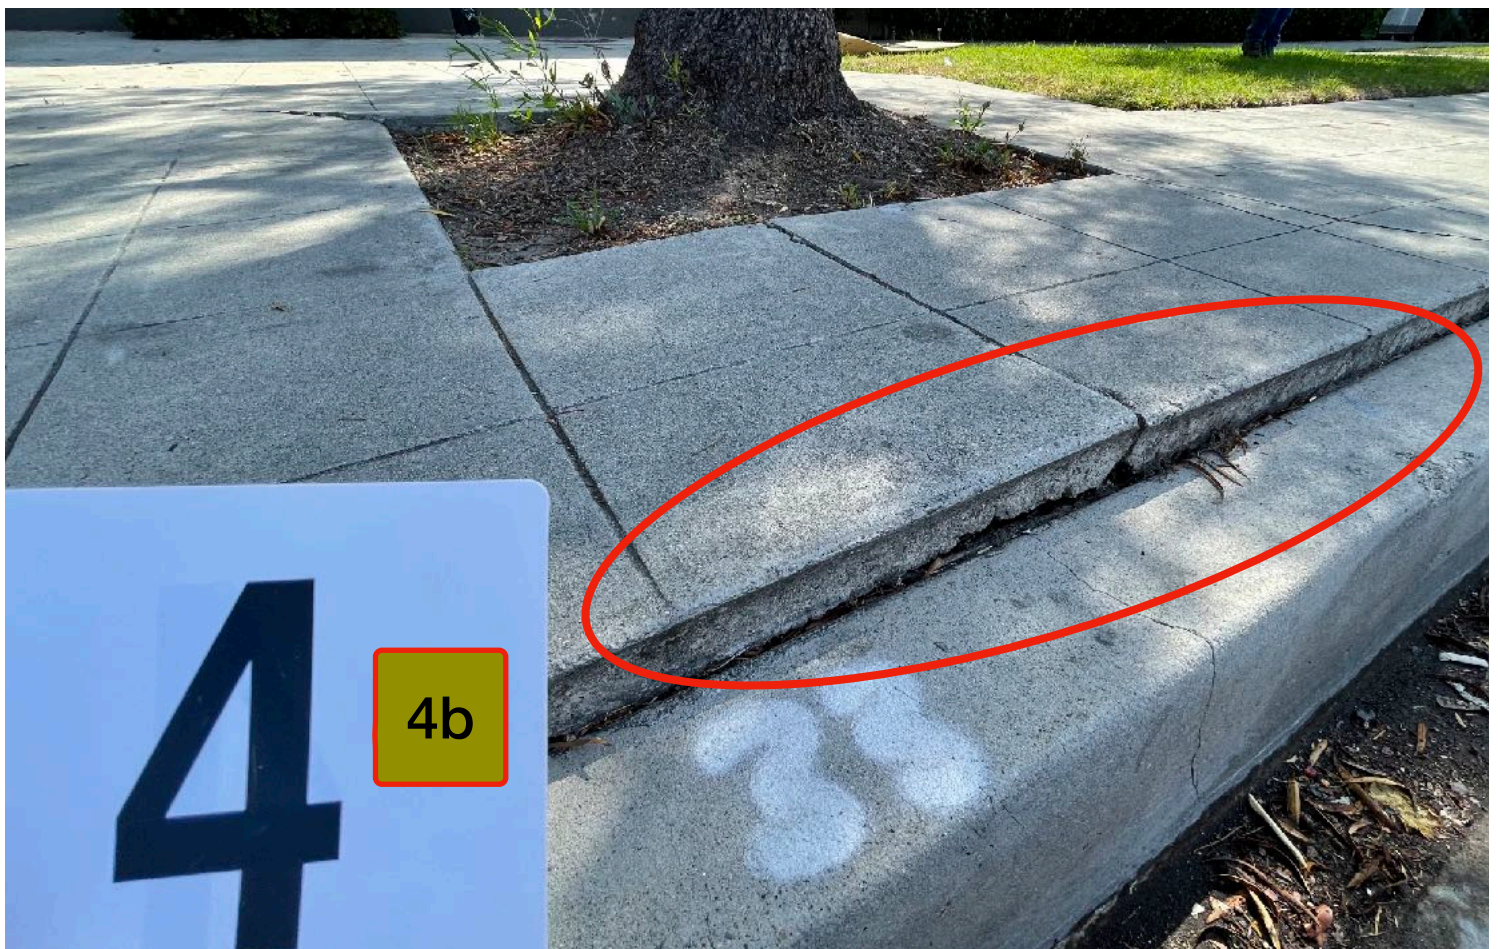
PHOTO - Shows City of Los Angeles street tree #4, recommend for removal.

3a) Cracking and uplifting of sidewalk in public right of way

3b) More prominent picture of sidewalk uplift.

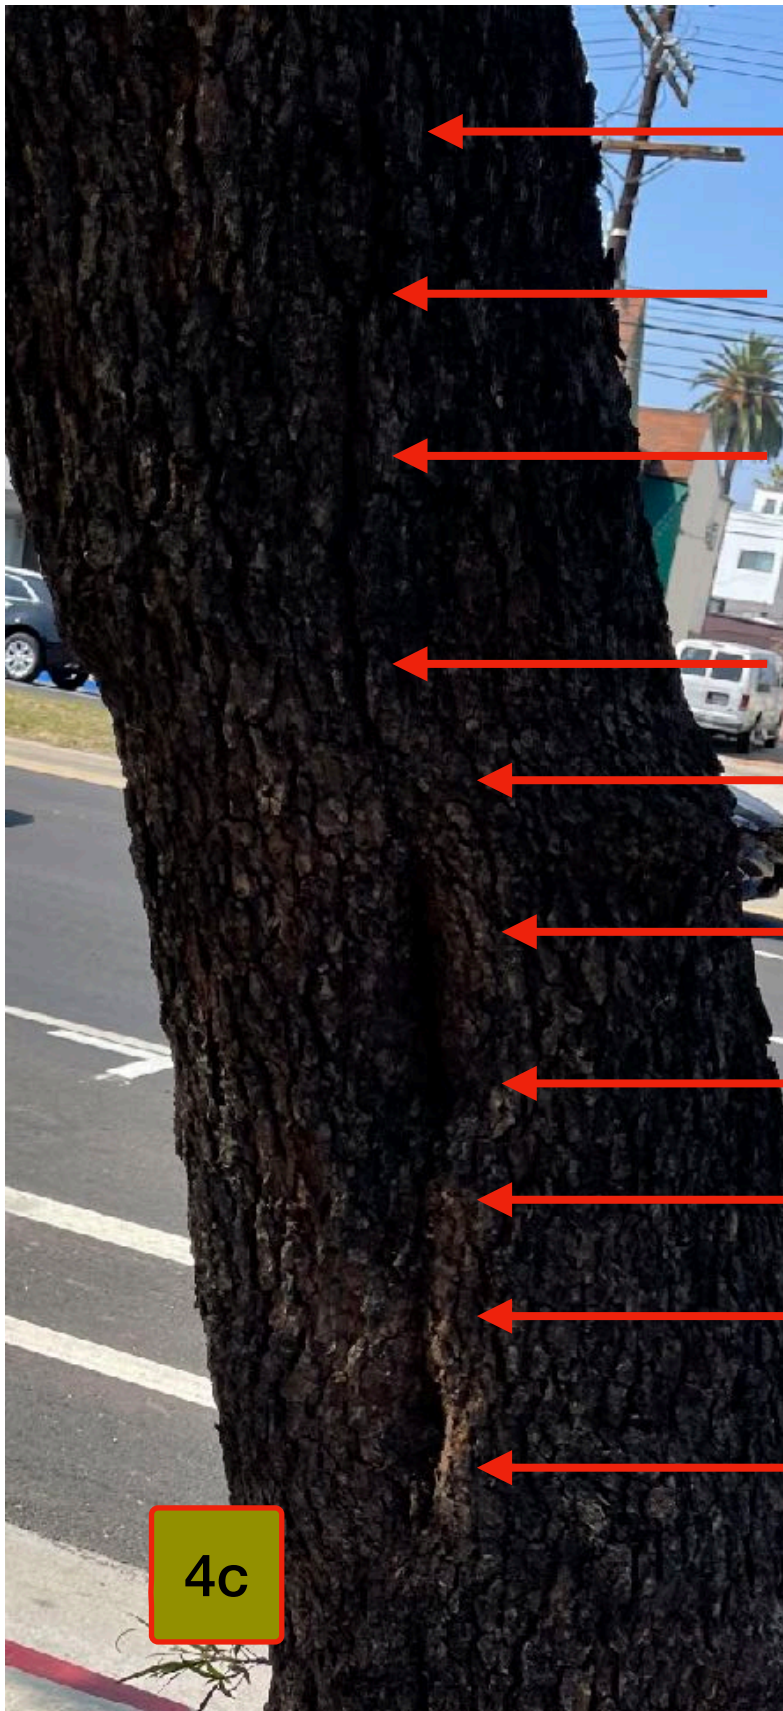
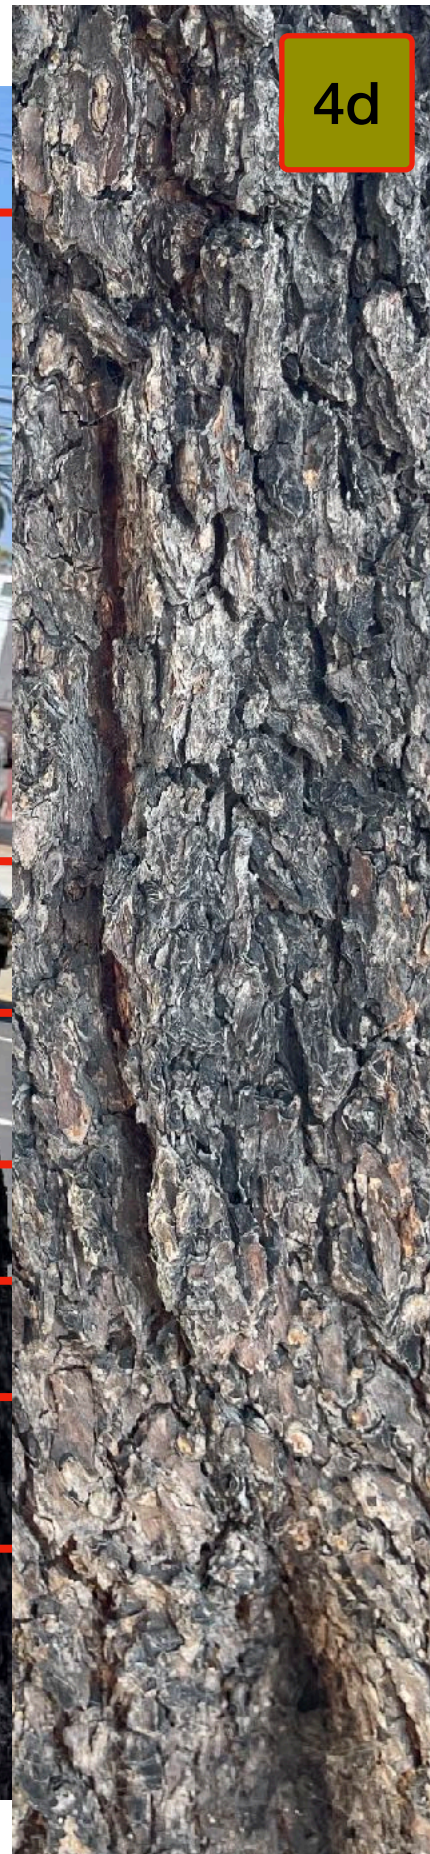
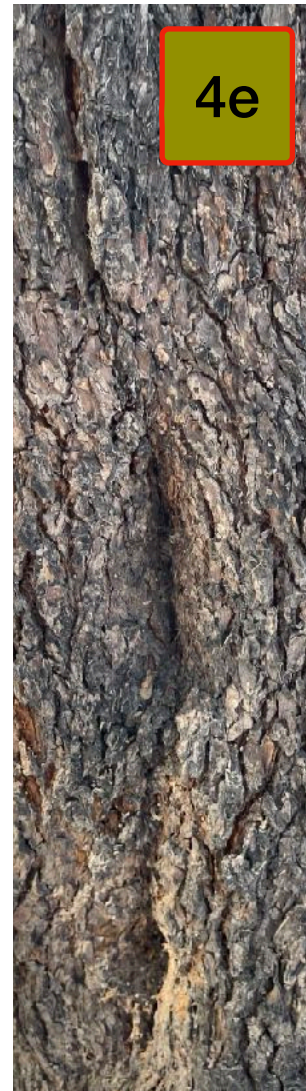
PHOTO - Shows City of Los Angeles street tree #4, recommend for removal.

4c, d, e) Bark fissure. Level 3 Tree Risk Assessment (Sonic Tomography) needed to determine extent of decay.

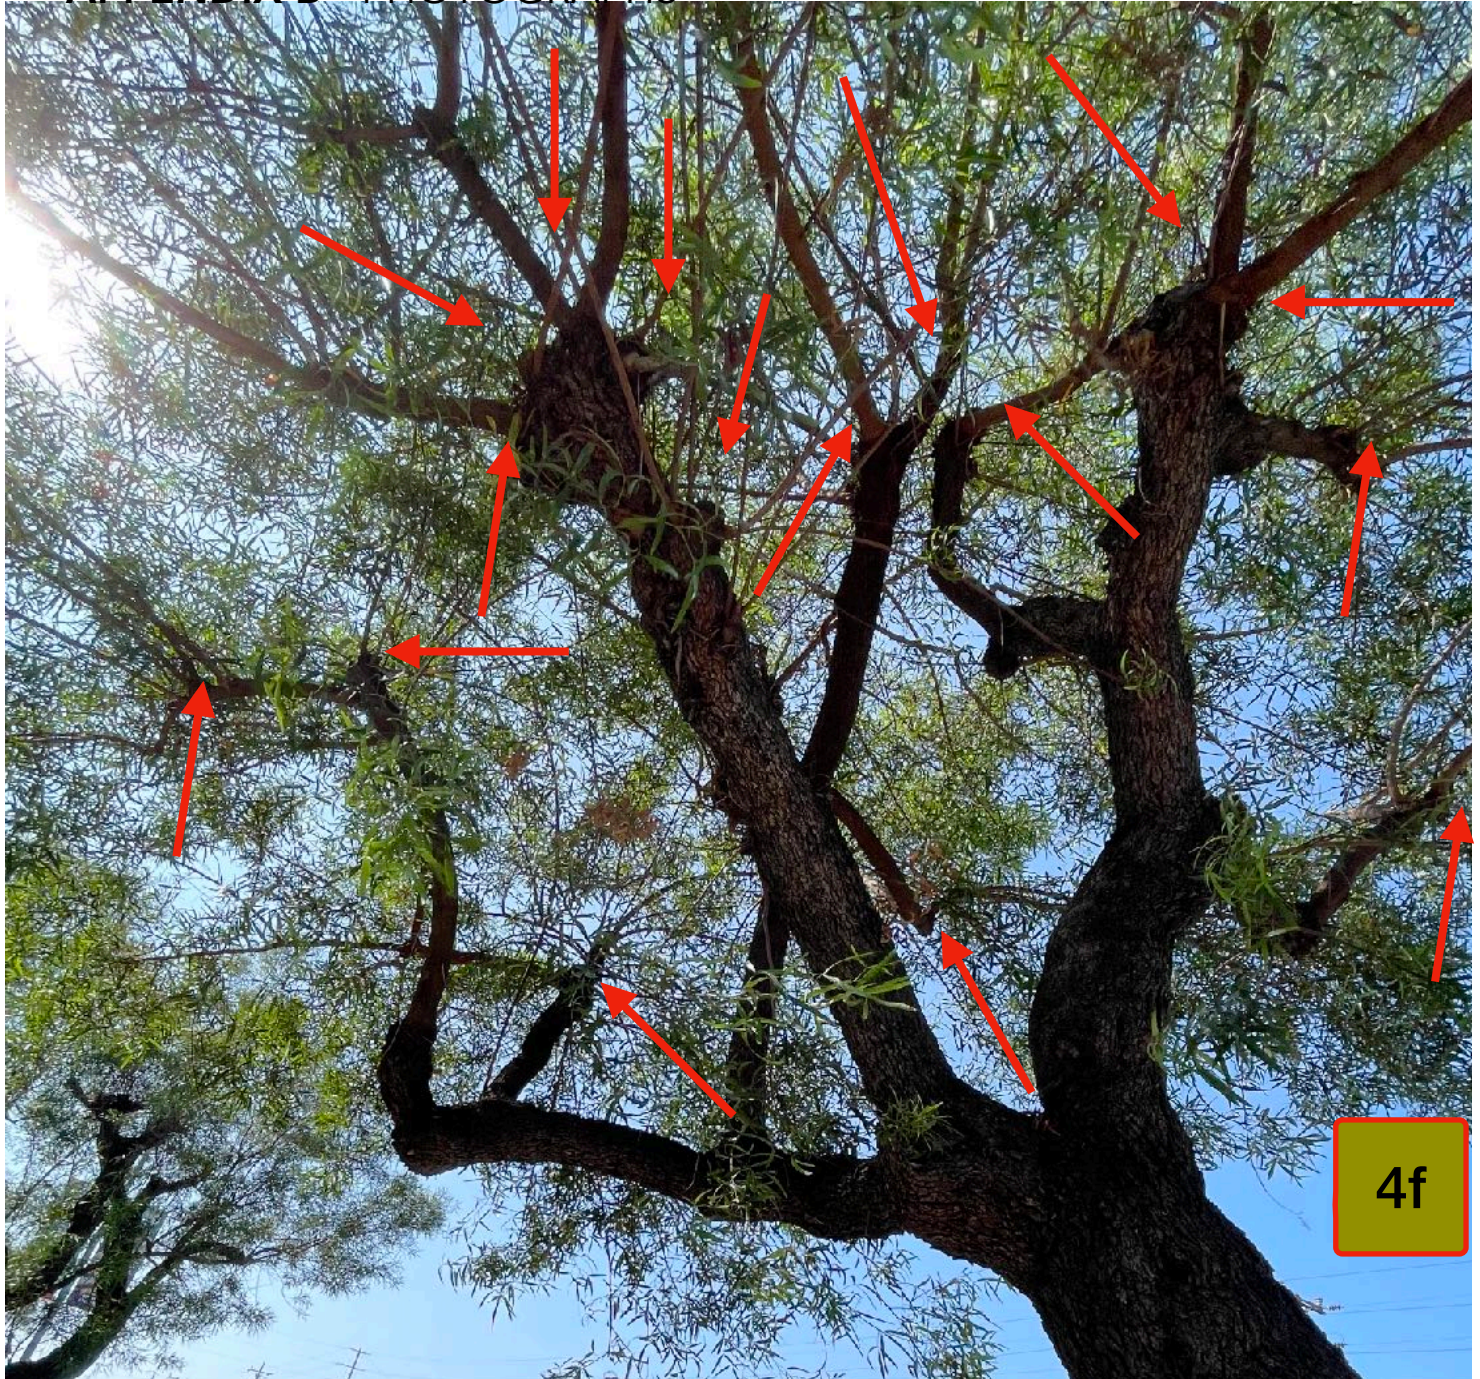
PHOTO - 4f) Shows the volume and extent of topping cuts. Sprouts emanating from these topping cuts have weaker attachment, are more prone to breakage and decay

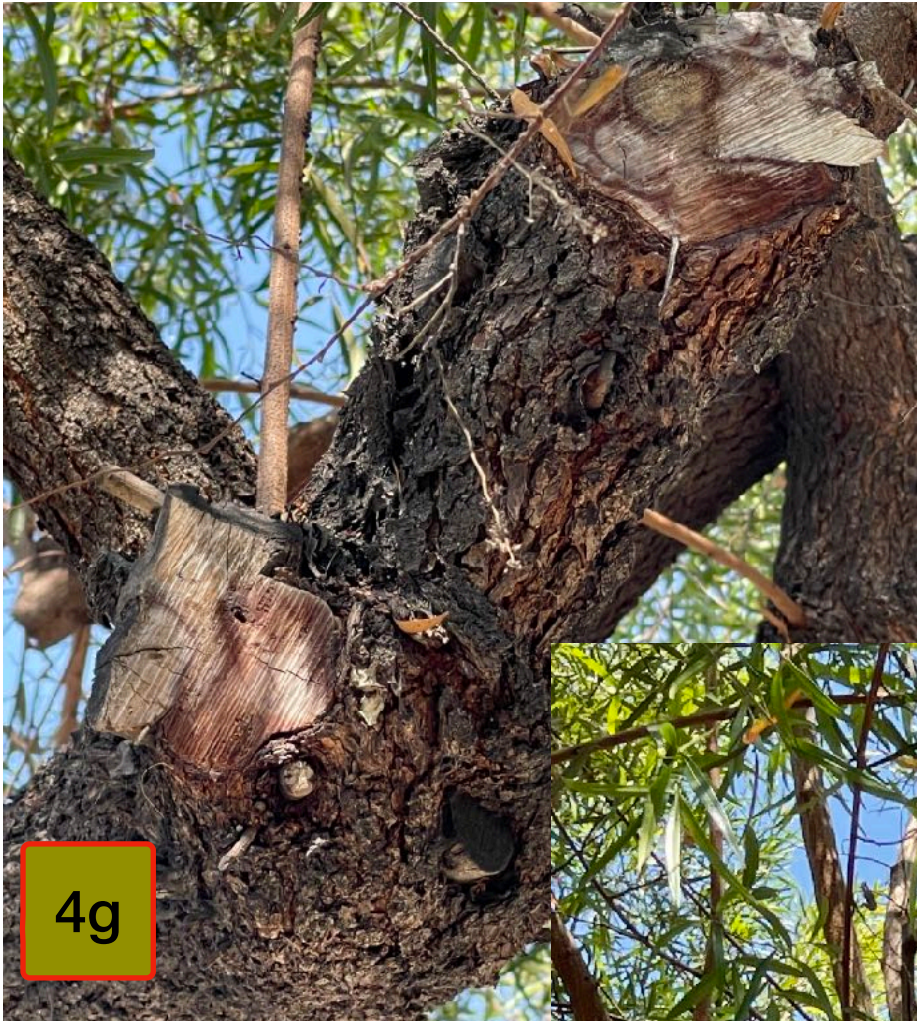
PHOTO - Shows City of Los Angeles street tree #4, recommend for removal.

4g) Old topping wounds with necrotic stubs

4h) Old topping wound with adventitious sprout growth.

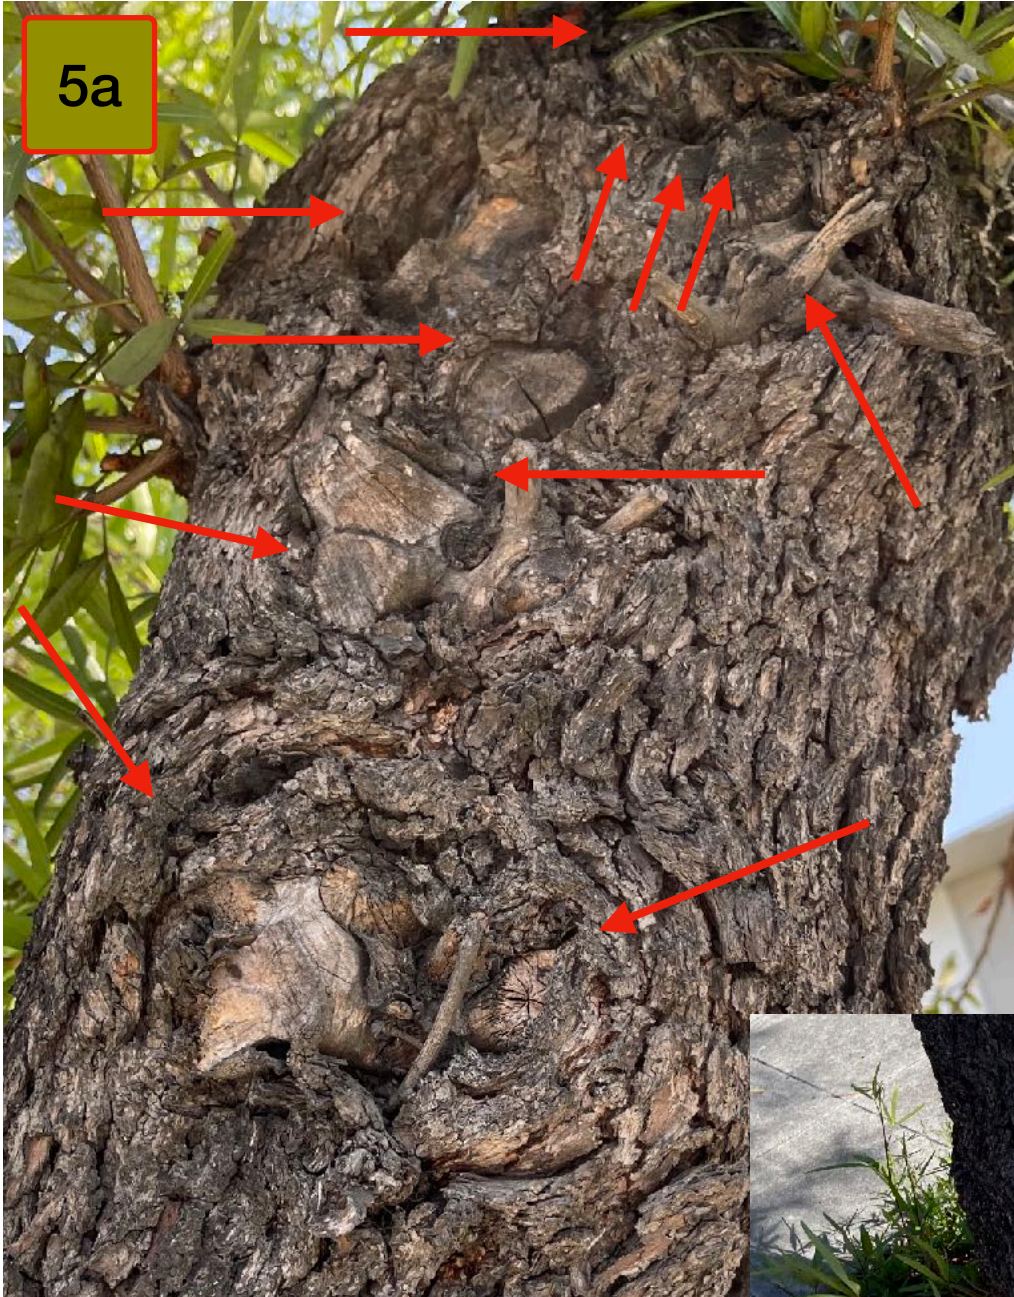
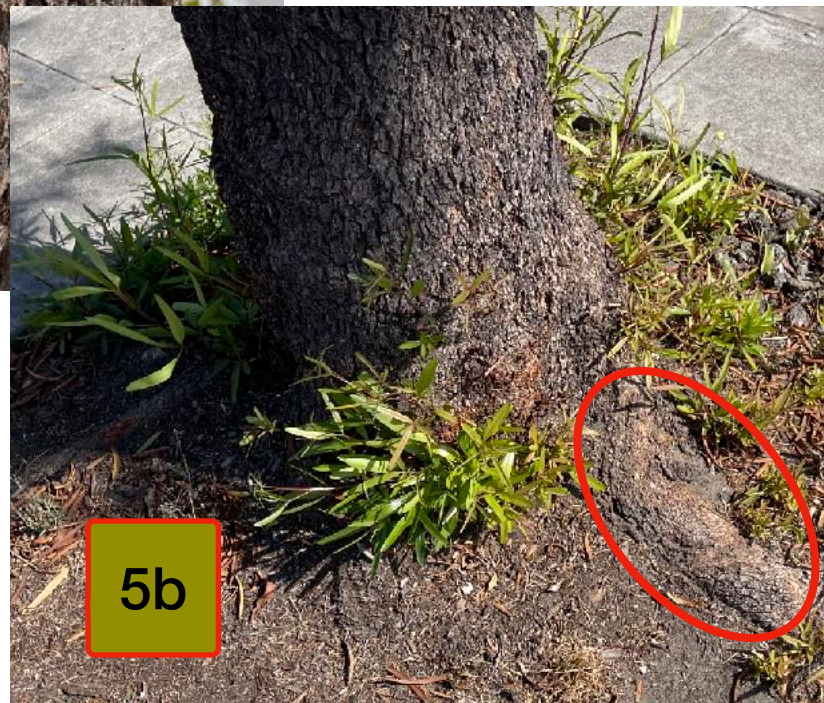
PHOTO - Shows City of Los Angeles street tree #5, recommend for removal.

5a) Many years worth of old flush cuts now with necrotic stubs, decay present.

5b) Girdling root

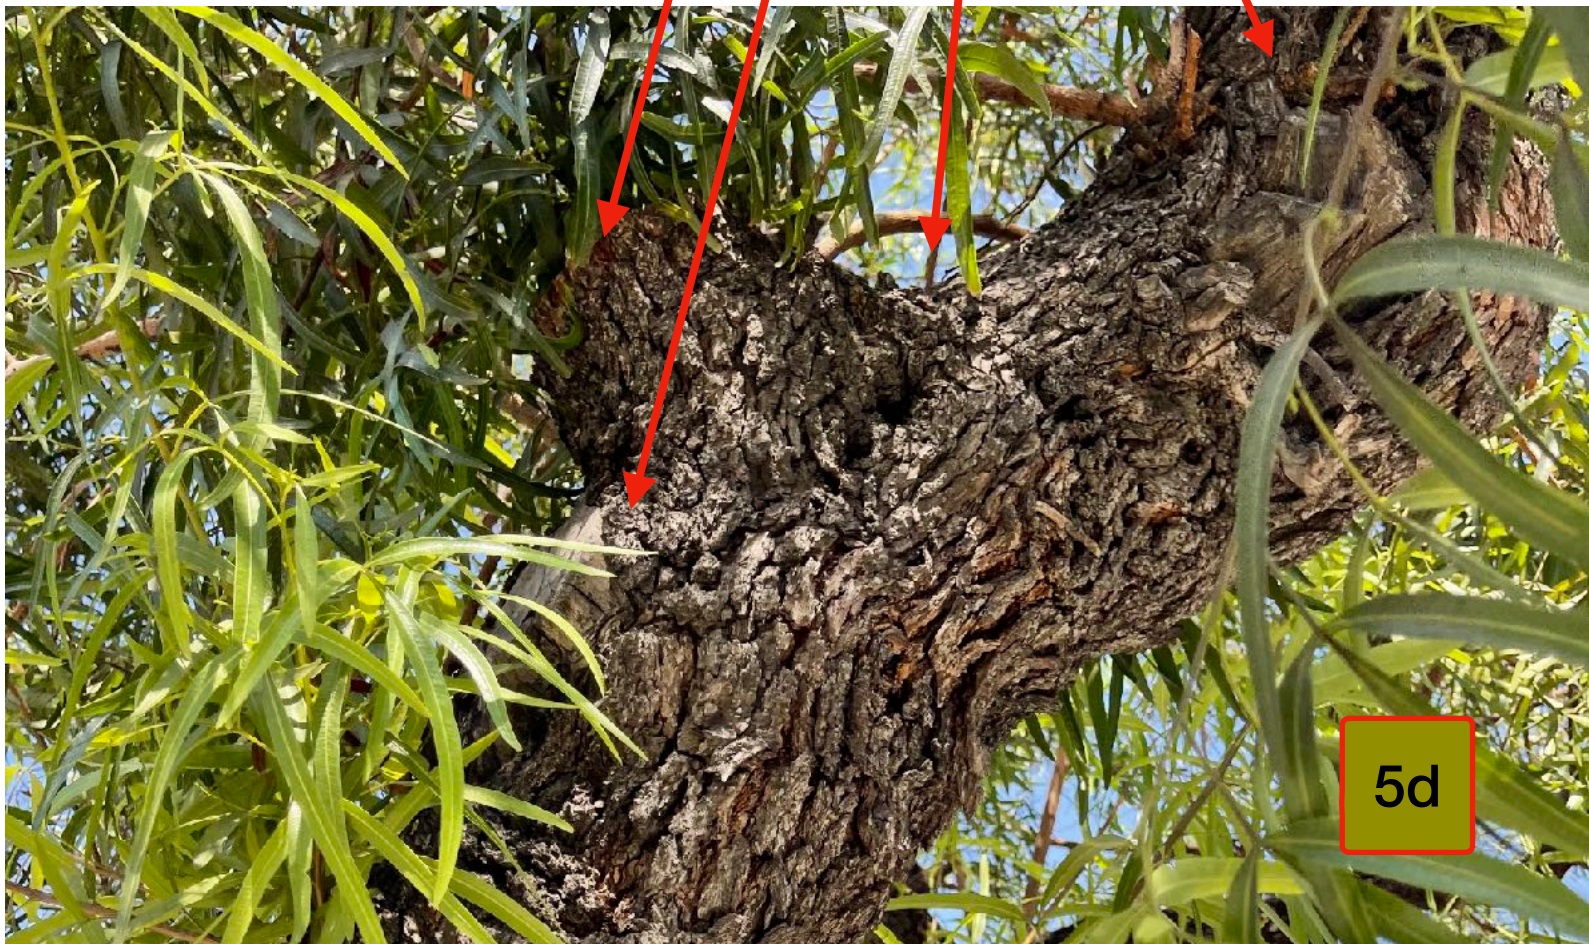
PHOTO - Shows City of Los Angeles street tree #5, recommend for removal.

5c) Macro view of area with necrosis.

5d) Expanded view of frequent flush cutting, necrotic stubs & cavity.

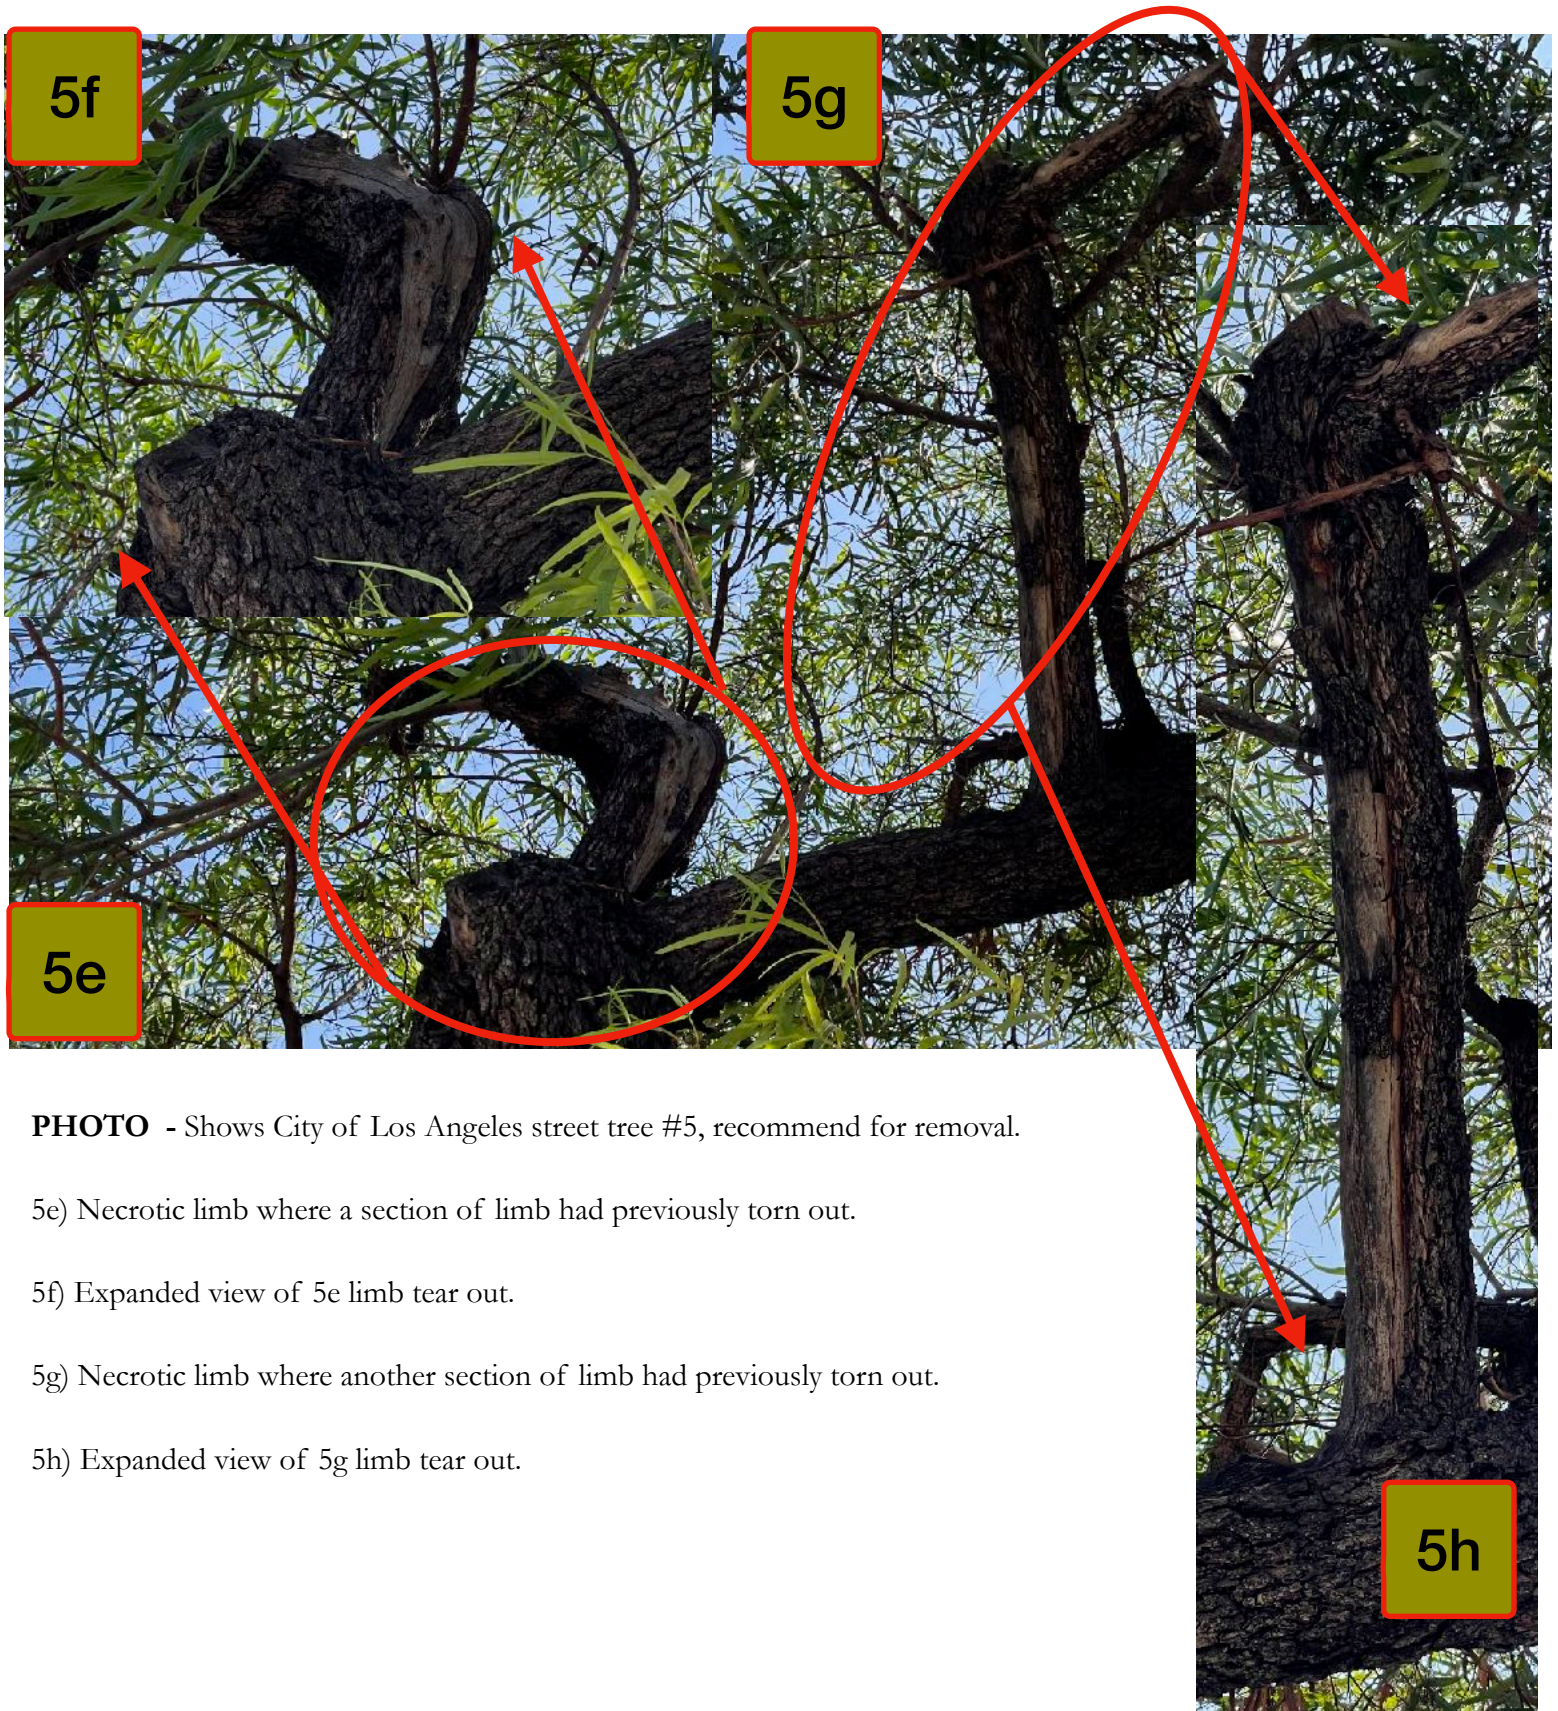
PHOTO - Shows City of Los Angeles street tree #5, recommend for removal.

5e) Necrotic limb where a section of limb had previously torn out.

5h) Expanded view of 5g limb tear out.

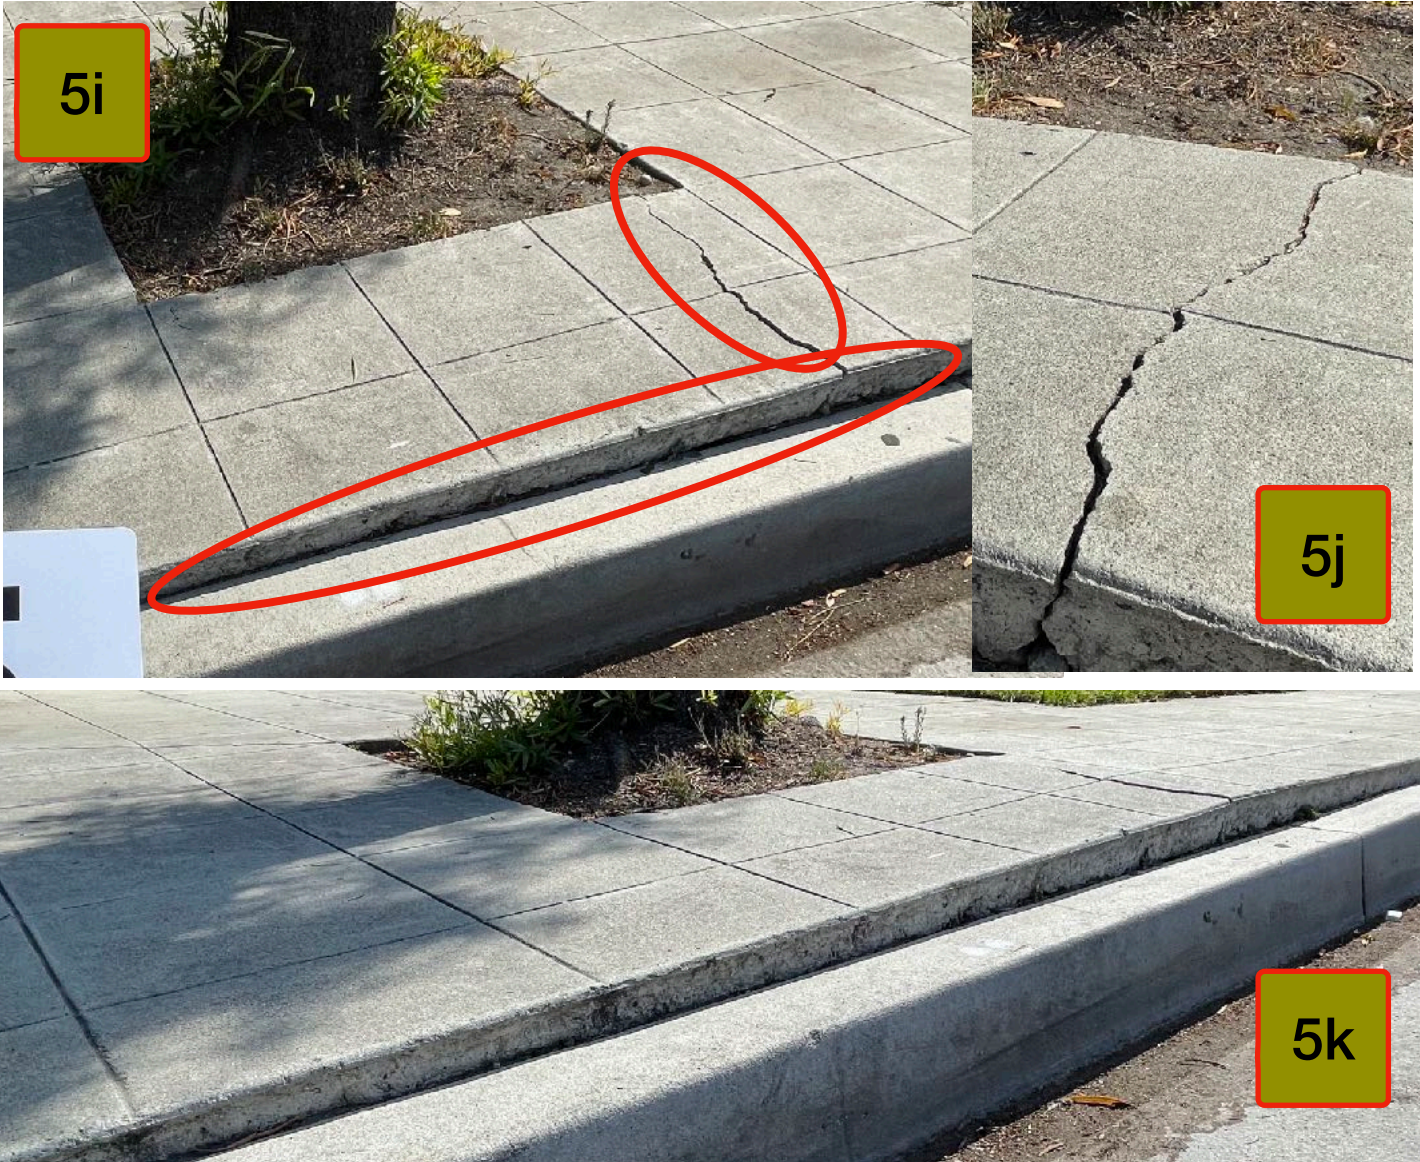
PHOTO - Shows City of Los Angeles street tree #4, recommend for removal.

5i) Cracking and uplifting of sidewalk in public right of way.

5j) Cracking of sidewalk.

5k) Uplifting of sidewalk

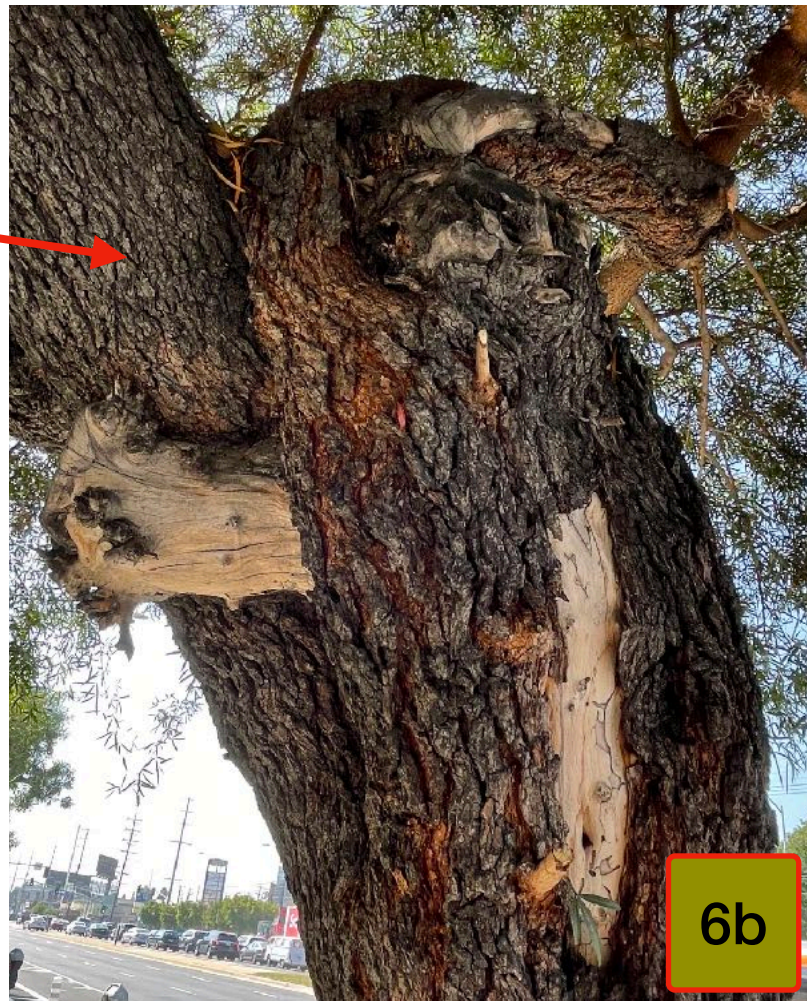
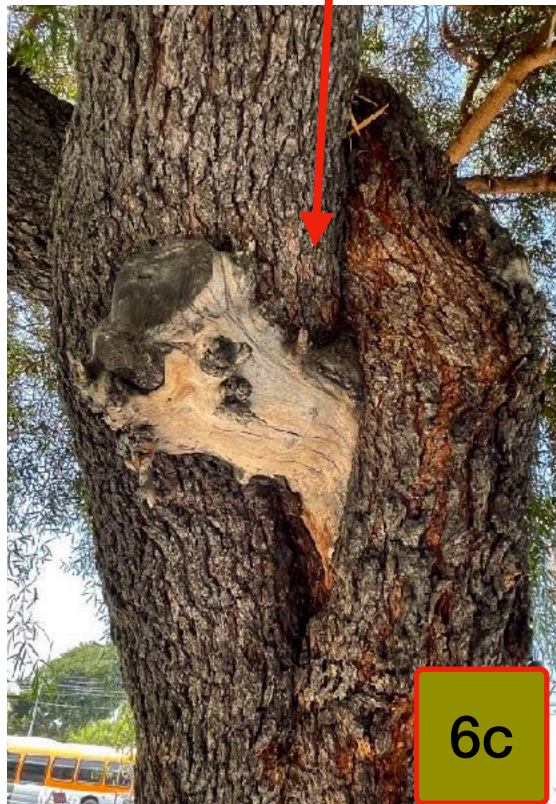
PHOTO - Shows City of Los Angeles street tree #6, recommend for removal.

6a) Where main trunk (bole) and largest scaffold limbs branch out.

6c) Scaffold limb with necrotic stub and very poor structure, expanding crossing limb and an inclusion, that has a high likelihood of being an area prone to trunk splitting.

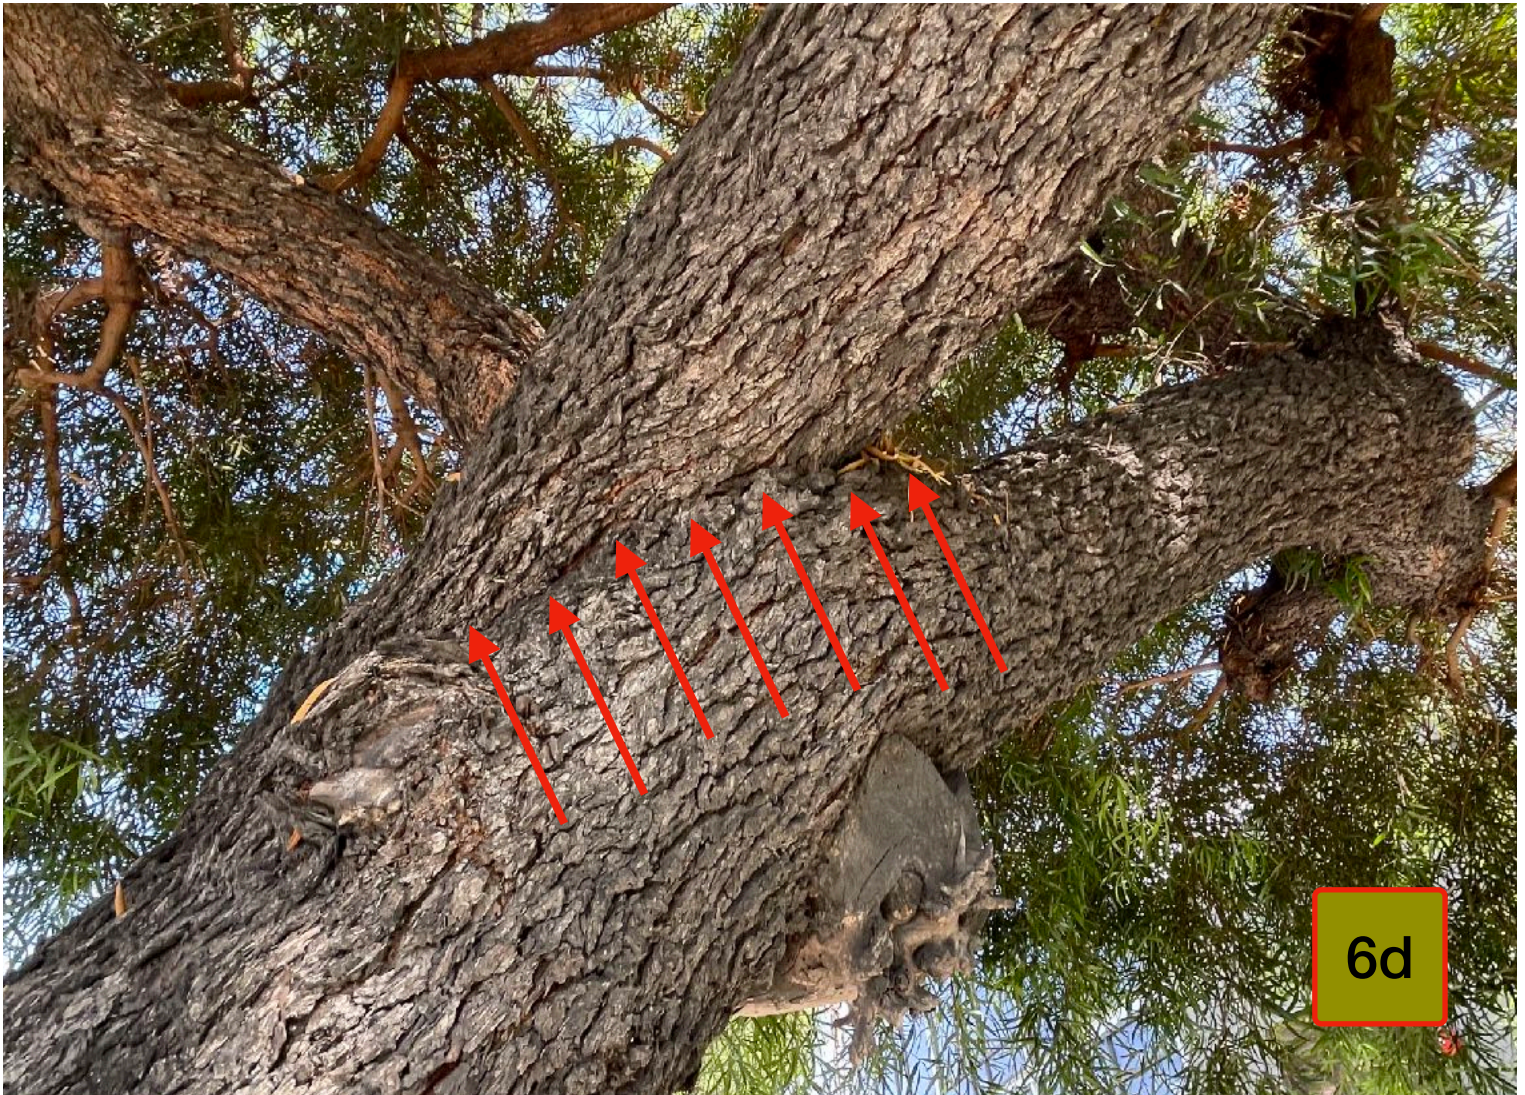
PHOTO - Shows City of Los Angeles street tree #6, recommended for removal and replacement.

6d) Shows the opposite side of the trunk from photos 6b and 6c. The inclusion from the crossing limb show the same potential or likelihood of failure is present on both sides of where the main trunk has generated primary scaffold limb structure.

All other defects or issues above this union only compound the problem. As the tree continues growing the weight this union is expected to support grows in every direction, increasing the likelihood of failure.
