CROSSINGS CAMPUS

Addendum to Draft Environmental Impact Report State Clearinghouse No. 2021110079

ADDENDUM TO THE ENVIRONMENTAL IMPACT REPORT FOR THE CROSSINGS CAMPUS PROJECT

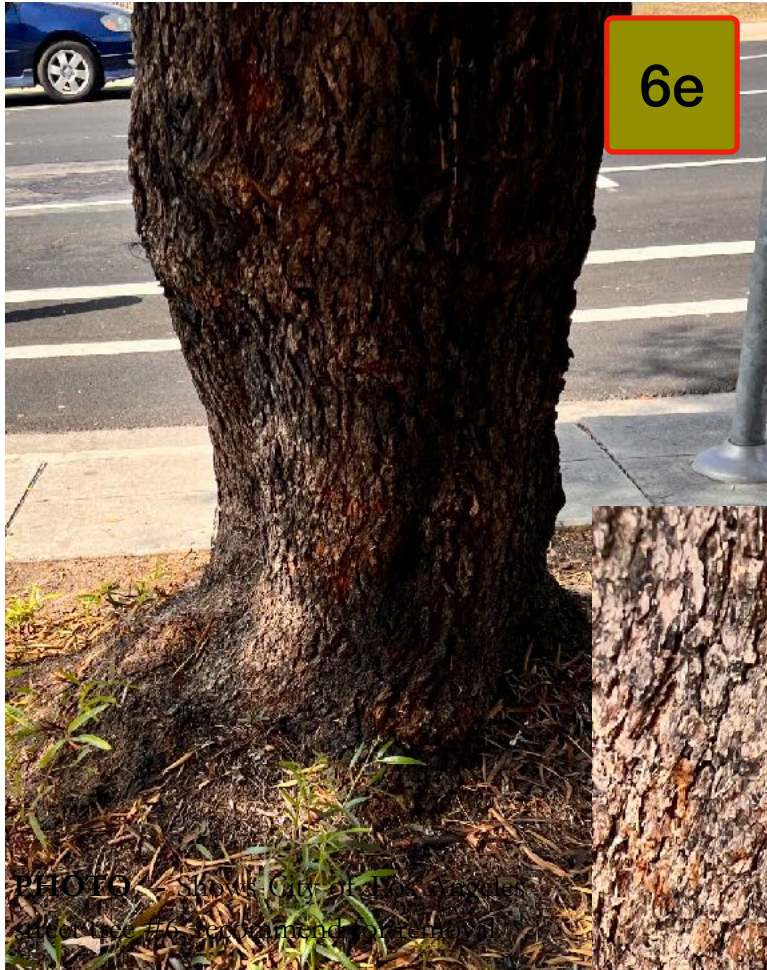
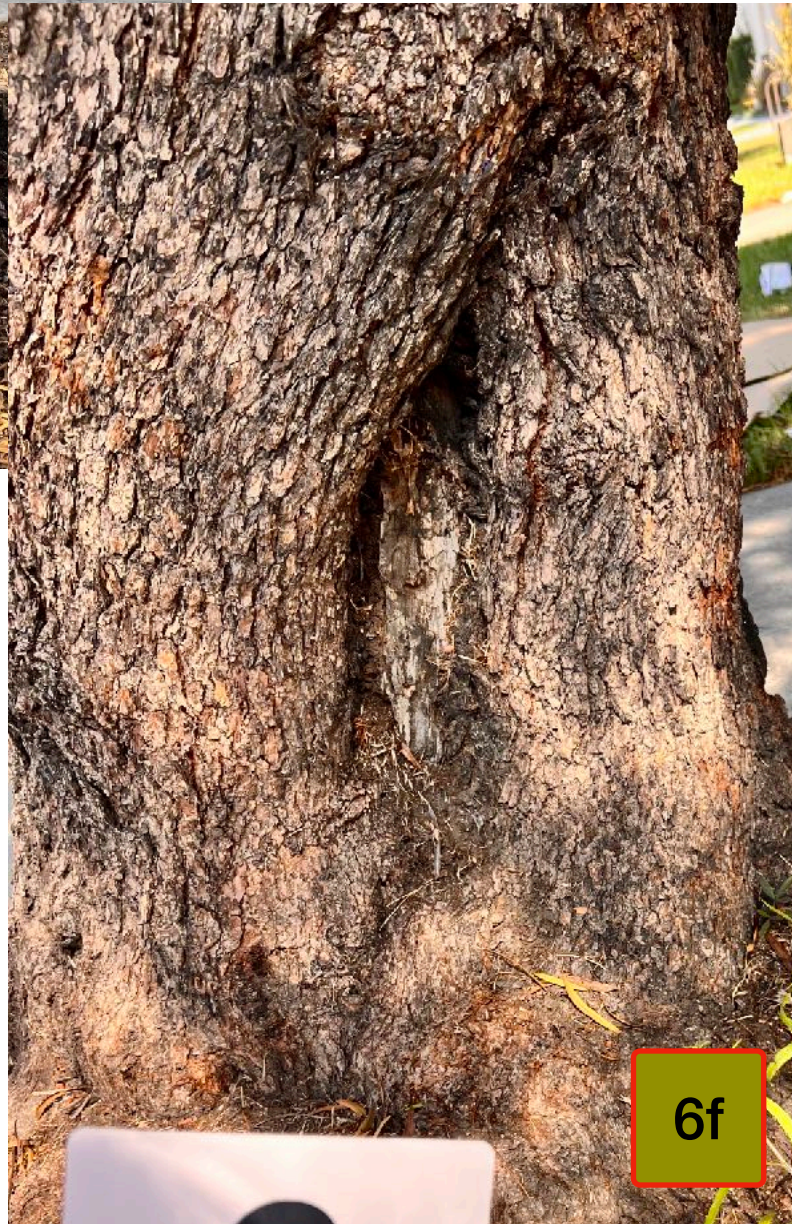
6e) A tree trunk with a vase shape is an indication that nutrient transport between the root system and the rest of the tree has been interrupted. The bottom of this “vase” is another area prone to failure.

6f) This cavity is a contributing factor in the tree trunk narrowing at the base, similar to a vase. The cavity was only noted and recorded, no probing of the cavity was performed.

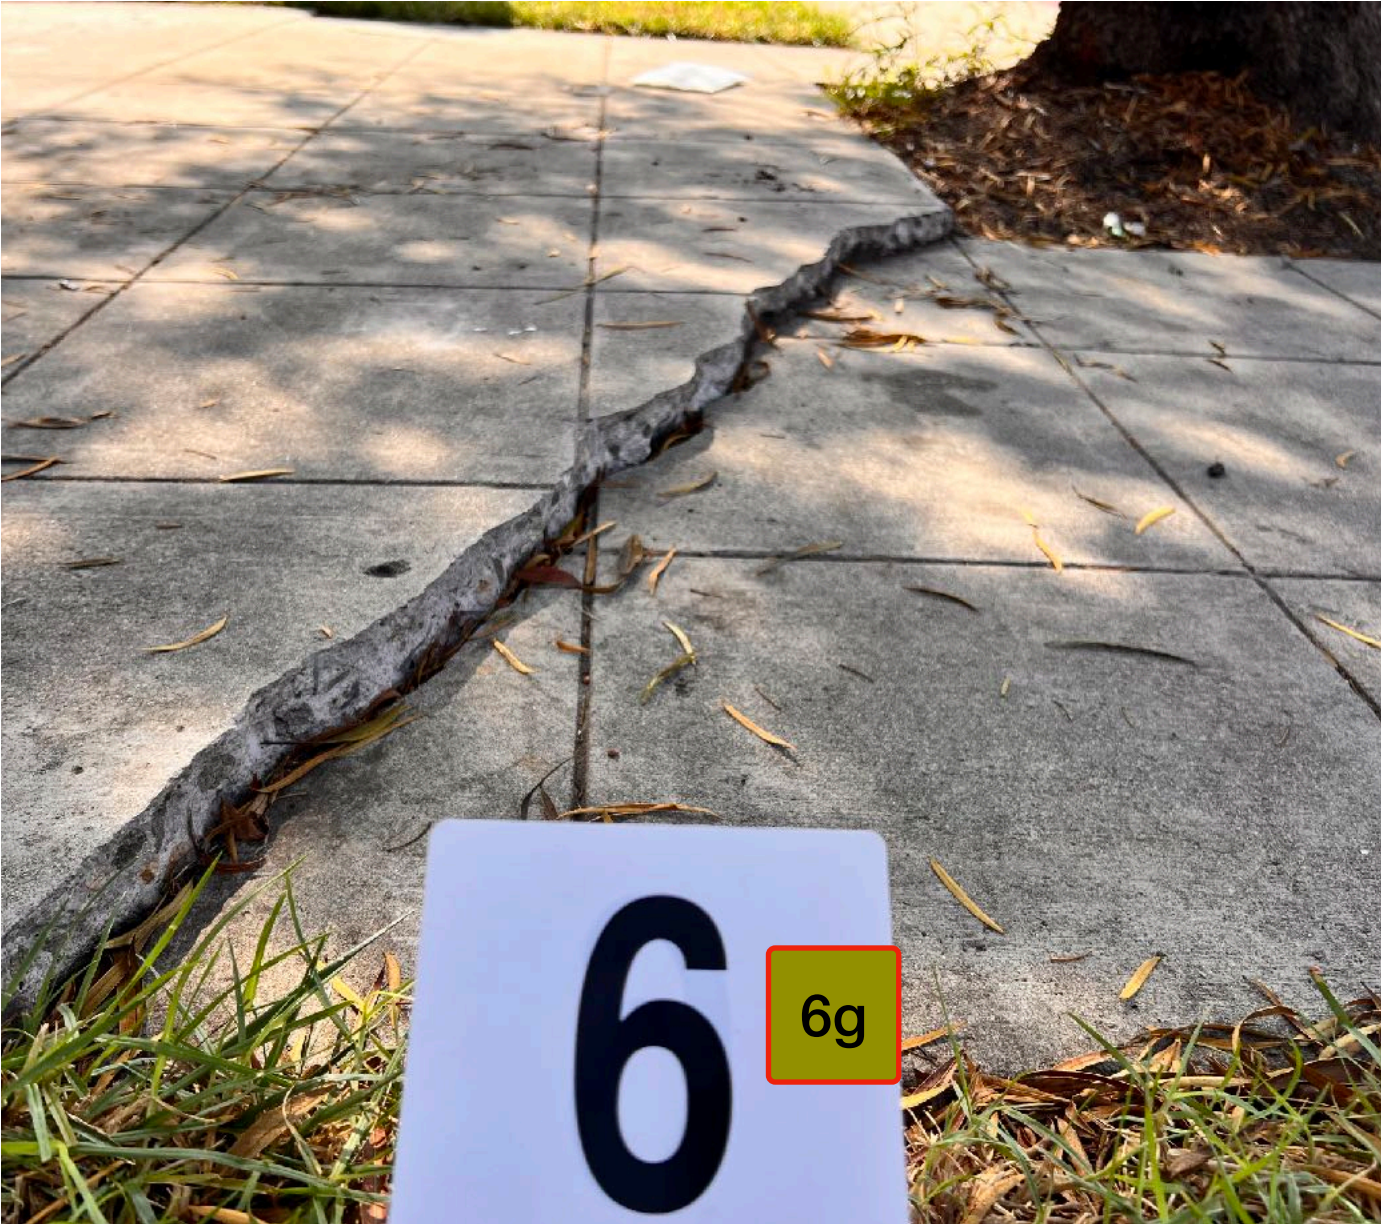
PHOTO - Shows City of Los Angeles street tree #6, recommend for removal.

6g) Cracking and uplifting of sidewalk in public right of way.

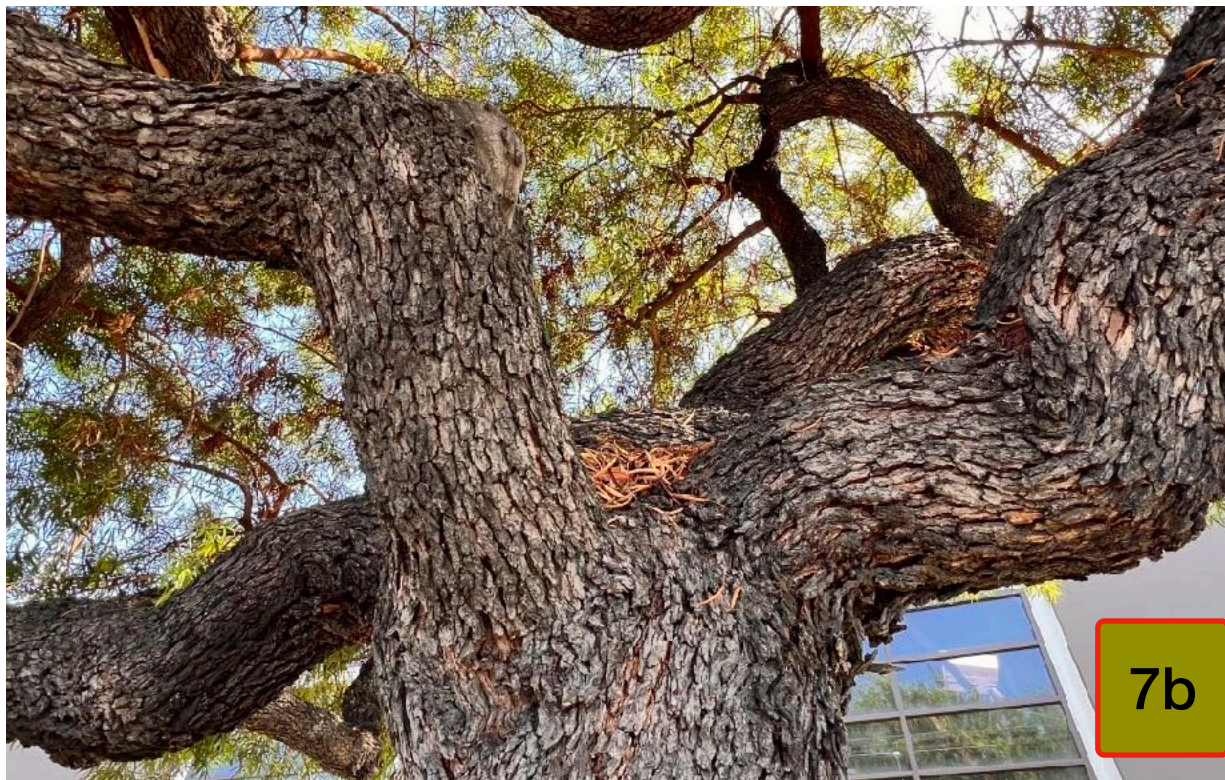
PHOTO - Shows City of Los Angeles street tree #7, recommended for removal and replacement.
7a, b) Represent poor structure and attachment for a tree of this species and size, that is prone to breakage.
8888 Venice Blvd, Los Angeles

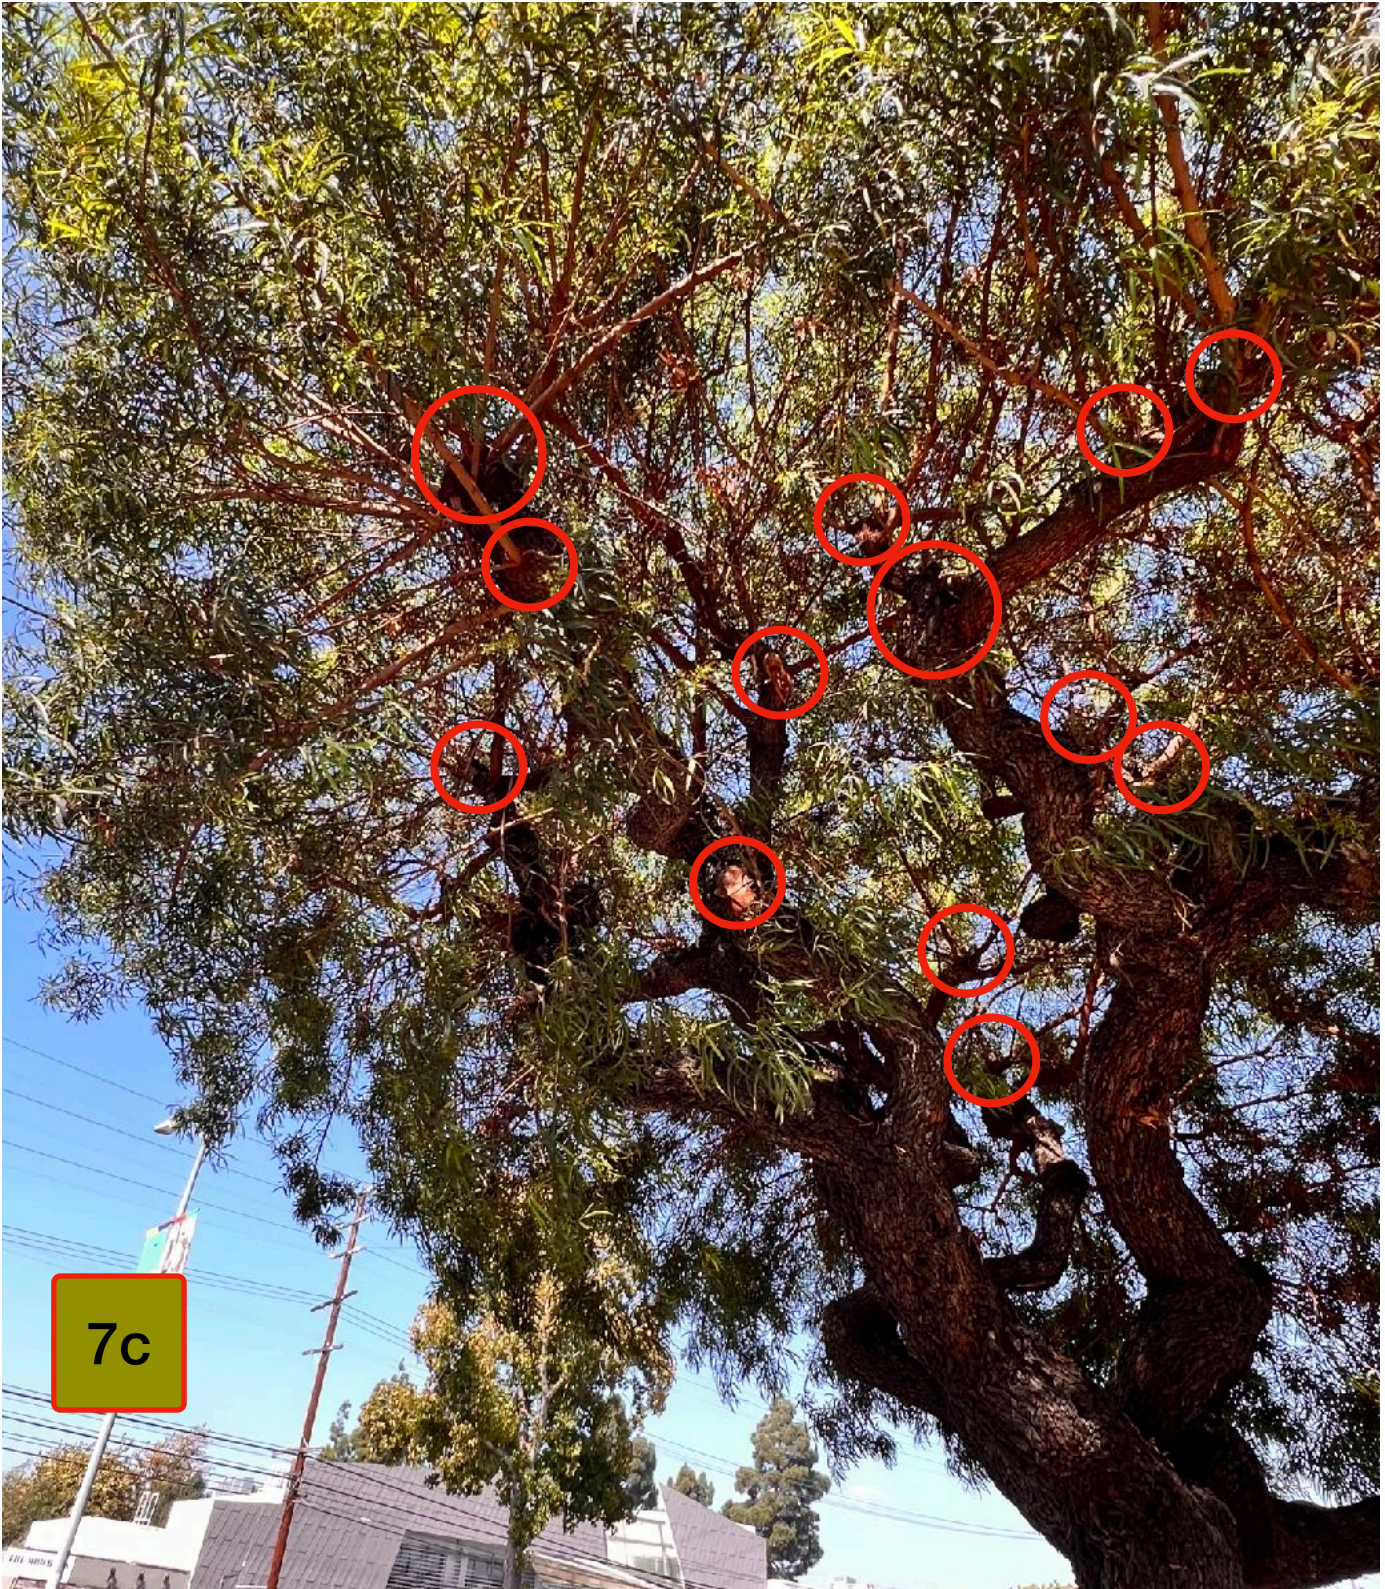
PHOTO - Shows City of Los Angeles street tree #7, recommended for removal and replacement.

7c) Red circles represent origin points for dozens of resprouting limbs from topping cuts.
8888 Venice Blvd, Los Angeles

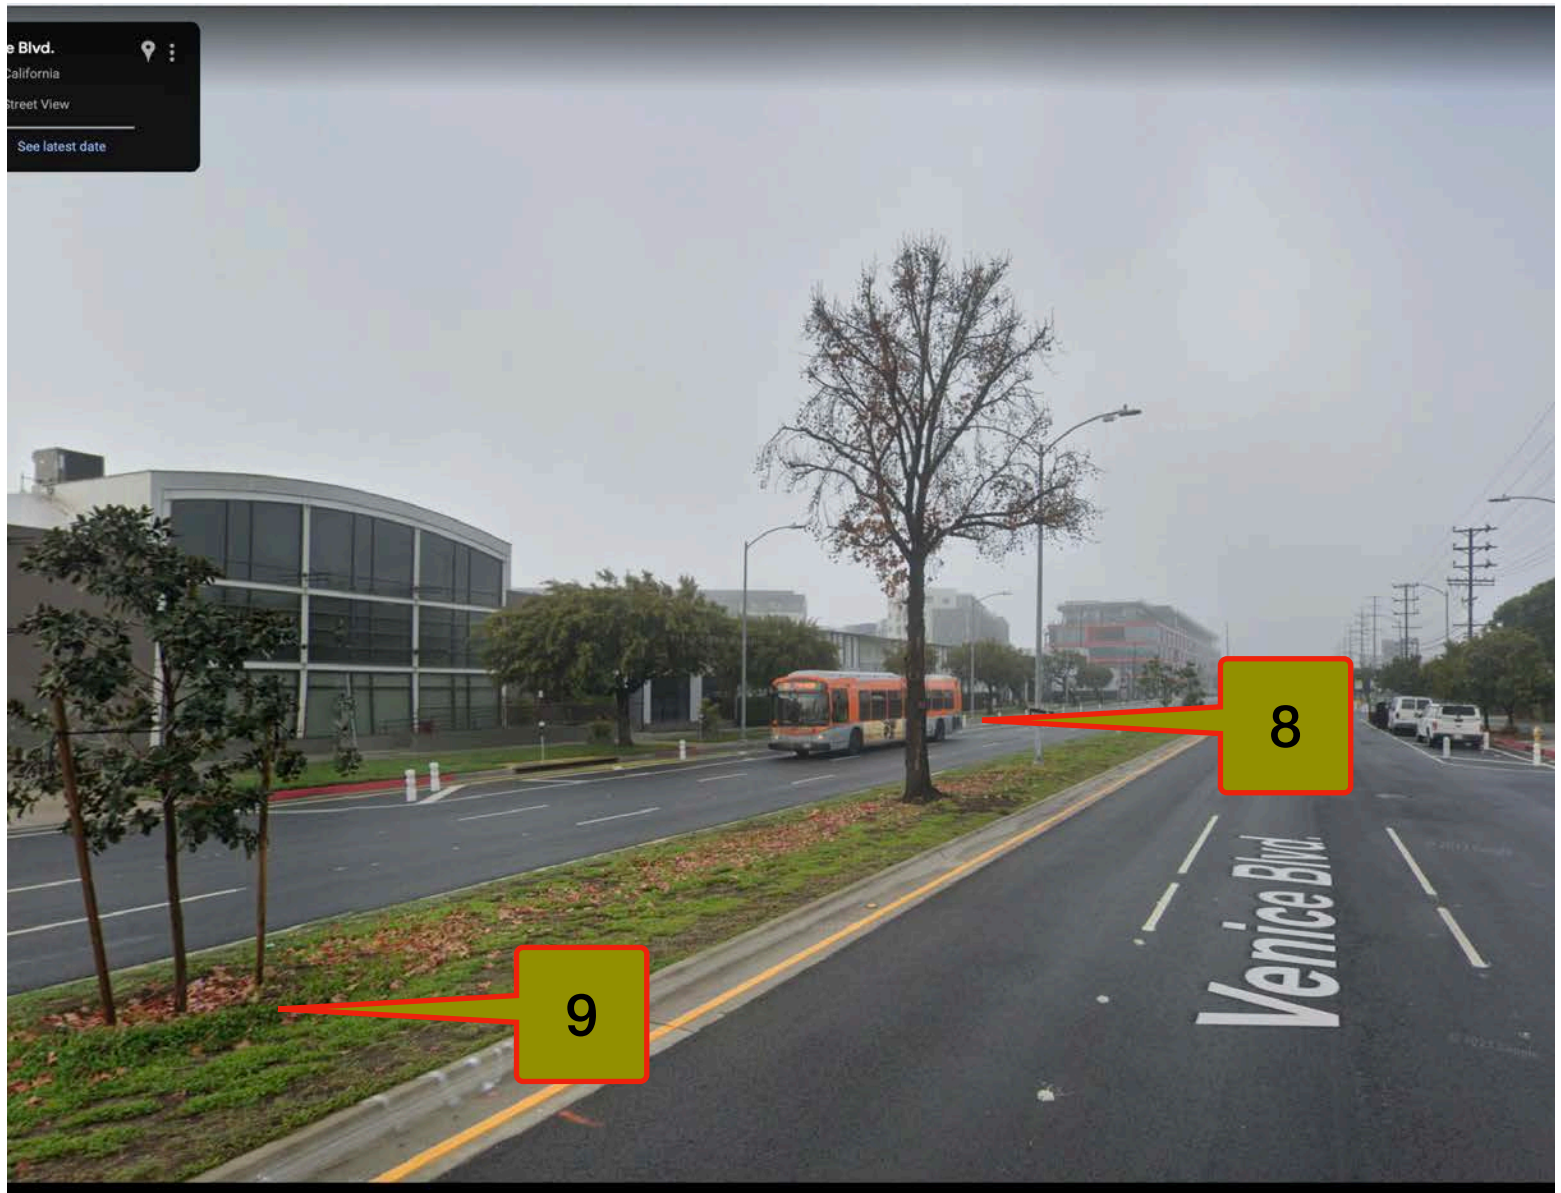
PHOTO - Shows City of Los Angeles street tree #8 - #9, recommended for removal and replacement.

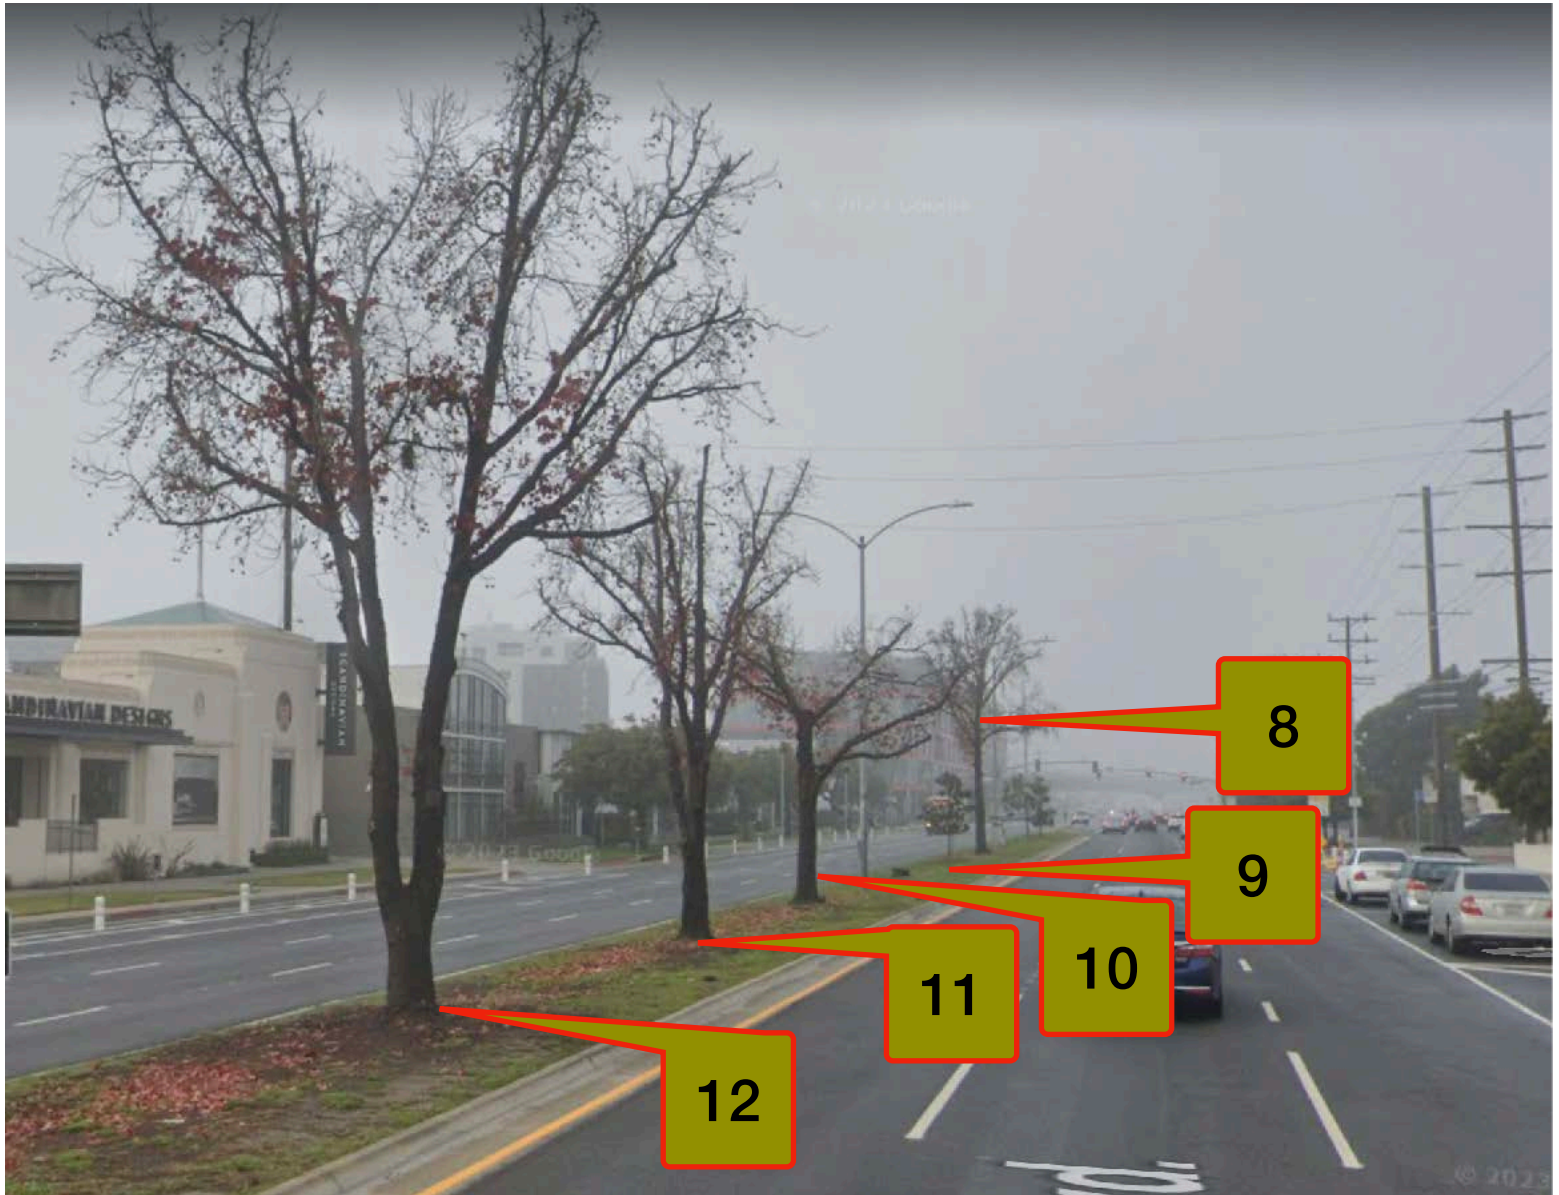
PHOTO - Shows City of Los Angeles street tree #8 - #12, recommended for removal and replacement.
