### Historical Resources Technical Report

# THE CULVER STUDIOS

## HISTORICAL RESOURCES TECHNICAL REPORT

September 2017

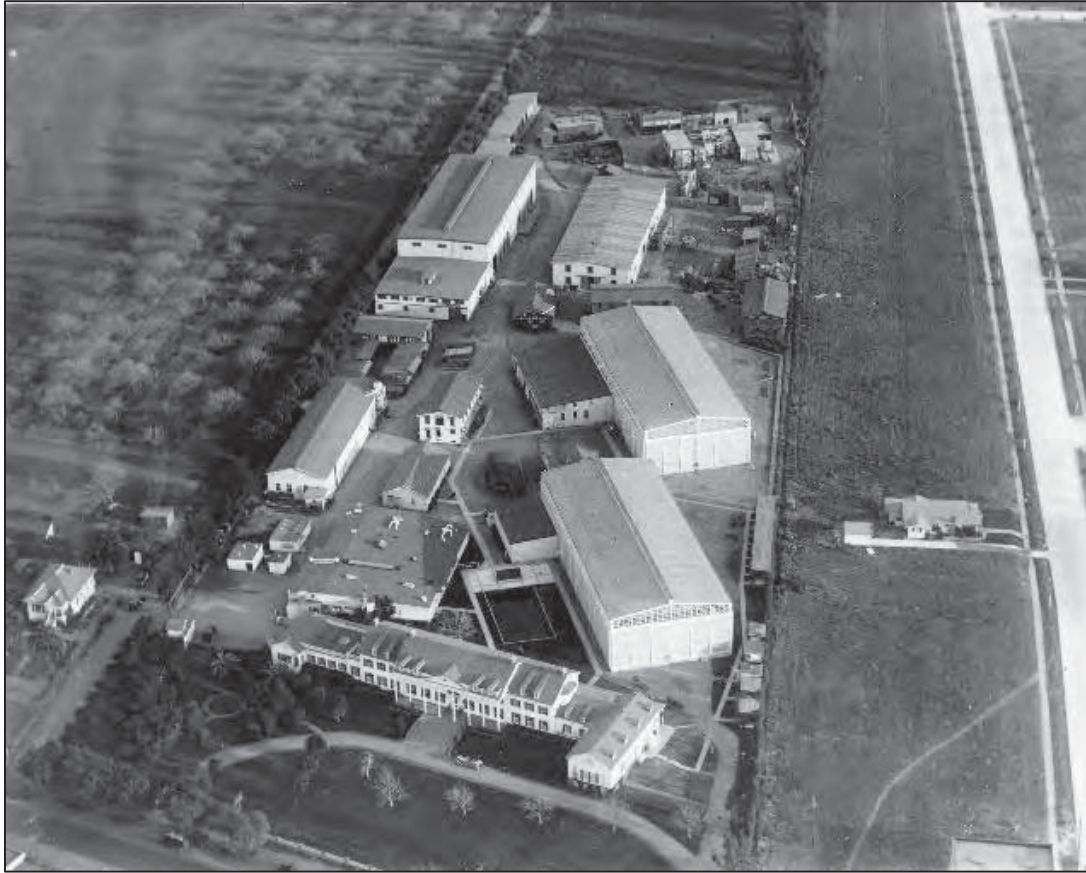
**Figure 8: Aerial view of Ince Studios, 1920 (Bison Archives).**

Ince's new studio was constructed on lots 1-6 of tract number 2530, which was originally subdivided in 1917. The earliest available depiction of the property is the 1919 Sanborn map, which illustrates fourteen structures on the north end of the tract, including an administration building and two large stages as well as several smaller support structures (Figure 8). The Administration Building was the first building constructed on the 14-acre lot and is commonly referred to as the Mansion Building (Building C). The two-story American Colonial Revival style structure housed Ince Studios' administration offices and was constructed facing north towards Washington Boulevard in December of 1918. Additional administration offices were added in 1919, including Buildings D and I. Like Building C, both structures were designed in the Colonial style. Building D remains in its original location at the northeast side of the lot, while Building I has been relocated, possibly more than once, to its current location on the northwest end of the lot. Later that year, Building O was added to the east side of the lot. The building was originally used as Stage 3 but by 1922 it was converted into office spaces and identified as a service building. In 1922, Building Z was constructed; however, its original location is unknown. The building currently sits on the south west corner of lot 6.

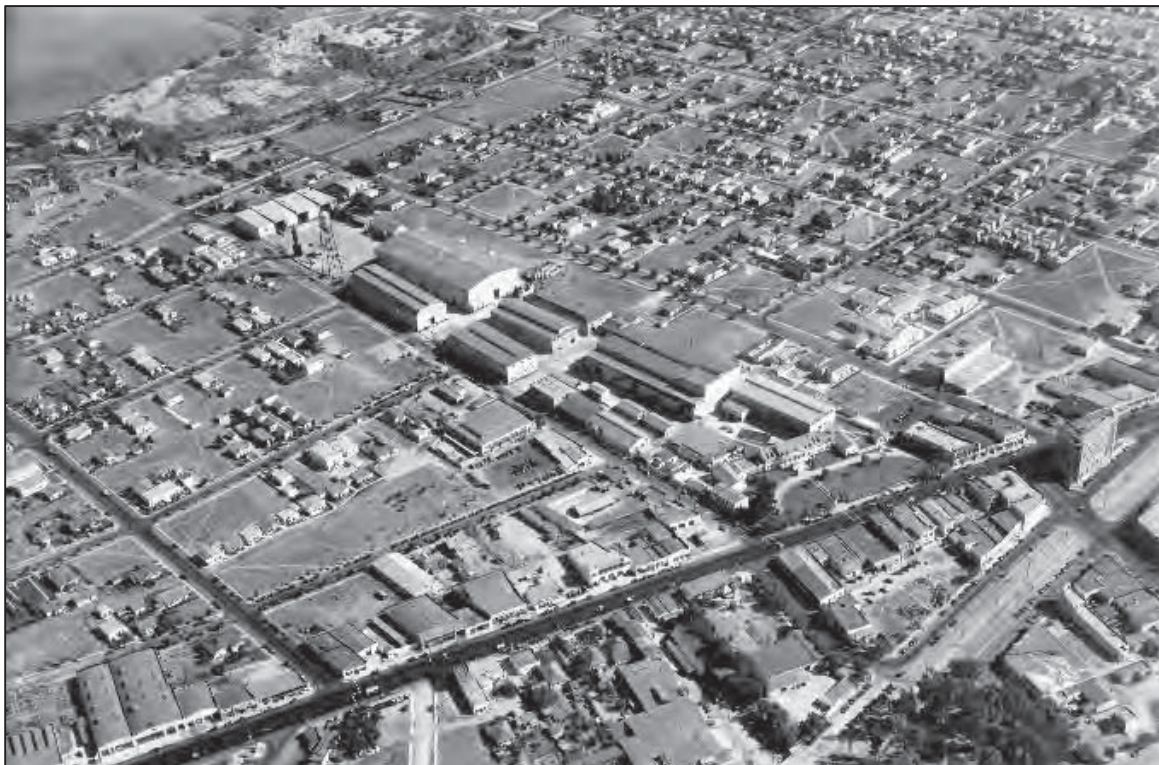
**Figure 10: Aerial view of The Culver Studios (RKO-Pathé), 1931 (Bison Archives).**

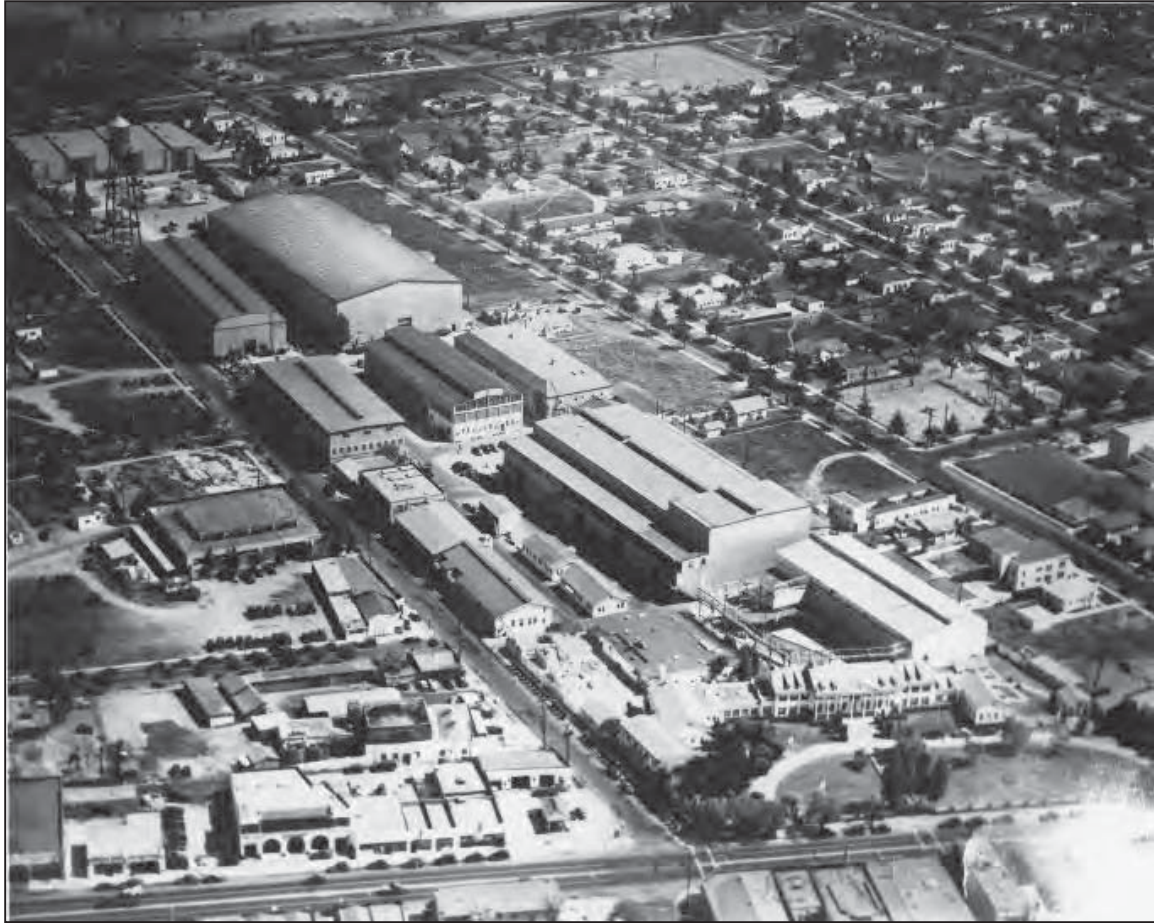
**Figure 12: Aerial view of The Culver Studios (RKO-Pathé/Selznick International Pictures), 1939 (Bison Archives).**

There was little new construction during the Selznick Era, most likely due to the outbreak of World War II. However, some of the existing buildings were altered during this period. Building D was altered with the addition of David O. Selznick's office in 1935 and expanded again in 1937. One of the major changes to the lot in the Selznick period was the construction of Sound Stage 15/16 in 1940. To make room for the new stages, Sound Stage 10 was relocated to the west side of the lot. Bungalows S, T, and U were added next to Bungalow V, providing additional dressing room space and a gym for major film stars like Orson Wells. In 1948 a new camera storage facility was built next to Sound Stage 7/8/9. The camera vault is known as Building X. The 1950 Sanborn Map displays the major changes to the lot during the Selznick period (**Figures 13 & 14**). **Table 4** lists the buildings constructed during the Selznick Era.

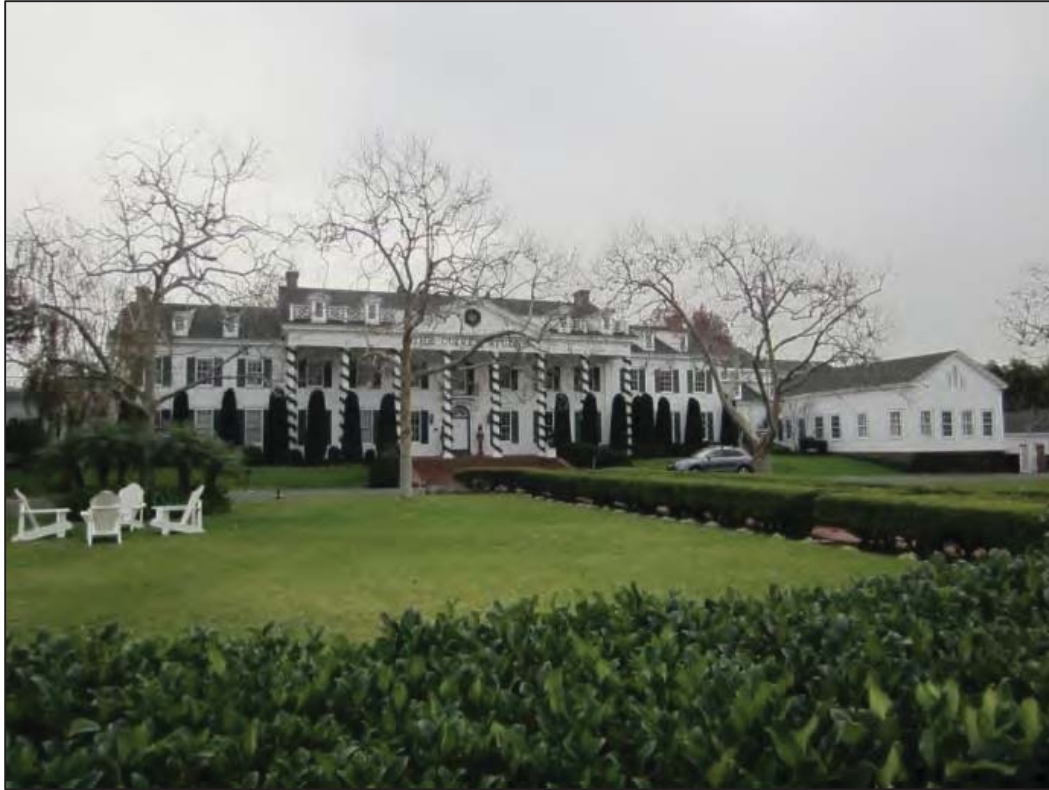
**Figure 15: The Mansion (Building C) Primary (West) Elevation, View East (PCR, 2015)**

In 1918, Thomas Ince constructed what would eventually be known as The Culver Studios. Ince purchased a trapezoidal shaped fourteen-acre tract, Tract Number 2530, which was subdivided into six lots in 1917. The studio lot is oriented to the northwest, with its American Colonial Revival Style Administration Building (Building C) fronting towards Washington Boulevard. Buildings on the site fall into two architectural styles. While many of the support buildings and sound stages are simple utilitarian structures, most of the administration buildings are designed in the American Colonial Revival style, defining the architectural theme for the site. Although the administration buildings provide a pleasant appearance throughout the lot, it is the utilitarian sound stages that dominate the landscape, both physically and programmatically. The sound stages are large structures, three or more stories in height, occupying a majority of the site's area. In addition to the sound stages, the site possesses utilitarian structures used in support roles, such as Buildings X, Y, and Z. The site also incorporates multiple former dressing room facilities, including four bungalows, which have been repurposed as production office spaces. Many of the buildings situated along the edges of the property double as barriers to the outside public. Spaces between the buildings are infilled with brick walls. Access to the site is gained through one of four gates. While Gate 3 and Gate 4 appear to remain in their original locations, the physical gates themselves have been replaced and associated gatehouses are new construction (alterations). Additional alterations to the site include the construction of Building J in 2006 and Building P/Stage 5/6 added in 1988. These buildings and gate houses were not evaluated because they were constructed outside of the Studio's period of significance.

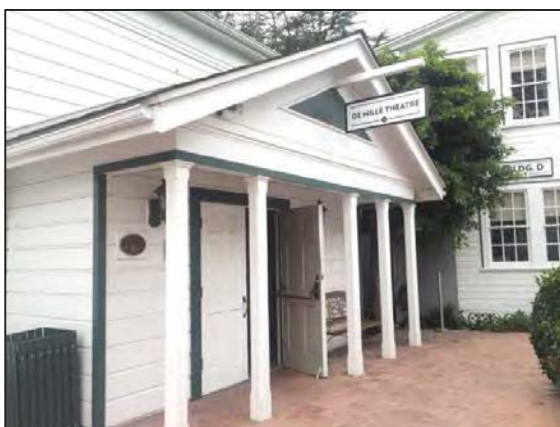
**Figure 16: (Left) The DeMille Theatre, Primary Elevation, View West (PCR, 2015)**

DeMille Theatre was built in 1927 as a screening room (consistent with 1926-1928 period of DeMille ownership). Attached to the east wing of Building C, the primary entrance to the Cecil B. DeMille Theatre is on the east primary elevation of the theatre which faces onto a brick courtyard south of Building D (**Figures 16 and 17**). The theater entrance is sheltered by a front-gabled porch that is supported by five chamfered square wooden posts with molded capitals and square bases. The entrance is framed by a classical frontispiece and has a pair of paneled wooden doors lead into the small lobby and theater. The classical revival theme continues on the interior (renovated) which has decorative wood detailing, coved ceiling, theater seating, and a large movie screen. On July 27, 1984 the DeMille Theatre was dedicated to the famous movie director and producer. The DeMille Theatre is a designated local Landmark Structure and is eligible for the National and California Registers for its architectural and historical significance in association with the Cecil B. DeMille/RKO Era (1925-1935).

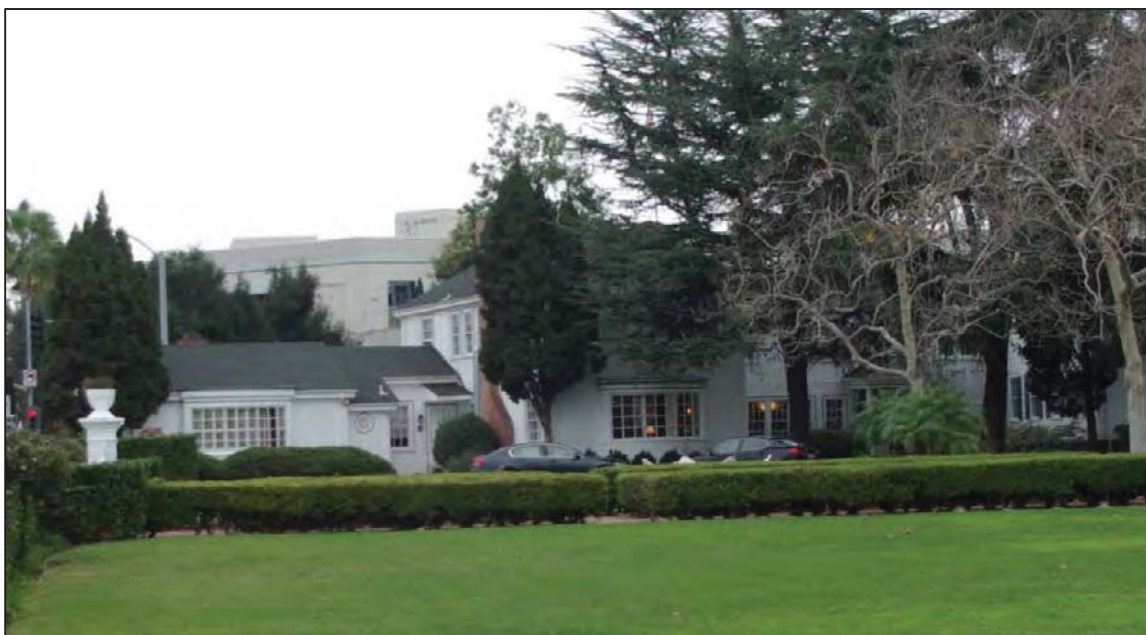
**Figure 18: Building D Primary (West) Elevation Showing all Three Eras of Construction, View North (PCR, 2015)**

Building D located at the perimeter of the front lawn immediately east of Building C and north of the Cecil B. DeMille Theater, is also an excellent and intact example of the American Colonial Revival style (**Figure 18**). Building D was constructed in three sections; the south section was constructed in 1919; the middle section was constructed in 1935, housing David O. Selznick's offices; and the north section was constructed in 1937. Building D is an individually designated Local Landmark Structure and is eligible for the National and California Registers for its architectural and historical significance beginning in the Ince Era (1918-1924) and extending through the Selznick Era (1935-1949). Character defining-features include its irregular footprint; one- and two-story scale; low-pitched intersecting gable roofs covered in green composition asphalt shingles (replaced); horizontal wood siding; six-over-six double-hung wood windows; paneled wood doors; and several features such as a brick exterior end chimney, two multi-pane curved bay windows; and a one-story, one-bay gabled entrance porch with triangular pediment supported by wood columns (**Figures 19 and 20**).

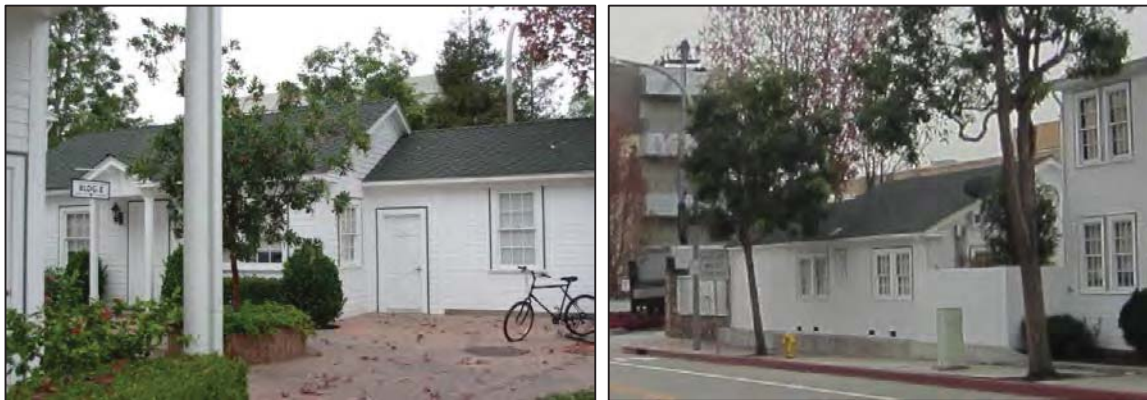
**Figure 21: (Left) Primary Elevation Building E, View East (PCR, 2015)**

Located directly across (east) from the DeMille Theater, Building E was constructed in 1925 as an ancillary support building for Buildings C and D, functioning as a casting office. The exterior of the single-story wood-frame building is intact although the interior has been updated over the years. Building E has a rectangular footprint with side-facing gable roof, narrow ship-lap siding, single and paired six-over-six double-hung sash windows, and gabled center-front entrance porch (**Figures 21 and 22**). A gabled wing with a recessed porch across the back extends from the south side.

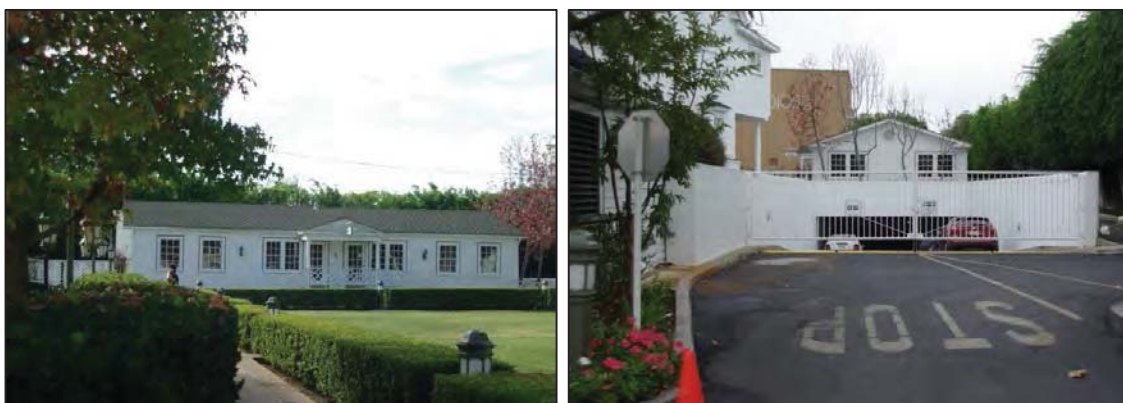
**Figure 25: Left) Primary (East) Elevation Building I, View West (PCR, 2015)**

Constructed in 1919 on the Studio Campus and relocated in 1936 to its current location in the south of Building C, Building I is an ancillary support building or office. Building I is a one-story wood-frame building sheathed in shiplap siding with a rectangular plan and side-gable roof (**Figures 25 and 26**). The entrance is sheltered by a gabled front porch and the building is lighted by single and paired six-over-six double-hung sash windows. Although the exterior is largely intact, the building has been relocated and the interior is substantially renovated.

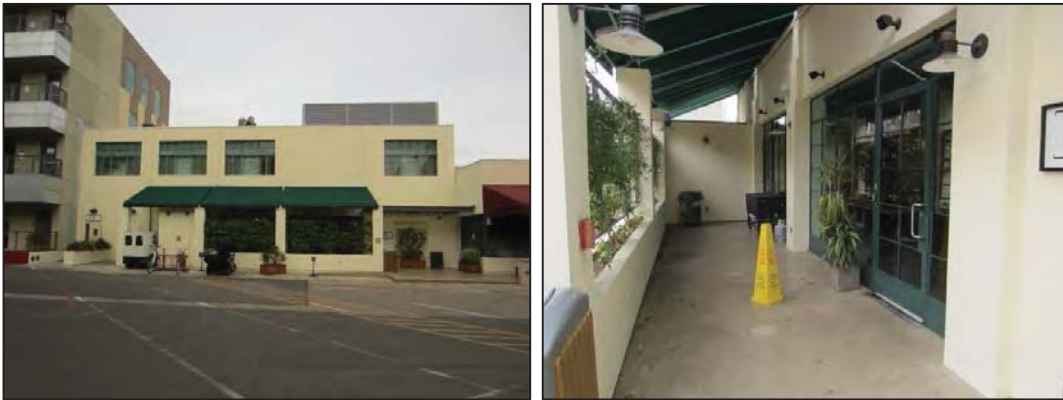
**Figure 27: (Left) Primary (West) Elevation, View East (PCR, 2015)**

with a rectangular footprint and flat roof (**Figure 27**). Oversize mechanical equipment sits on the flat roof shielded by a short parapet. The primary elevation is divided into five bays by pilasters. Each bay is punctuated by multi-pane steel industrial windows (alteration, replacements) except the fourth bay to the east (window opening appears infilled). The first floor has a patio covered by fabric awnings attached to square concrete columns connected by a low knee wall (**Figure 28**). This patio appears to be a modern addition. Underneath the patio cover are two sets of multi-pane doors flanked by multi-pane sidelights (alteration). There are two other entrances into the building (alteration, replacements), a flat panel door with single-light leads to the second-story and the other door is a flat-panel opening onto the first floor, located in the far west corner of the primary elevation. The rear elevation has a row of four evenly-spaced steel multi-light windows (alteration, replacements) on the first and second story. There appears to be two missing windows. The east elevation is conjoined to the Commissary, only the secondary story of the east elevation is visible. The west elevation abuts Building J and is not visible. Due to the numerous changes that have occurred over the years that detract from its integrity of design, workmanship, materials, setting, feeling and association, Building L no longer retains integrity.

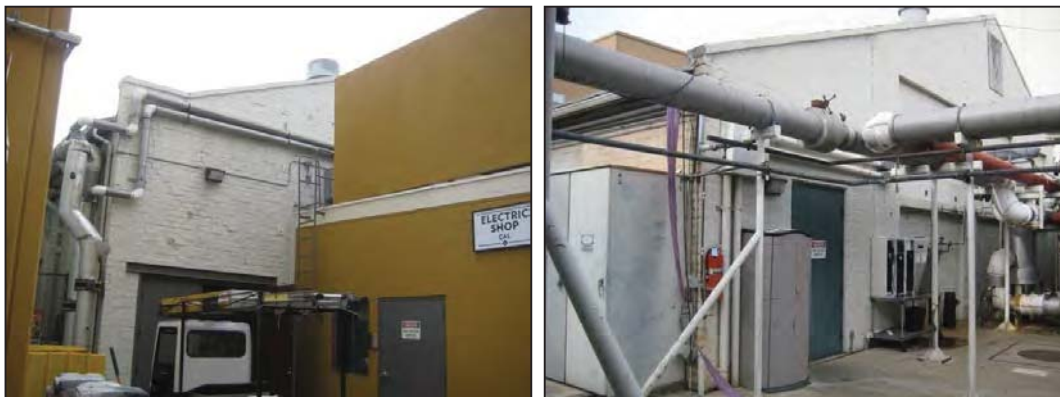
**Figure 29: (Left) North elevation of Building N, with cinder-block addition, view to south (PCR, 2015)**

numerous changes that have occurred over the years that detract from its integrity of design, workmanship, materials, setting, feeling and association, Building N no longer retains integrity.

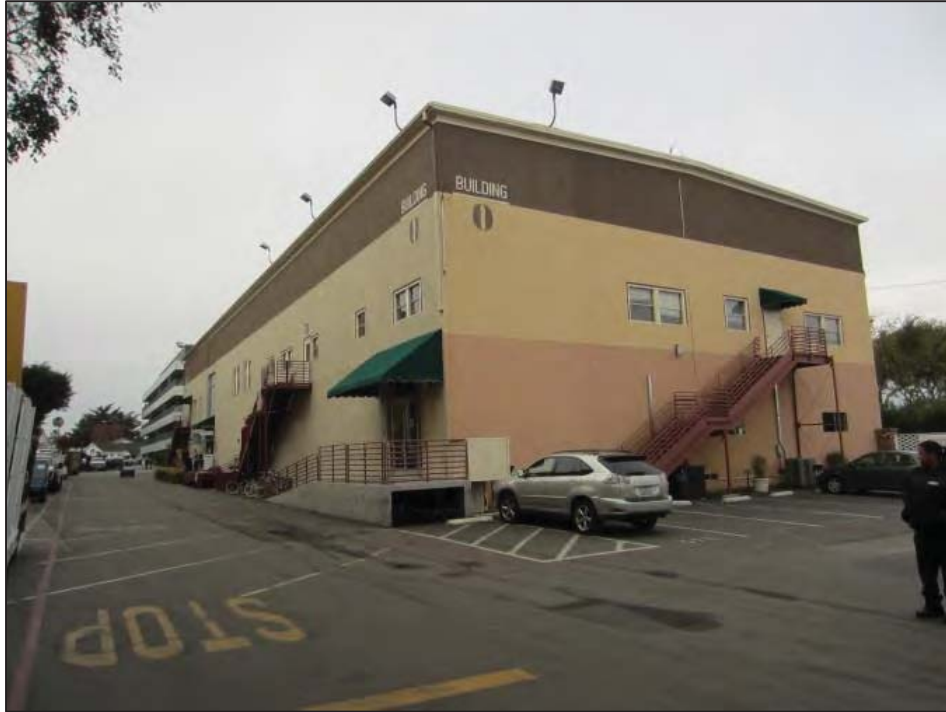
**Figure 31: Building O, Side and Primary Elevations, View North (PCR, 2015)**

The three-story Building O has a rectangular plan and low-pitched front-facing gabled roof accented with a plain frieze and molding (**Figure 31**). Building O is clad in stucco and has been substantially renovated. Building O is now used as a general storage space. According to the Sanborn maps, it was initially Stage 3 and was transformed into a storage and scene dock space when DeMille operated the Studio. Since its initial construction, Building O has undergone substantial alterations, first in 1988 and again in 1998. The row of windows along the third floor has been removed, infilled, and stuccoed over. The double-hung windows on the second floor have been replaced with aluminum double-hung windows, but the original wide board trim, bordered with narrow molding, is still intact. Two sets of exterior stairs lead to the second floor. Separating the first and second floors is a narrow belt-course. Along the west elevation are a variety of wood-trimmed windows and doors. A pair of large wooden freight doors is located on the west side. The east side is devoid of ornamentation and is a flat, stucco surface. Due to the numerous changes that have occurred over the years that detract from its integrity of design, workmanship, materials, setting, feeling and association, Building O no longer retains integrity.

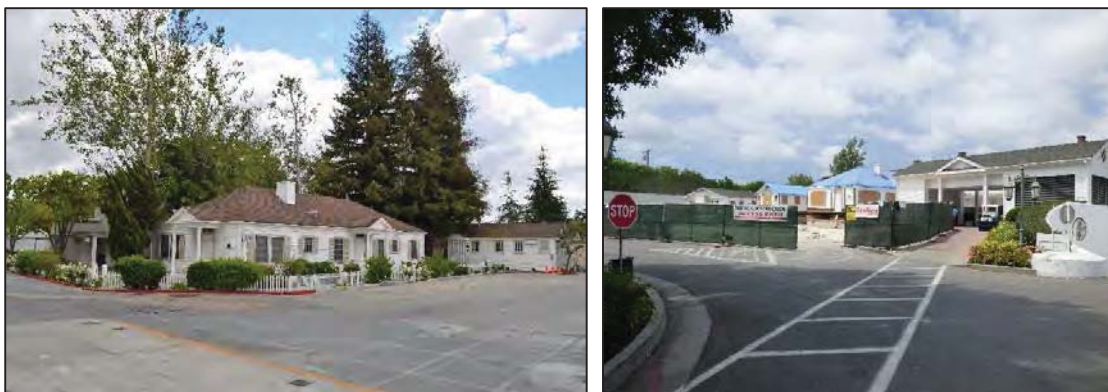
**Figures 32 and 33: Bungalow Group in original location (left) and after relocation (right) (ESA PCR 2017)**

A Relocation and Rehabilitation Plan (Plan) for Bungalows S, T, U and V (July 21, 2017) was prepared to ensure conformance with Standards and submitted to the City for a Certificate of Appropriateness. The Plan implements and satisfies the conditions of approval for CPA No. 6 and California Environmental Quality Act (CEQA) requirements associated with the December 2015 MND. The Bungalows were moved July 30 and August 20, 2017 from their original location south of The Culver Studios parking structure R to their new location (CPA No. 6) in the lawn area to the South of the Mansion Building (Building C) above the parking garage. After rehabilitation, a new landscape setting with similar plantings, sidewalks and perimeter fence will be created for the Bungalows to provide a historically compatible setting. The new landscape setting will be bordered by a picket fence, incorporate meandering concrete sidewalks similar to the original, and include decorative plantings similar to the original landscape.

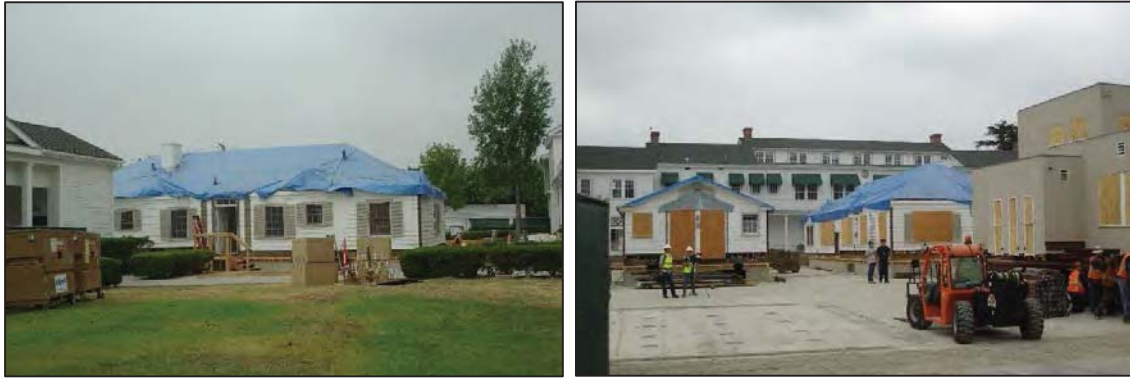
**Figures 34 and 35: Bungalow S after relocation (left) view to west, and Bungalows S, T, and V after relocation (right) view to north (ESA PCR 2017)**

Building S is an intact one-story American Colonial Revival-style bungalow. It consists of a rectangular floor plan on a concrete foundation (replaced after relocation). The bungalow is clad in wood clapboard siding and topped with a hipped roof with wood shingles (removed for replacement) and boxed eaves with a cornice. The primary (north) façade has a centrally located stoop with two concrete steps (to be replaced), a porch supported by two wood columns, and wooden balustrades on both sides of the stoop (removed during relocation to protect from damage). The main entrance consists of a wood panel door with a transom. Offset to the northern side of the east elevation is a stoop similar to the one located on the primary elevation, with a porch supported by wood columns, balustrades and concrete steps (removed during relocation to protect from damage). Fenestration (boarded during relocation for protection) is made up of single, paired, and tri-partite wood frame, double-hung windows with divided light and shutters.

Prior to relocation, Building T was oriented along a northwest-to-southeast axis and was immediately southwest of Building S, northwest of Building U, and west of Building V. Building T was moved on July 31, 2017 to its current location behind Building C on the roof of the existing parking garage (**Figure 35** above, and **Figure 36** below).

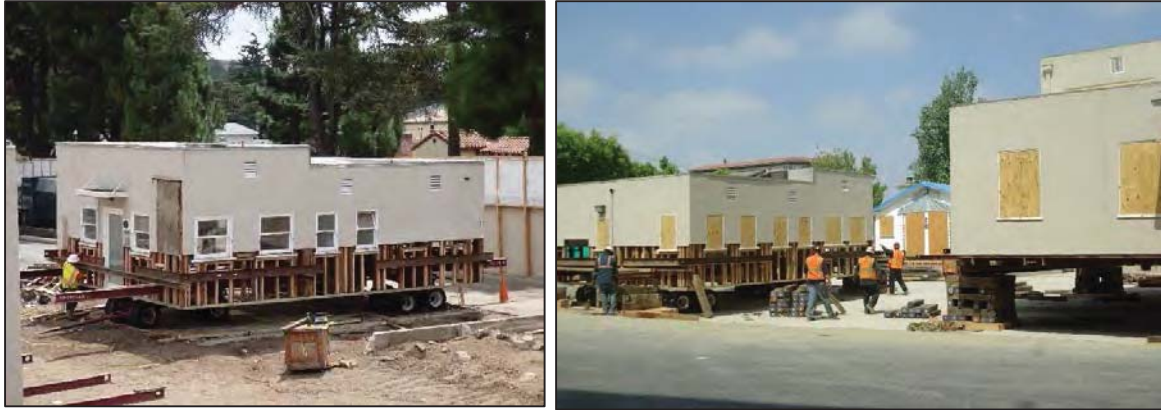
**Figure 37: Bungalow U being prepared for relocation (ESA PCR 2017)\_**  
**Figure 38: Bungalow U upon arrival at relocation site (ESA PCR 2017)**

Designed in the Moderne style, Building U is one-story with a square footprint and is covered in stucco. The front portion of the building is taller than the back, as the side elevations step down to the rear. The primary entrance has single-pane non-original door inset within a wood door-surround sheltered by a horizontal Moderne canopy and is flanked by two double-hung wood frame windows. Just below the canopy is a single wall light. The secondary elevations are also punctuated by narrow and regular sized double-hung wood-frame windows. Both side elevations have wall vents underneath the roof-line.

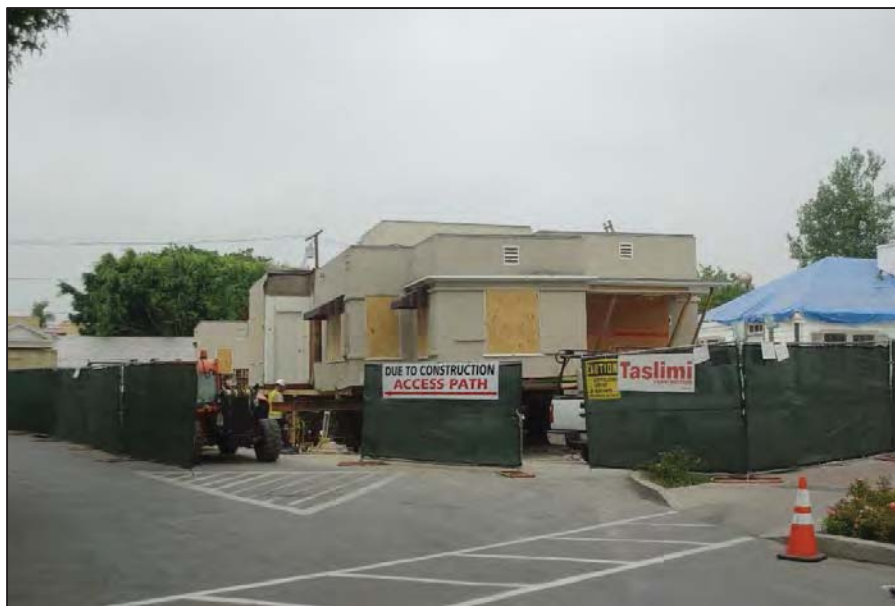
**Figure 39: Bungalow V upon arrival at relocation site (ESA PCR 2017)**

windows. To the north of the former garage, is a secondary entrance into the building covered by a wood awning. Underneath the roofline are wall-vents.

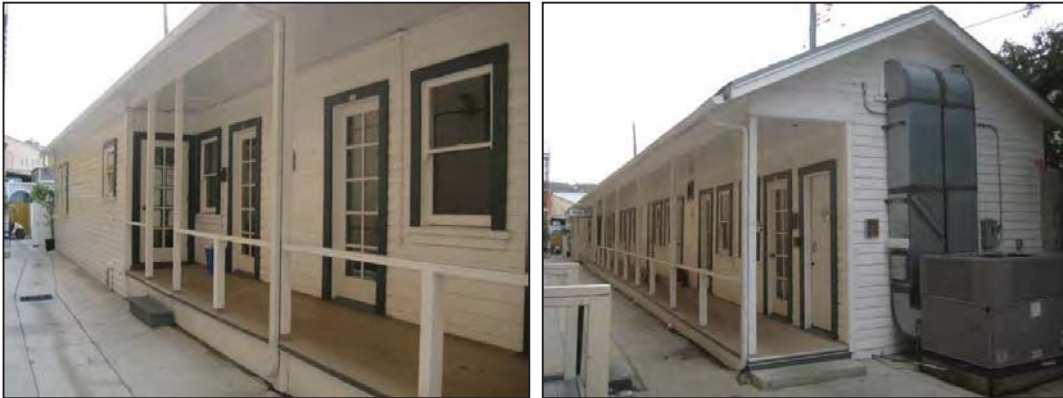
**Figure 40: (Left) Recessed porch and entrances to offices Bungalow W, east elevation, view to south (PCR, 2015)**

**Figure 41: (Right) Air-conditioning ducts and equipment at north elevation of Building W, view to south (PCR, 2015)**

Constructed sometime between 1922 and 1927, Building W is a wood frame Building with a rectangular footprint and concrete foundation. The building is located on the west side of the lot and is oriented to the east, inward towards the interior of the property. The primary façade (east elevation) has a recessed porch three quarters of the building's overall length (**Figure 40**). The porch is supported by wood beams with wood railings between the beams support beams. The building is clad with wood clapboard siding and topped by a gabled roof with overhanging eaves and composite shingles. Several entrances are located on the east elevation and consist of wood doors, most of which are fully glazed, divided light. Fenestration includes multiple wood frame double-hung windows. At the south end of the east elevation is a pair of wood frame double-hung windows. The south elevation has a stoop with a secondary entrance consisting of a fully glazed wood door. An overhang supported by wood posts provides shade to this end of the building (alteration) as well as housing an air-conditioning unit on the roof (alteration). The north elevation provides access to the east elevations porch with a single concrete step. Aluminum ventilation ducts and an air-conditioning unit (alterations) decorate this side of the building (**Figure 41**). Building W possesses a high level of integrity required to exemplify its historical and/or architectural significance for individual listing. Although Building W is associated with the DeMille/Early RKO period of significance (1925-1935), there is no indication that Building W individually played a role in the studio's development or significant events surrounding the studio when it was constructed in the mid-1920s. The building is not identified with historic personages related to the main currents of national, state, or local history. As an early film industry dressing room, Building W does not appear individually eligible for listing in the national, state or local registers as an exceptional, distinctive, outstanding, or singular example of

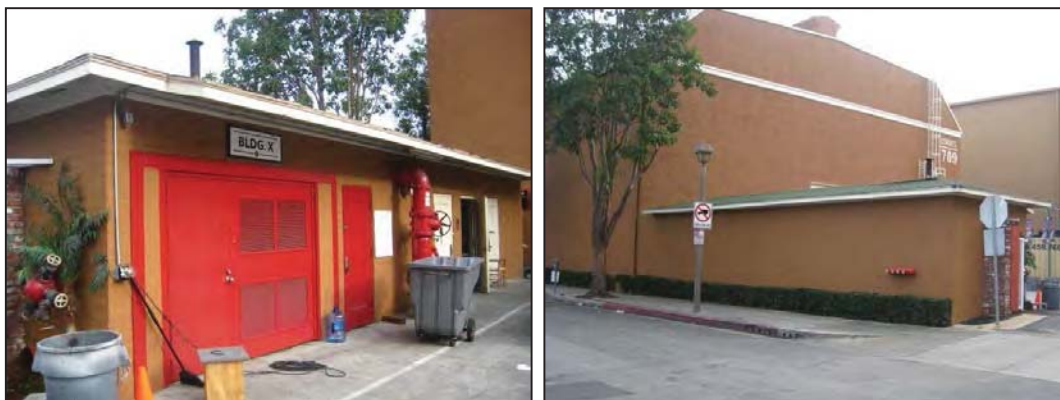
**Figure 42: (Left) West façade of Building X, view to east (PCR, 2015)**

Building X is located on the east side of The Culver Studios lot near Gate 3. Oriented fronting west towards the interior of the compound, Building X is a one story, utilitarian structure with a rectangular footprint (**Figure 42**). Constructed in 1948, the structure is built out of brick and topped with a low sloping hipped roof and composite shingles. Open eaves reveal exposed rafter tails. Four wood paneled doors lead to individual offices and utility spaces. In addition to the four wooden doors, there is a new metal door at the north end of the main façade and a large water pipe protruding from the center of the building. The north elevation consists of another red water pipe protruding from the wall as well as a pipe for ventilation. A brick pillar is attached to the north elevation and is part of the studio's gate. The east elevation consists of more red piping protruding from the wall (**Figure 43**). The south elevation contains electrical boxes. The structure has no fenestration. Building X has been altered over the years and no longer retains integrity of design, setting, workmanship, materials, feeling or association. The building's original configuration consisted of seven rooms with individual doors for the purpose of storing cameras, however it has been altered and transformed into offices and a utility Building housing firefighting equipment. The building's elevations have been significantly altered to accommodate the housing of water pumping equipment, including the addition of large pipes and valves. While Building X retains its original Building materials (brick), setting, and location, it no longer retains its association, design, and workmanship conveying its use as a camera vault due to extensive alterations to its primary (west) and secondary (north) elevations. Therefore, Building X retains a low level of integrity.

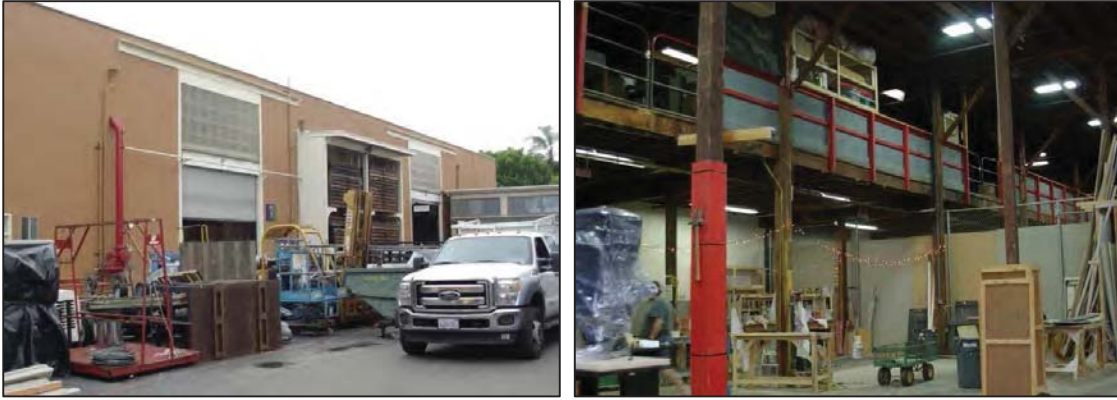
**Figure 44: (Left) Primary (North) Elevation, View Southwest (PCR, 2015)**

Constructed in 1931, the utilitarian designed Building Y is one-story with an irregular rectangular plan, rectangular massing, covered by a flat roof, and sheathed with stucco (**Figure 44 and 45**). The 1950 Sanborn map notes Building Y was used as a scene dock and had wood posts and a concrete floor. Three sets of oversized openings punctuate the primary (west) elevation. The openings have metal roll-up doors (alteration, replacements) and metal multi-light transom windows above (alteration, replacement). Also, there are four single-doors leading into restrooms and storage rooms (alteration, doors and transoms are replacements) on the primary elevation. Located between the two southern oversized openings is a tall scene dock. Building Y is connected to Stage 10 to the west by a canopy addition in 1941 and also connected to Building Z; these connections give the impression Building Y is part of a larger Buildings with a u-shape floor plan. The side and rear elevations are utilitarian, flat stucco surfaces. While Building Y was originally utilitarian in design when it was constructed in 1931, small changes such as door replacements, insertion of doors openings, addition of a scene dock and pipes on the primary elevation, and the connection to Stage 10 and Building Z have compromised its integrity in terms of design, workmanship, and materials. The 1987 Citywide Survey identified Building Y as having “severe” alterations. Because of these alterations the integrity of association and feeling as Building constructed during the Cecil B. DeMille/Early RKO Era (1925-1935) has been compromised. Furthermore, the setting of Building Y from its period of significance (Cecil B. DeMille/Early RKO Era) has been diminished because of alteration to neighboring Stage 10 and Building Z. Building Y only retains integrity of location.

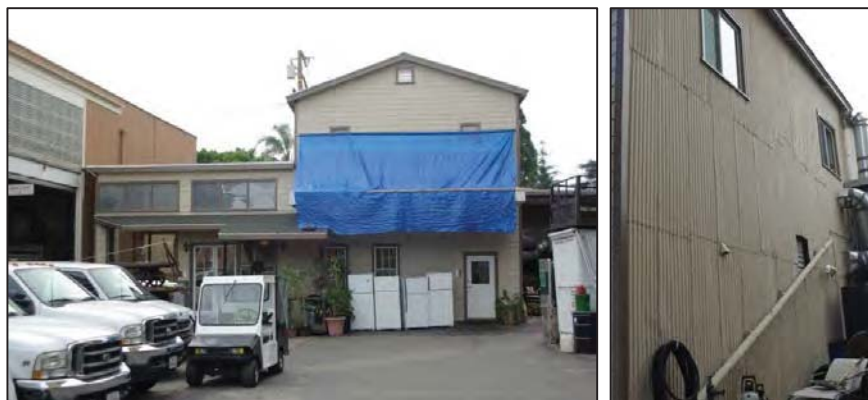
**Figure 46: (Left). Primary Elevation Building Z, View West (PCR, 2015)**

The one-and-two story Building Z has a rectangular plan and its side (east) elevation is located along the southern end of Building Y. The one-story portion has a flat, while the two-story portion has a front gable roof covered in composition (**Figure 46**). The primary elevation is sheathed in horizontal wood boards and the side elevations are covered with sheets of corrugated metal (**Figure 47**). The primary elevation has a number of alterations including different types replacement doors and windows, an attached porch and a make-shift second-floor awning. The side (west) elevation has aluminum slider windows on the second floor and attached mechanical equipment. Constructed circa 1922 as noted on the original assessor record, Building Z was originally one-story and had an L-shape plan, comprised of two rooms for the blacksmith and stage shed. The roof was noted as a gable and was covered with corrugated tin. Later the 1950 Sanborn map shows the building maintained its L-shape plan, was one- and two-story, and used as a plaster shop and tractor shed. Since its original construction, Building Z has undergone many changes that have degraded the integrity of workmanship, design and materials. Building Z no longer has an L-shape plan, as a result of an addition in front of the one-story shed Building Z now has a rectangular plan. There are no original windows or doors on the building, the primary elevation has been re-sheathed with wood vertical boards, and two awnings were added onto the primary elevation. The most original aspect of Building Z is the corrugated metal covering the side elevations, however, the retention of this material on the secondary elevation is not enough for Building Z to retain integrity of materials or design. Furthermore, the 1987 Citywide Survey identified Building Z as having “severe” alterations. Because of these alterations, the integrity of association and feeling as Building constructed during the Thomas Ince Era (1918-1924) has been compromised. Furthermore, the setting of Building Z from its period of significance (Cecil B. DeMille/Early RKO Era) has been diminished because of alterations to neighboring Building Y. Building Z only retains integrity of location.

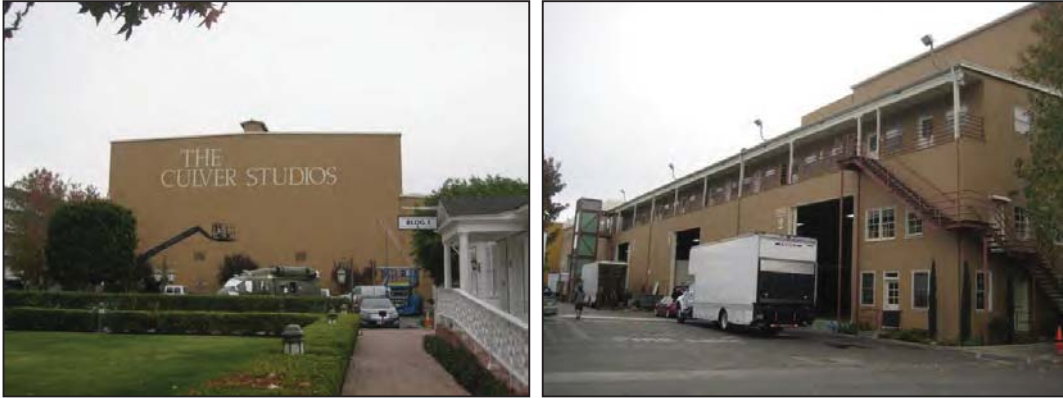
**Figure 48: (Left) North elevation of Sound Stage 2/3/4, view to south (PCR, 2015)**

Sound Stage 2/3/4 is housed in a large utilitarian structure on the northwest portion of the lot. The three-story structure has a rectangular footprint that is oriented fronting north towards the Building C (Mansion) (**Figures 48 and 49**). Constructed in 1926, Sound Stage 2/3/4 is the earliest remaining stage constructed on the lot. Sound Stage 2/3/4 is an undistinguished utilitarian common to other studio lots. Historically however, Sound Stage 2/3/4 represents a change building in stage construction, abandoning glass walls and relying on an increased use of artificial lighting, and was altered to accommodate the Studio's transition from the Silent Film Era into the Era of the "Talkies." Several ground level offices were added to the building in 1943. Elevator shafts have been added to the east and west elevations, but their design conforms to the Secretary of the Interior's Standards. The structure is clad with stucco and topped with a low pitched roof with a cupola that runs the length of the building. Each end of the building contains three floors of office space, accessed via metal stairs (alteration). Four large wooden freight doors located along the east side of the structure provide access to the sound stages. Recessed porches supported by wood posts run halfway along each side of the building on the third floor, providing access to various office spaces. Where the recessed porch ends, a row of metal frame double hung windows begins. An elevator shaft made of metal framing and glass (alteration) is attached to the east side of the building. There are multiple doorways located along each side of the building, consisting of a variety of door types, including wood paneled doors and partially glazed wood panel doors. Fenestration throughout varies as well with a combination of wood frame double-hung windows, metal frame double hung windows, metal frame sliding windows, and metal frame tilt windows. Sound Stage 2/3/4 possesses a high level of integrity by retaining its original design, materials, location, workmanship, feeling and association as an early sound stage. Although the sound stage has been altered with the addition of several ground level offices in 1943, these offices have attained additional significance due to their association with the David O. Selznik era. Elevator shafts have been added to the east and west elevations, however they conform to the Secretary of the Interior's Standards and therefore do not detract from the building's individual eligibility as a historical resource. Although the building's setting has changed from its original date of construction in 1926, the building retains enough integrity to convey its significance as an early sound stage.

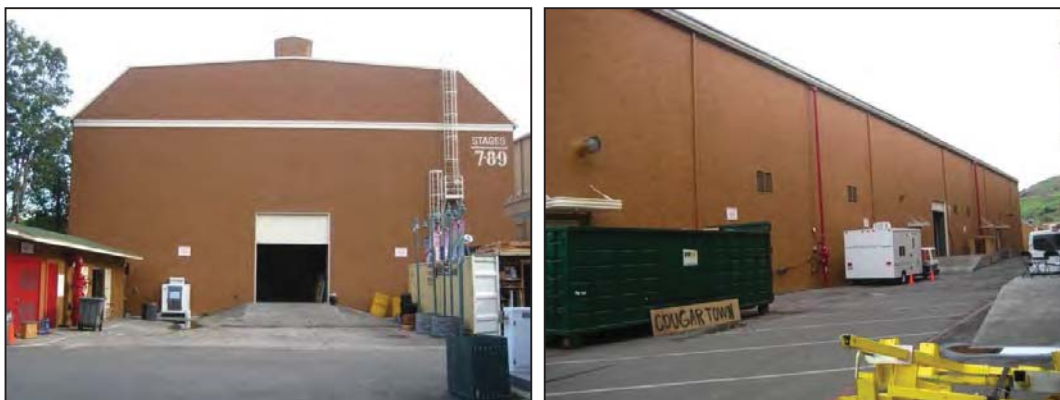
**Figure 50: (Left) North elevation of Sound Stage 7/8/9, view to southwest (PCR, 2015)**

Sound Stage 7/8/9 was built in 1929 and is located on the east side of the lot next to Building X. Oriented fronting west towards the interior of the compound, Sound Stage 7/8/9 is housed in a one story, utilitarian structure with a rectangular footprint on a concrete foundation (**Figure 50 and 51**). The existing structure is clad with stucco and topped with a low pitched Dutch Colonial style roof. A large wooden freight door and concrete ramp are located at the center of the main façade. In addition to the freight door, four walk-in doors provide access to the sound stages via concrete stairs with metal railings. The walk-in doors are specially made sound proof doors situated below flat metal Moderne-style canopies (alterations). The north elevation consists of another concrete ramp leading to a wooden freight door. A walk-in entrance is situated on the east side of the freight door and includes a wood paneled door with flat wooden canopy and wooden stairs. On the west side of the freight door is a large metal ladder leading to the building's roof. The south elevation consists of a large wooden freight door and a concrete ramp. A pair of ventilation ducts extends from the façade on the east side of the freight entrance. Also on the east side of the freight entrance is a walk-in door with concrete steps, metal railing, and a metal Moderne-style canopy (alteration). Sound Stage 7/8/9 possesses a high level of integrity by retaining its original design, materials, location, workmanship, feeling and association as early sound stages. The stage has no apparent major or minor alterations. Although the building's setting has changed from its original date of construction in 1929, the building retains enough integrity to convey its significance as an early sound stage.

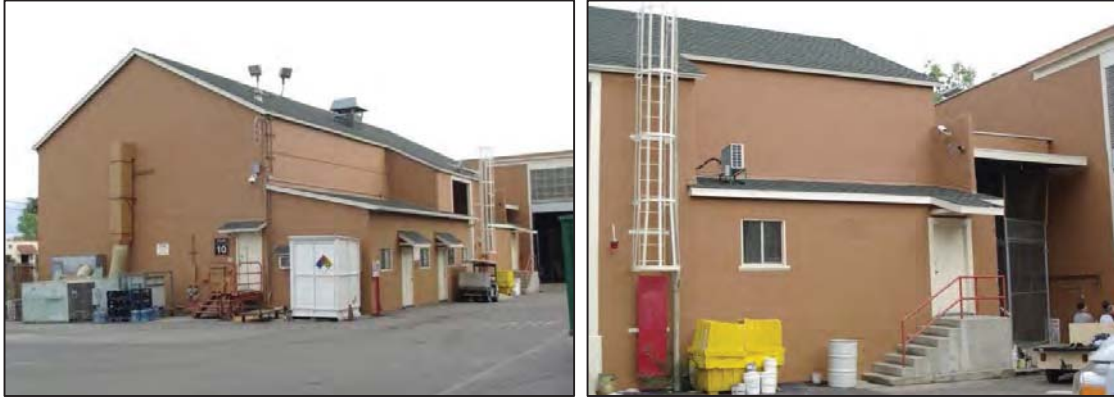
**Figure 52: (Left) Side (West) and Primary (South) Elevations Sound Stage 10, View Northeast (PCR, 2015)**

association with movie production. The setting of Stage 10 from its period of significance Cecil B. DeMille/Early RKO Era (1925-1935) has been diminished because of its relocation and alteration to neighboring Building Y and Building Z. Furthermore, Stage 10 does not retain integrity of location.

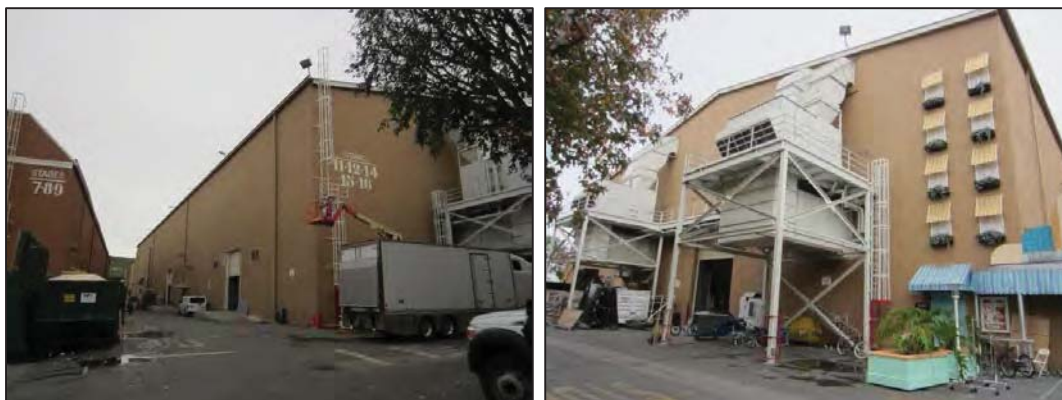
**Figure 54: (Left) West and North Elevations Stage 11/12/14, View Southwest (PCR, 2015)**

Constructed in 1927 as Stage 6, Stage 11/12/14 is one story and utilitarian in appearance and has a concrete foundation, rectangular plan and massing, steel frame, stucco sheathing, and low-pitch steel truss roof (**Figure 54**). The overall building is divided into three stages, which are accessed via three oversized openings on the primary (east) elevation. The oversized entrances consist of metal-clad freight doors accessed from a concrete platform with a side ramp (alteration, appears to be a recent addition). There are two regular pedestrian doors (alteration, doors appear to be replaced) accentuated by Streamline style awnings and concrete platforms and stairs (alteration) that open into Stage 14 and Stages 11/12. Rectangular vents nearly aligned with the top of the oversized doors punctuate the east elevation at regular intervals. A fourth oversized opening is located on the side (north) elevation and to the west is a pedestrian door (alteration, door appears to be replaced) that leads into Stage 11 (**Figure 55**). The south elevation is located within an enclosed entry porch with a shed roof centered on the south elevation. A concrete ramp (alteration) leads to the entrance, consisting of tall, floor-to-ceiling wood double doors. Flanking the entry porch are two additions. In 1934, an addition with the approximate dimensions of twenty-four feet by eight feet was constructed just west of the primary entrance. At an unknown date, an addition was constructed just west of the primary entrance and appears to have been derived from canopy and shed additions built in 1943. Both of these additions are one-story and have shed roofs, vertical slider windows, and paneled wood entry doors. Both side (west and east) elevations have secondary entrances into the stage. The rear elevation is a flat, stucco surface with several gutters leading to the roof.

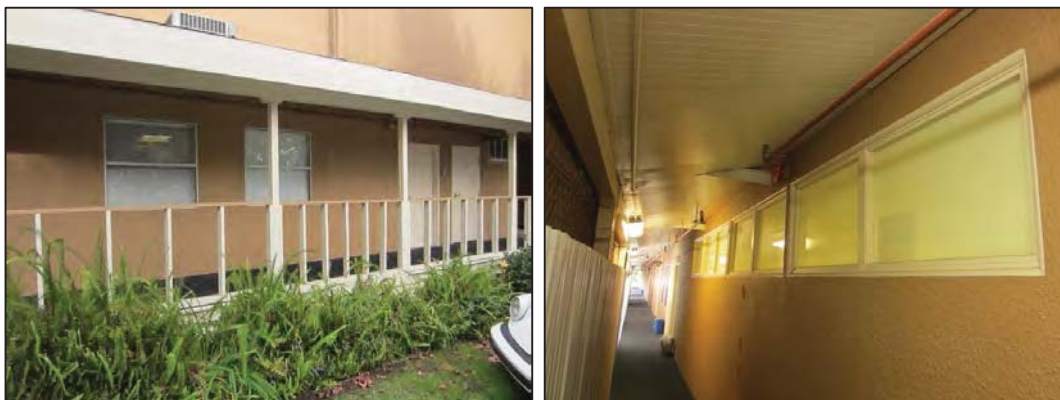
**Figure 56: (Left) Close-up of Dressing Room Addition Stage 11/12/14, West Elevation, View East (PCR, 2015)**

**Figure 57: (Right) Close-up of Dressing Room Addition Underneath Walkway Cover Stage 11/12/14, West Elevation, View North (PCR, 2015)**

Stage 11/12/14 is attached to Stages 15/16, constructed in 1940, at the side (south) elevation. Stage 11/12/14 was sound proofed in 1931, and a rear one-story addition (dressing rooms) was added in 1932 (**Figures 56 and 57**). This addition remains extant and runs the entire length of the side (west) elevation. The shed roof extends past the front elevation of the dressing room addition to create a covered walkway. The dressing room addition is covered in stucco and has rows of clerestory wood-frame single-light fixed windows, vertical aluminum slider windows (alteration), and wood panel doors (alteration, replaced). Stage 15 was added to the south elevation in 1940, and the original Stage 6 was divided into three sound studios sometime before 1950. As a whole, Stage 11/12/14 retain enough workmanship, feeling, and materials to represent the Cecil B. DeMille and David O. Selznick eras. Furthermore, Stage 11/12/14 retains its feeling and association as a sound studio and its original location.
