### Historical Resources Technical Report

# THE CULVER STUDIOS

## HISTORICAL RESOURCES TECHNICAL REPORT

September 2017

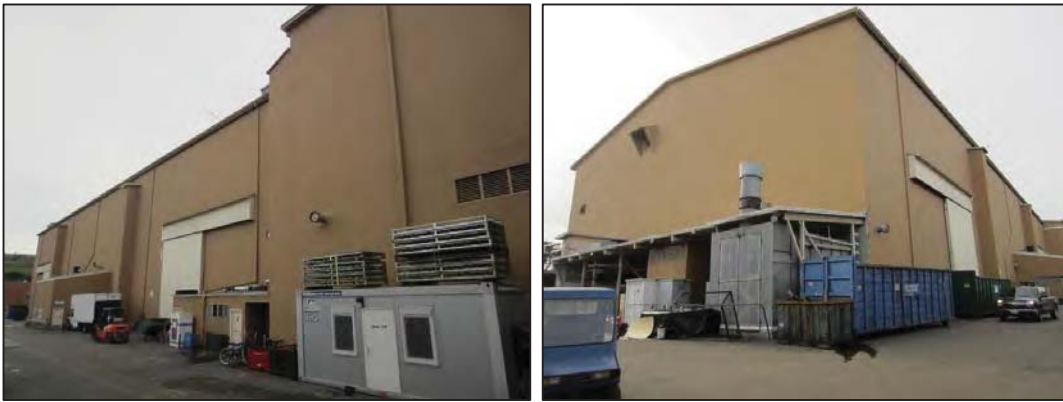
**Figure 58: (Left) East Elevation Stage 15/16, View West (PCR, 2015)**

**Figure 59: (Right) South and East Elevations Stage 15/16, Showing Screendock, View Northwest (PCR, 2015)**

In 1940, Stage 15/16 was constructed onto the side (south) elevation of Stage 11/12/14. Stage 15/16 has a concrete foundation, wood-frame, concrete piers, steel columns, steel truss roof, and wood sash windows and doors (**Figures 58 and 59**). Stage 15/16 is sheathed in stucco and is

devoid of ornamentation. The original structure had two-inch wool blanket insulation/interior finish, which appears to be intact. The primary (east) elevation is set back from Stage 11/12/14 approximately thirteen feet. At the corner created by the intersection of Stage 11/12/14 and Stage 15/16, is a one-story bathroom (original, constructed in 1940). Two oversize metal sliding doors punctuate the east elevation. Located in between the oversize metal sliding doors, is a 20 foot by 29-foot storage addition with a shed roof added in 1943. The secondary south and west elevations are utilitarian in appearance and plain stucco surfaces. Located on the south elevation is a screen dock constructed of wood in 1942 and a fan protected by a shed roof near the roofline. A process screen stage room protrudes from the northern end of the rear elevation and has a heavy metal door and wall light. To the west of the east elevation along the parcel line is another scene dock. Stage 15/16 retains integrity of workmanship, feeling, materials, location, setting, association, and feeling. In 1940, Stage 15/16 was constructed onto the side (south) elevation of Stage 11/12/14. Stage 15/16 appears to be overall intact and retains its original materials, workmanship, design, and location. Furthermore, Stage 15/16 retains its feeling and association as a sound stage.

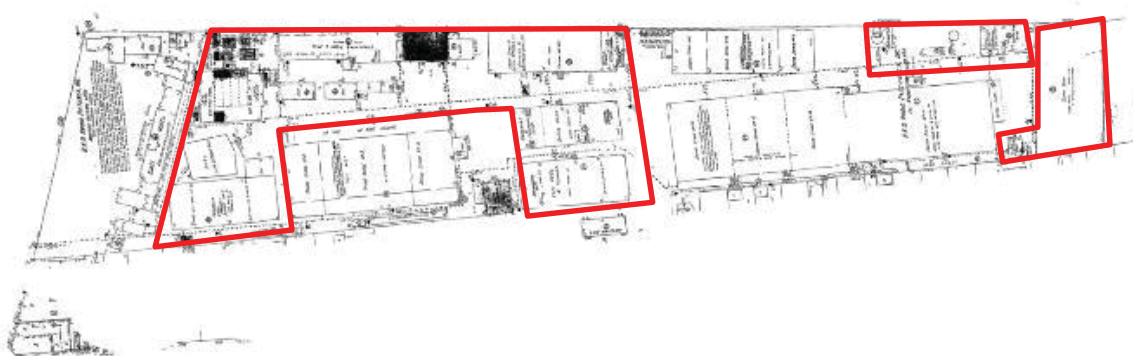
**Figure 60: 1950 Sanborn map depicting the Studio at the end of its period of significance. Portions outlined in red have been demolished or altered and no longer contribute to the potential district. (ESA PCR, 2015)**

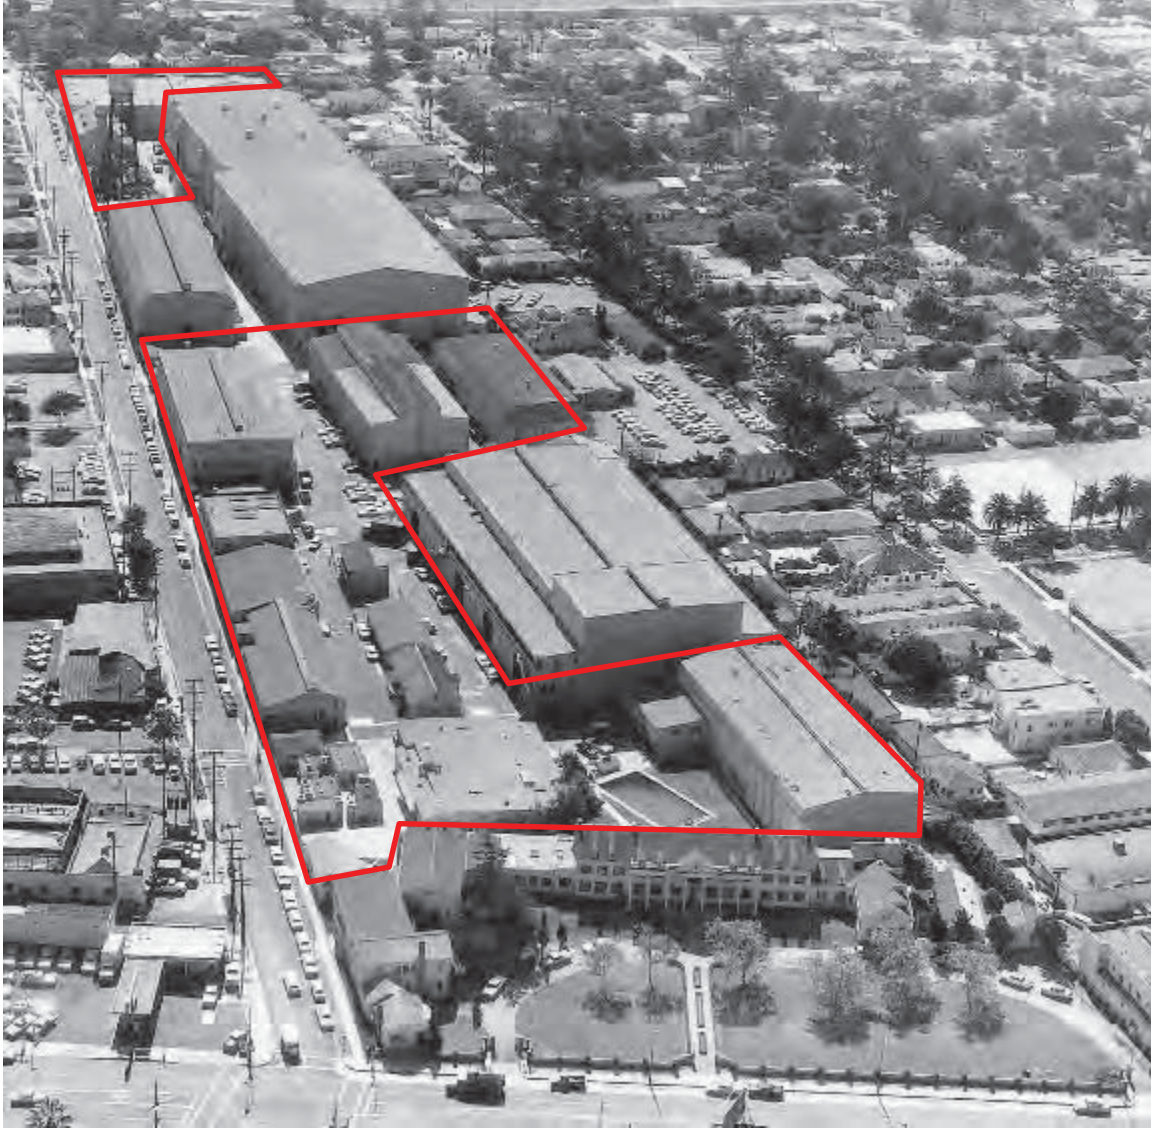
**Figure 61: Aerial view of The Culver Studios, circa 1958. Areas outlined in red represent portions of the Studio that have lost integrity due to demolition or alteration (Bison Archives).**

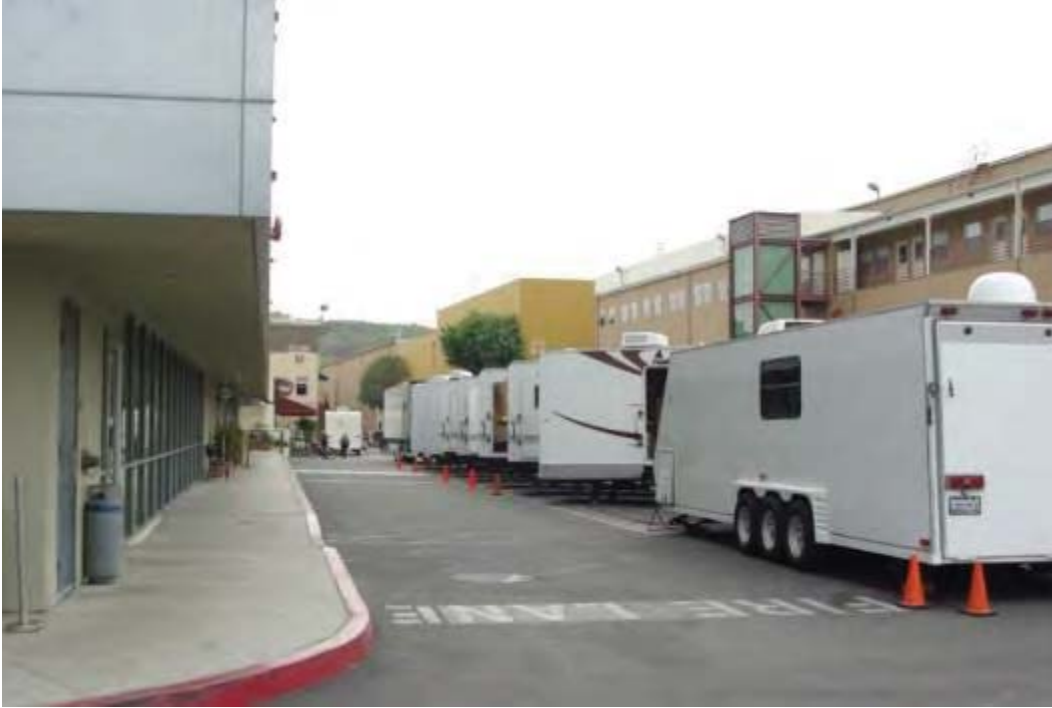
**Figure 62: Present day view of The Culver Studios' interior, View Southeast (ESA PCR, 2015).**

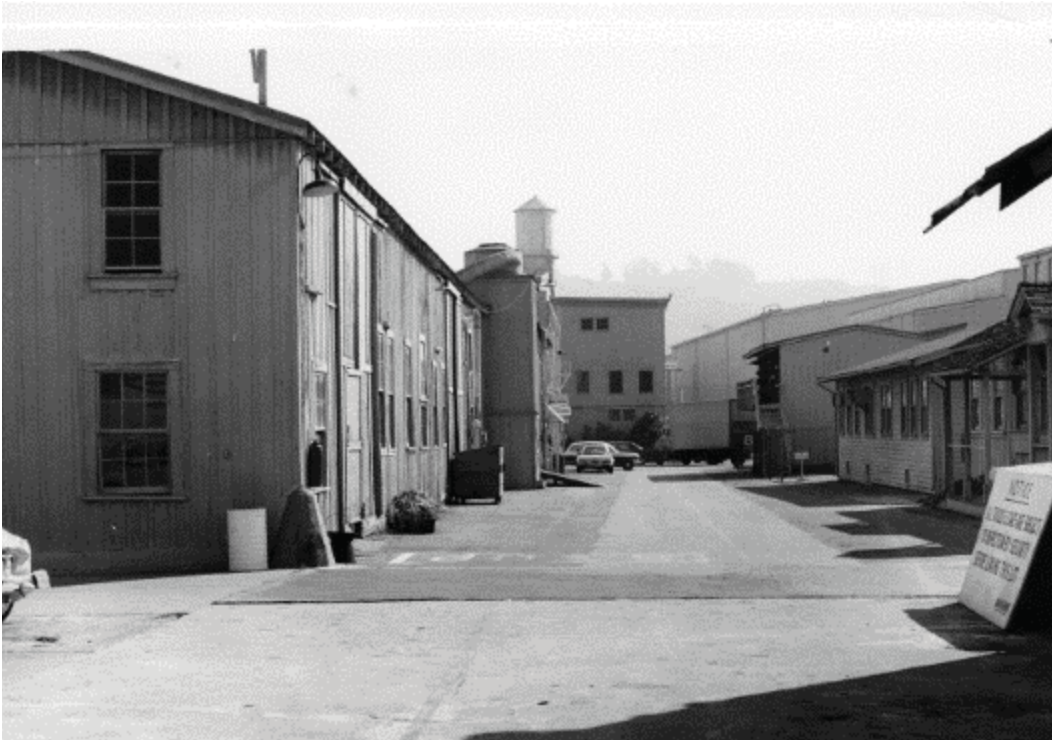
**Figure 63: Interior view of The Culver Studios, circa 1976, View Southeast showing former historic appearance before to later alterations (Bison Archives).**
