Top 10

Building-Code Violations

A veteran building inspector reviews the mistakes he sees over and over

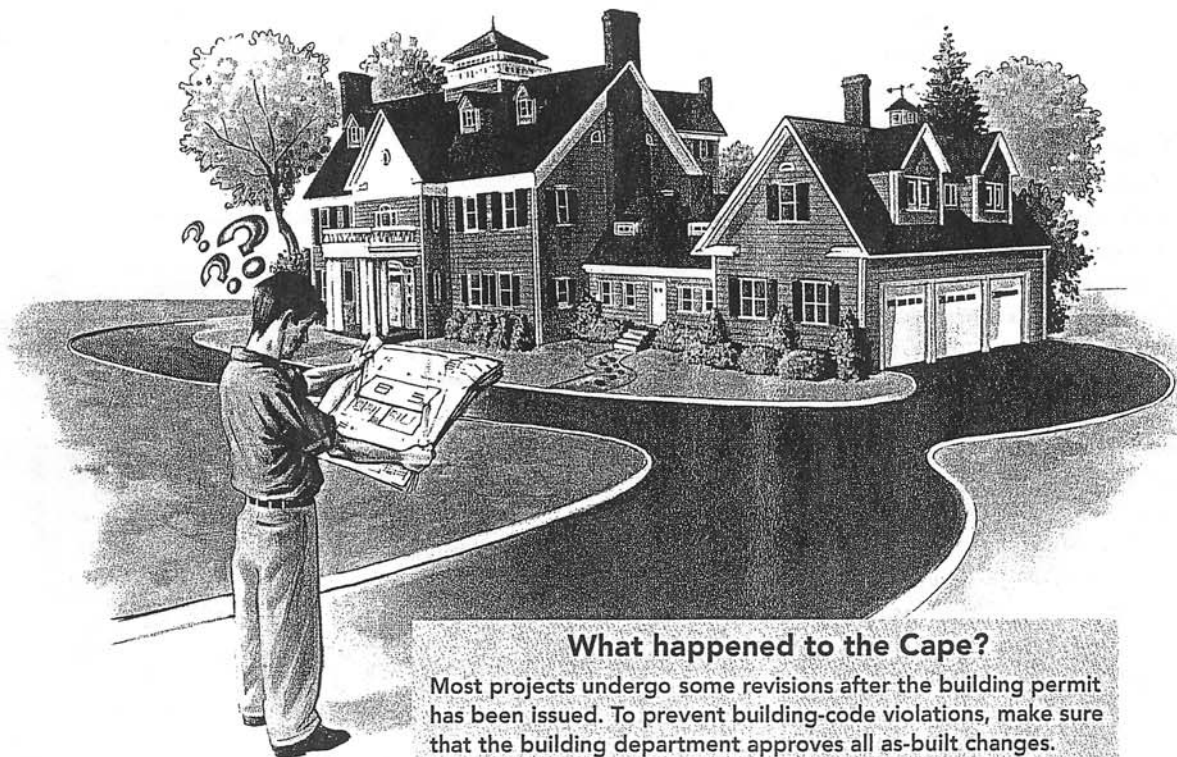
What happened to the Cape?

Most projects undergo some revisions after the building permit has been issued. To prevent building-code violations, make sure that the building department approves all as-built changes.

I don't meet a lot of builders who willfully disregard house plans. However, I do see a lot of builders—or, more often, their subcontractors—who don't realize they're working from an outdated set of plans (drawing facing page). To avoid delays at the outset, architects often ask contractors to submit bids based on preliminary drawings.

Field changes are another problem. During the course of a typical project, builders often have to make field changes to apply the design to real-world conditions. Drawings must be made to reflect these changes, and these as-built drawings must be routed through the building department for analysis and approval.

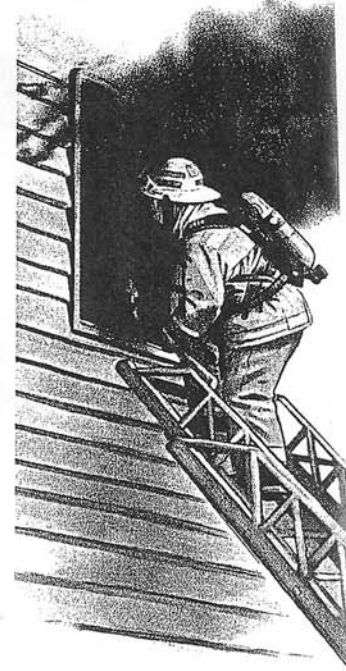
Egress windows serve two functions

At least one window in each bedroom must be of sufficient size to permit the occupants to escape a fire and also to allow a fully outfitted firefighter to enter. An egress window must satisfy all four IRC criteria:

To achieve the required net clear opening of 5.7 sq. ft., a 20-in. wide window **B** would have to be 42 in. high.

Likewise, a 24-in. high window **C** would have to be 35 in. wide.

- **Emergency-egress windows too small.** The one thing that inspectors never fail to check is the required emergency-egress window from a sleeping room. One window in each sleeping room must be large enough to ensure that occupants can escape a fire safely or that a firefighter can enter for a rescue (drawing above).
